CEEn-2018CPST-001: Bluffdale Bridge Options

Submitted to Michael Fazio and Dan Tracer
3/27/2019

Structural Calculations and Options for a Roadway Bridge over Utah Canal
14400 S., Bluffdale, UT

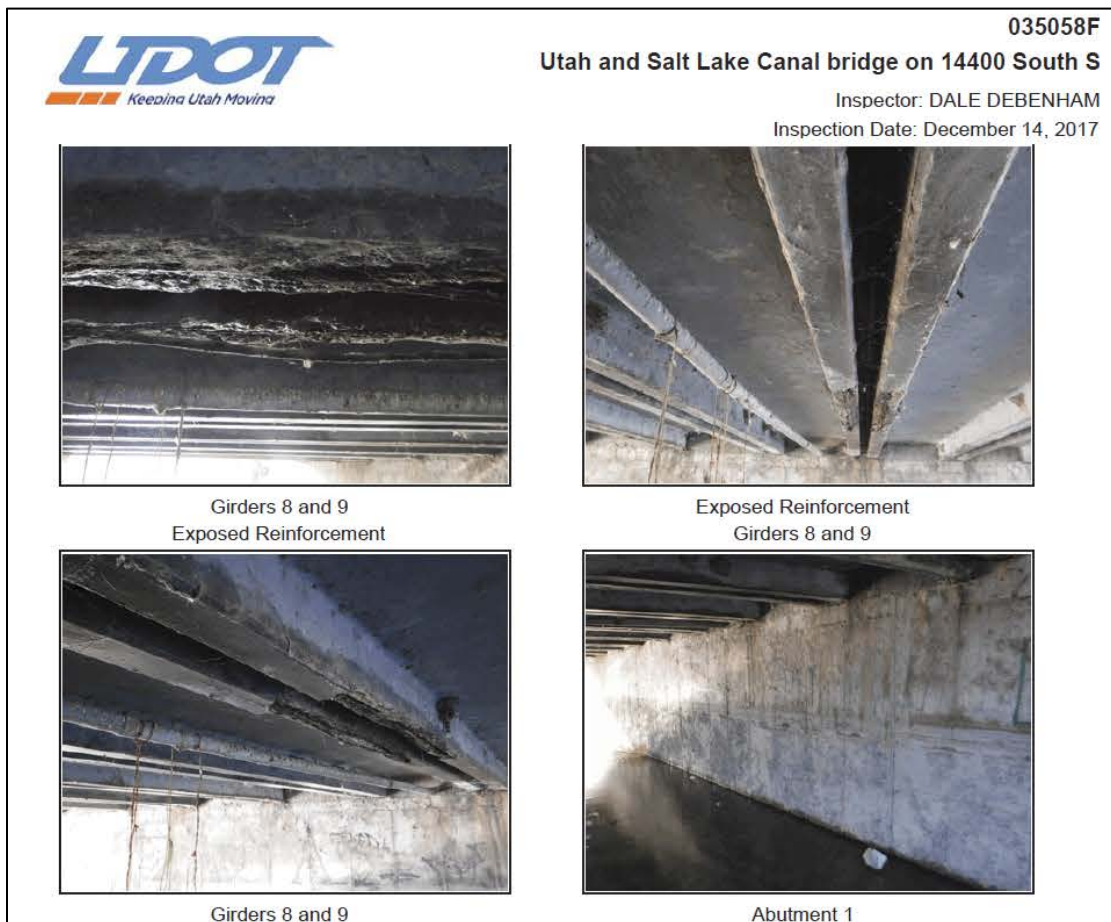
Figure 11: UDOT Report Photos, 14 December 2017

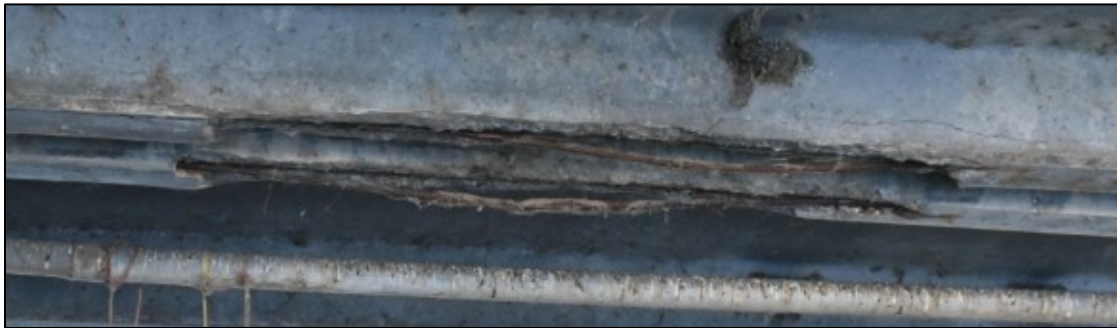
A comparison between Figure 12 and Figure 13 shows that additional corrosion has taken place during the winter. The rebar on girder 9, the beam in the foreground, has sagged significantly more. This sagging indicates active degradation of the bond between the steel and the concrete, and similar. Comparing Figure 12 and Figure 14, it is clear to see that a large piece of concrete has fallen off the left side of the beam. Concrete will continue to crack off as time progresses, exposing more rebar to the atmosphere. Once the steel is exposed, the rate of corrosion is intensified.

Concrete cracking off is a major concern for the future strength of the bridge. The concrete protects the reinforcing steel from corrosion; once the concrete cracks off, there is nothing left to protect the steel. As shown in the strength analysis section, corroding steel causes a major decrease in strength.

Figure 12: Corrosion on Girders 8 & 9, October 2018

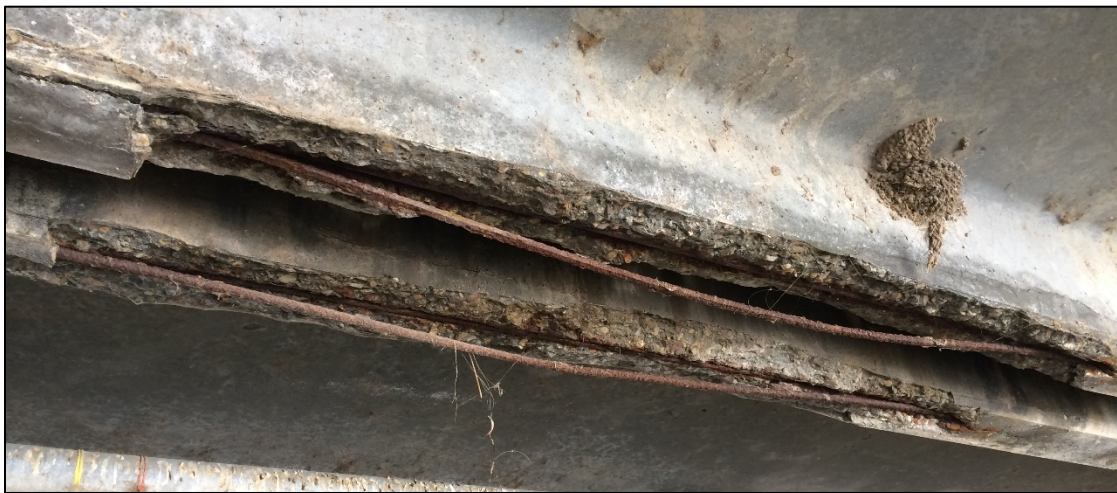
Figure 13: Corrosion on Girders 8 & 9, January 2019

Figure 13 also clearly shows a line of discoloration in the concrete. All the concrete near the spalling is dark in color, while the concrete above is lighter. This is likely caused by efflorescence, water seeping through the concrete and carrying away minerals. This is cause for concern because it is evidence that water is actively penetrating the concrete, especially surrounding the spalled region. With the water line coinciding well with the location of the prestressing strand, it is very likely that all the strands have an active and sufficient supply of water. The steel is at high risk of corrosion within the beam because of this penetration.

According to the December 2011 UDOT inspection report, these girders that now exhibit severe spalling showed only longitudinal cracking; thus, the six-feet of complete delamination and spalling of concrete occurred within a 6-year time period.

The concrete continues to spall at a very fast rate; we observed 4-6 inches of additional spalling of Girders 8 & 9 within just the time frame of our project (5 months). These girders are expected to lose a significant portion of concrete within the next few months.

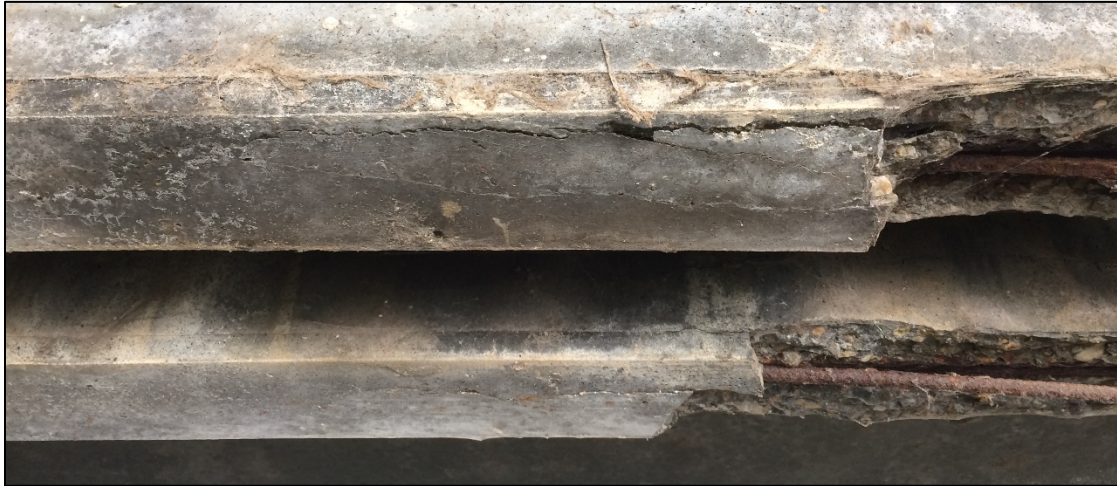
Figure 14: Close-Up of Corrosion, January 2019

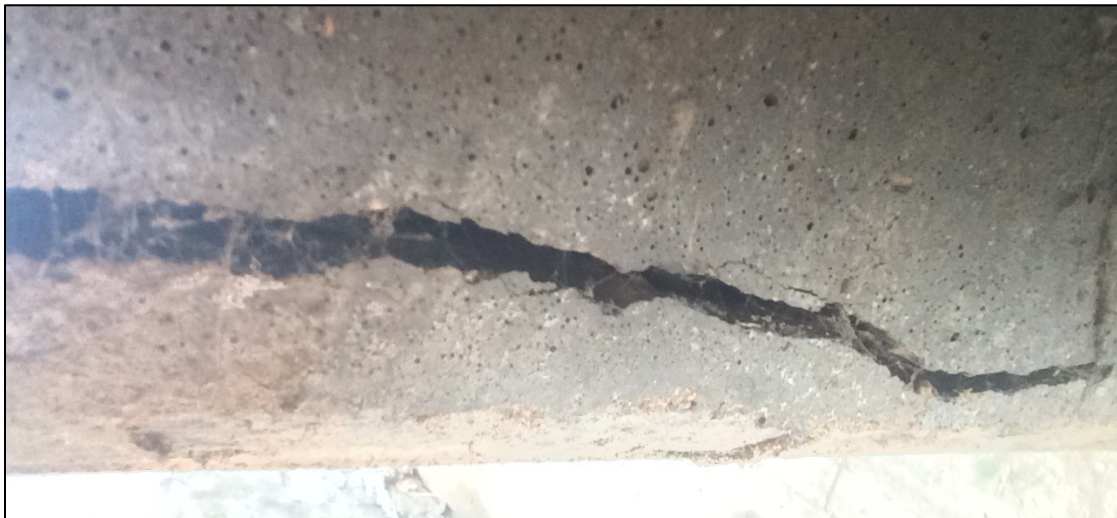
Figure 15 shows a large crack developing in the beam. This piece of concrete is likely to detach completely from the beam in a very short time and expose more reinforcing steel. This crack is approximately 18 inches long—if it were to fall, it would expose a significant amount of prestressing steel and rebar.

Figure 15: Large Developing Crack, January 2019

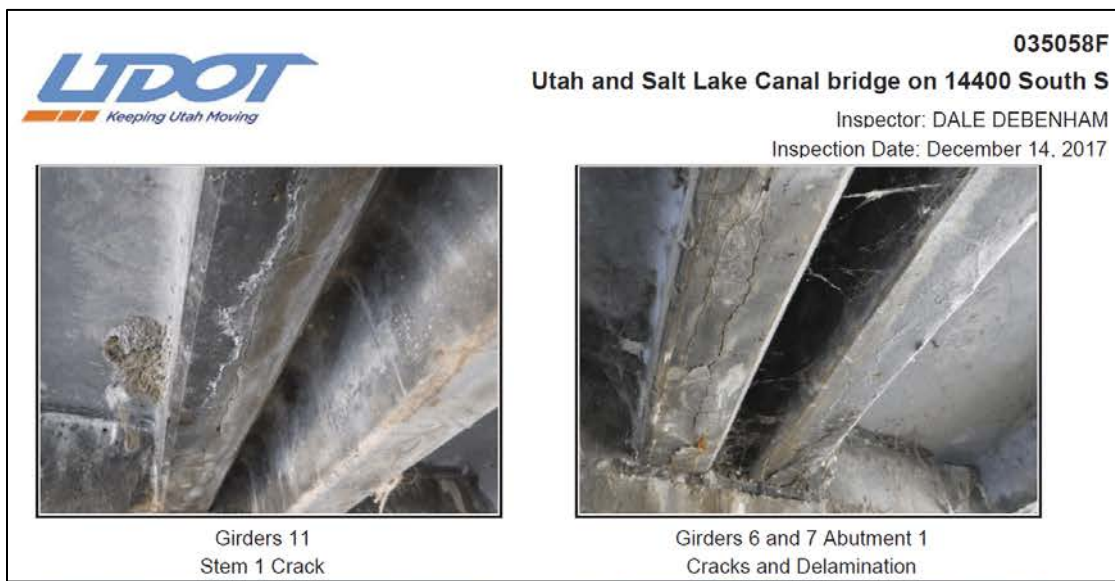
In addition to the significant deterioration of Girders 8 and 9, other girders show signs of cracking at the ends of the beams. The figures below show examples of this cracking, almost all of which show evidence of rust staining.

Figure 16: UDOT Inspection Report Cracking, 14 December 2017

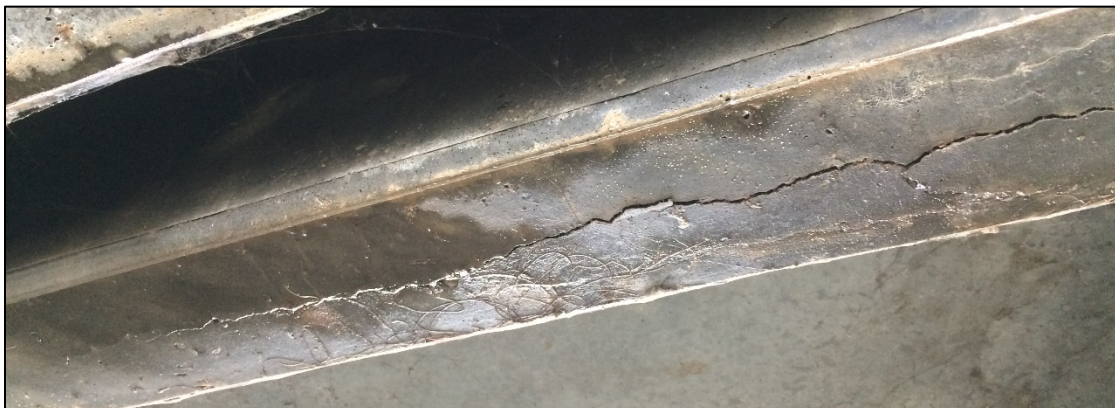
Figure 17: Girder 6 Cracking Near Mid-Span, January 2019

The cracking in the pictures above are expected to produce significant problems in the near future. According to the UDOT inspection report, the deterioration shown in girders 8 & 9 began as middle longitudinal cracking in 2011, similar to the current cracks shown in girder 11 in Figure 16 and girder 6 in Figure 17. Figure 17: Girder 6 Cracking Near Mid-Span, January 2019. Additionally, Figures 18 and 19 show the same longitudinal cracking at the ends of the girders. While the type of failure may not be exactly the same, we can assume that these cracks will develop in a similar manner and time frame as girders 8 & 9. This indicates that girders 6, 7, 10 & 11 are expected to have a similar deterioration as girders 8 & 9 within approximately 5 years.

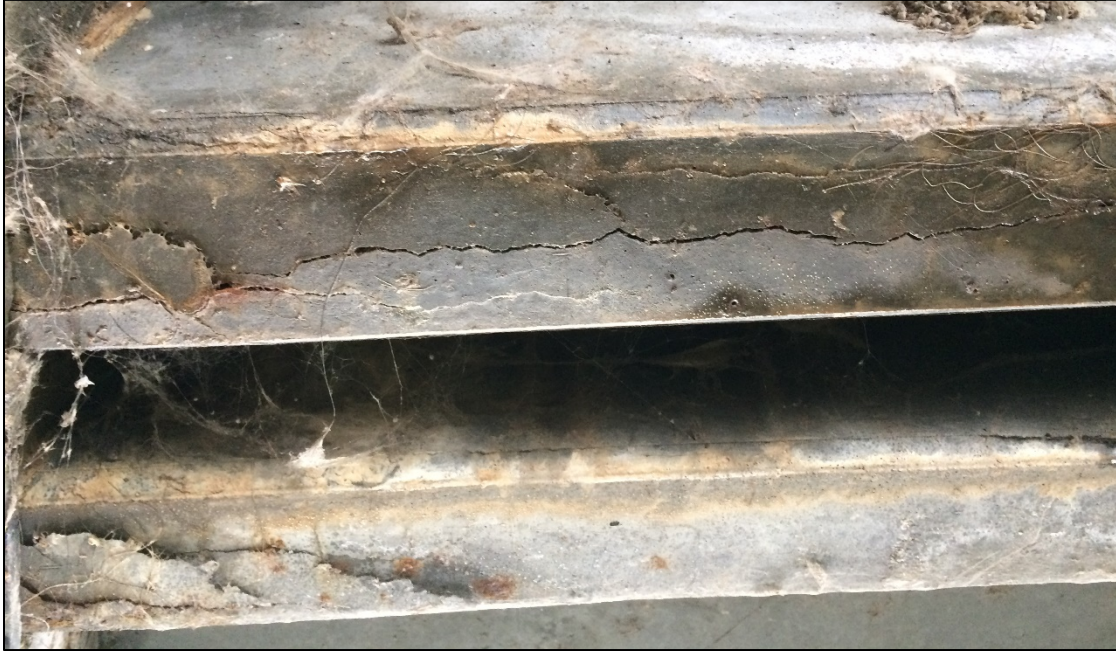
Figure 18: Girders 6 & 7 Cracking and Delamination, January 2019

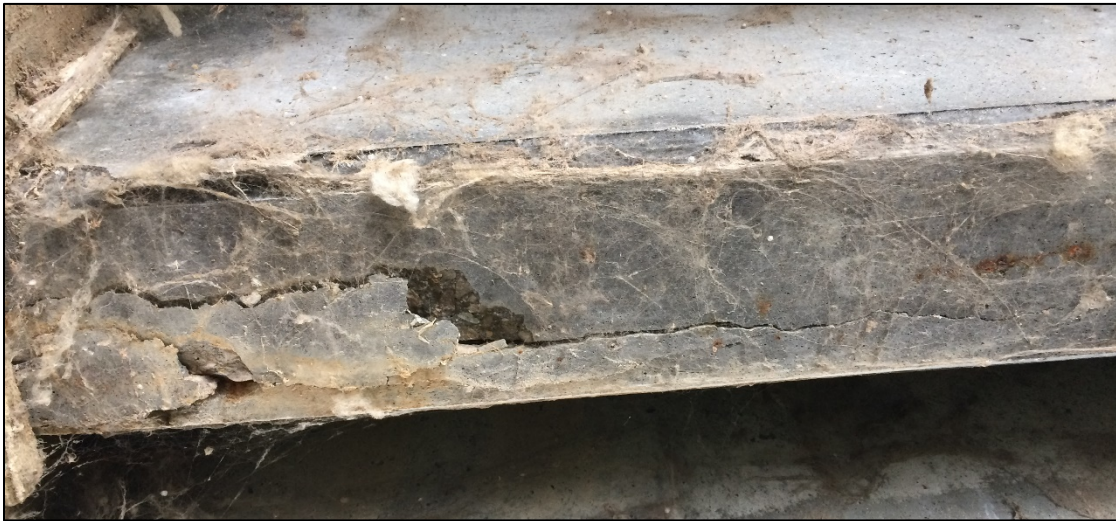
Figure 19: Other Cracking and Delamination, January 2019

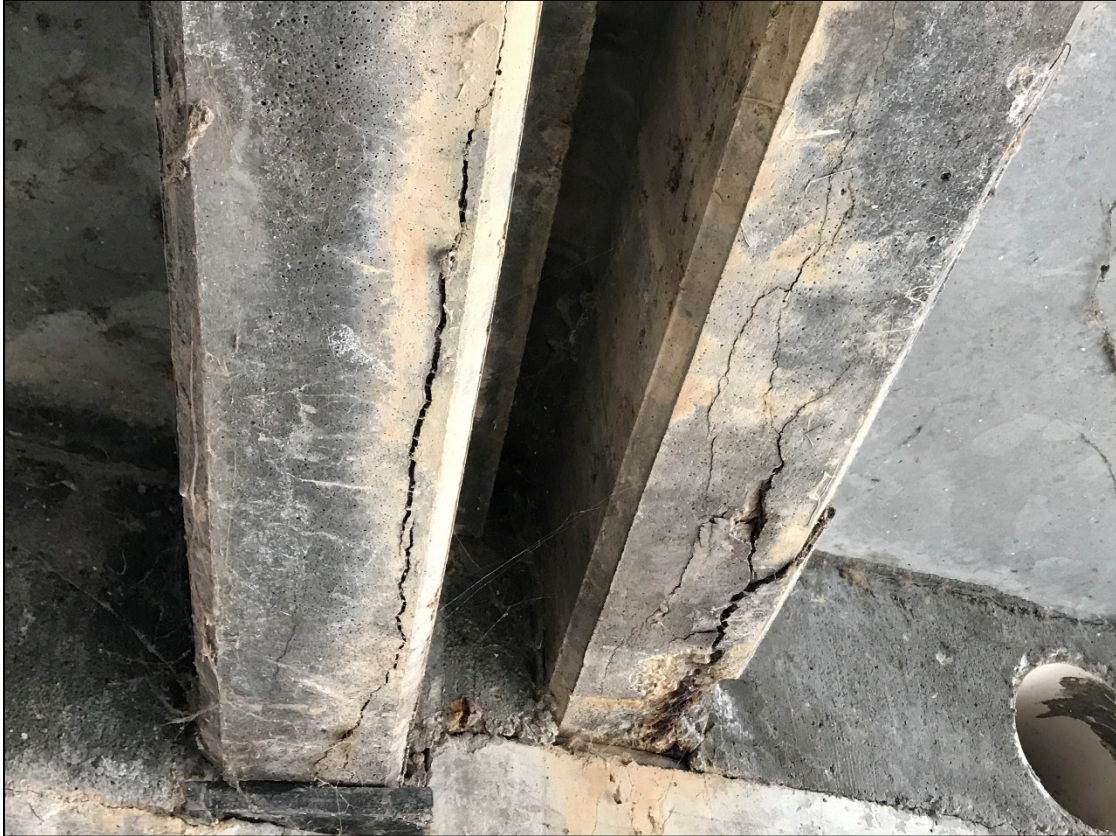
Figure 20: Girders 10 & 11 Cracking, March 2019

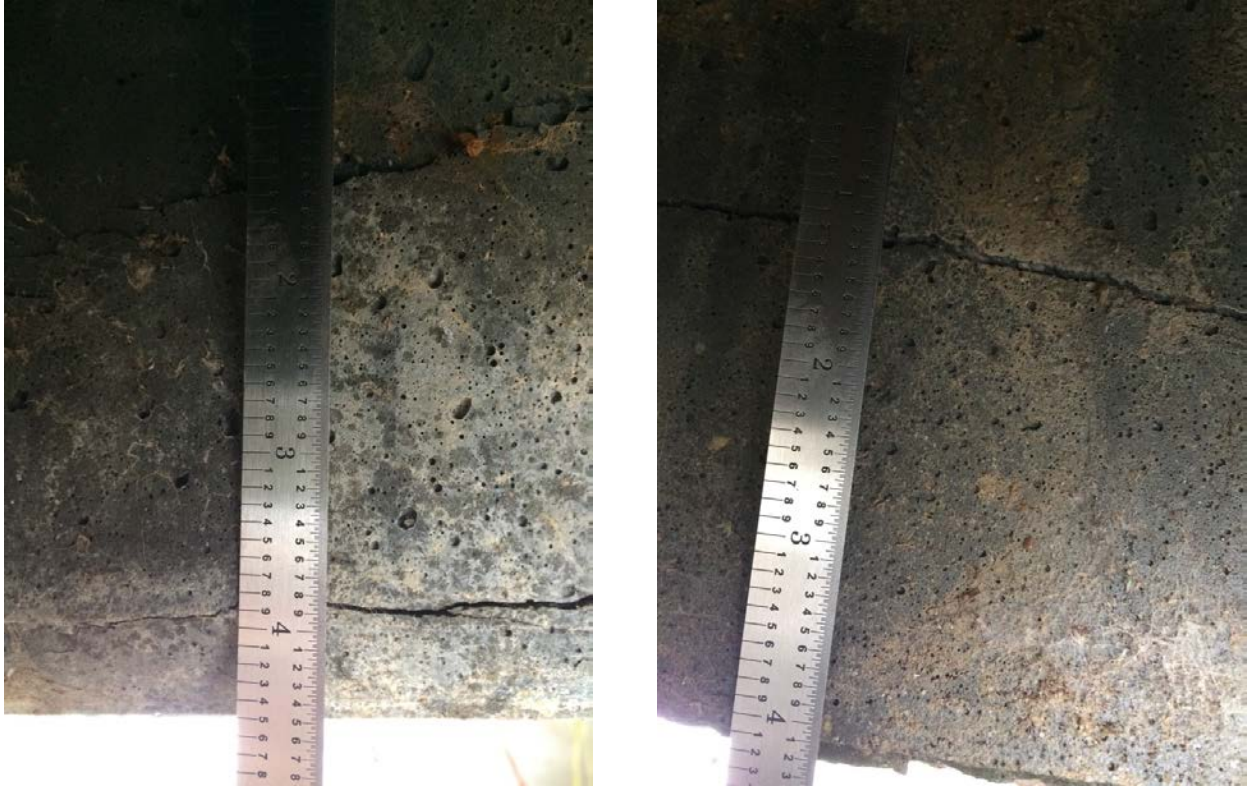
Figure 21 shows a major concern for the future structural integrity of the bridge. The two photos shown are of opposite sides of the same beam flange. This crack on each side is approximately 3” from the base of the beam. These cracks are very concerning because of their proximity to the prestressing steel strands.

In the Comments on Analysis section, probable layouts for the prestressing strand were presented. If the strand is constructed in a vertical pattern as was assumed, this crack located 3” from the bottom of the beam approximately aligns with the location of the second and third prestressing strands from the bottom. If it is constructed as drawn in the original plans, the crack is located at the top of all 5 strands. In either case, a crack on both sides of the beam indicates that water and oxygen may be readily penetrating through the concrete to reach multiple steel members.

Figure 21: Primary Crack Concern, January 2019

The cracks seen in these photos occur at multiple points along the beam. The wide range of locations affected by such cracking necessitate the use of conservative assumptions regarding the corrosion of the prestressing strand within the concrete. It is highly unlikely that, given the frequency and size of these cracks, that the reinforcement contained in the concrete has been unaffected up to this point in time.

The structural analysis calculations assume that this reinforcing steel has begun to corrode. On each double-tee beam, only one leg exhibits such cracking and exposed reinforcement. However, in the analysis, we must assume that each leg has an equal balance of strength. With the bottom strand considered to be entirely lost, $1/5$ of the steel in one of the legs, the overall strength of the beam must be assumed to be $4/5$, or 80%. If additional corrosion has occurred, the percentage decreases further. Our estimate is that roughly 70-75% of the original cross-section of the strand is remaining.
