**LDS Church Camp Concrete Storage Tank
50% Report
Project ID: CEEEn_2017CPST_012**

**Genesis Engineering
Jeremy Fowler
Seth Richardson
Michael Reynolds
Kyler Ashby**

**Roy McDaniel
The Church of Jesus Christ of Latter Day Saints**

**Department of Civil and Environmental Engineering
Brigham Young University**

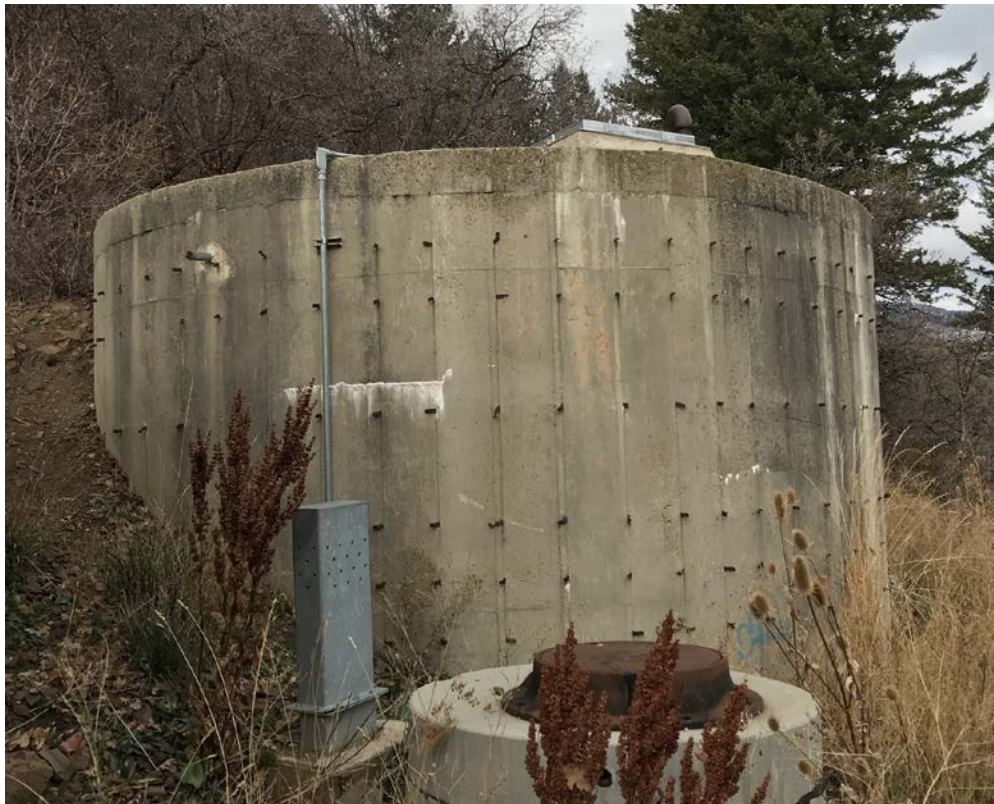
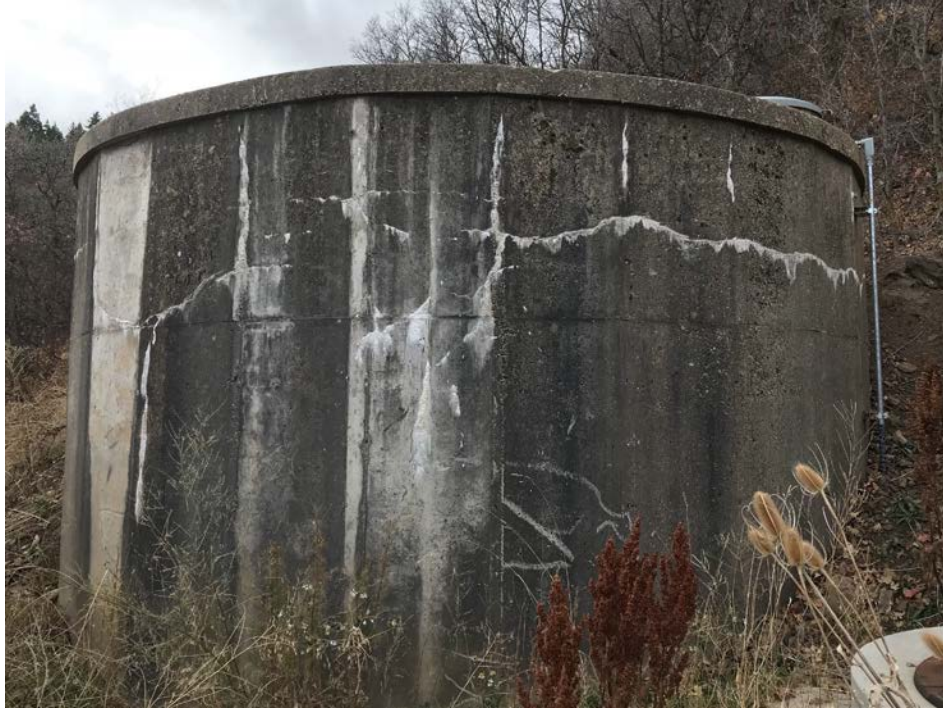
Last October, we performed a preliminary site visit to observe the general condition of the two water tanks. This visit was quite helpful for us to better understand the scope of the project, and better understand the needs of the tanks. From our site visit we could easily see that the tanks were rather worn. The south tank was especially worn, and had a lot of exposed aggregate, and even some exposed rebar on the top of the tank. There were some signs of past leakage through cracks on the sides of the tanks as well. Included below are pictures of the north tank, and south tank respectively.

As can be seen from the pictures, the tanks are built partially into a hillside. Signs of leakage are visible on both tanks. It also appears that the tanks were built at different times, or in different manners. This is evident from small differences in lids, tank tops, color, and general condition. The north tanks appears to be newer than the south tank. This could potentially have an effect on the final decision, with the possibility of replacing only one tank.

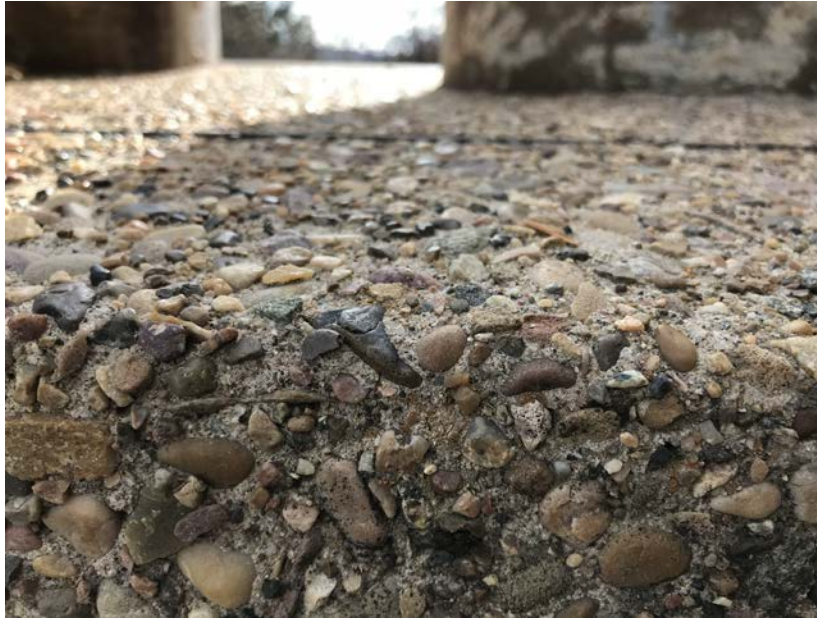
During our site visit a few months ago, we observed several signs of wear that could result in tank failure at some point. The first thing that we observed was significant spalling on the South tank. The top of the tank had significant amounts of concrete worn off, exposing the aggregate on top (see picture below).

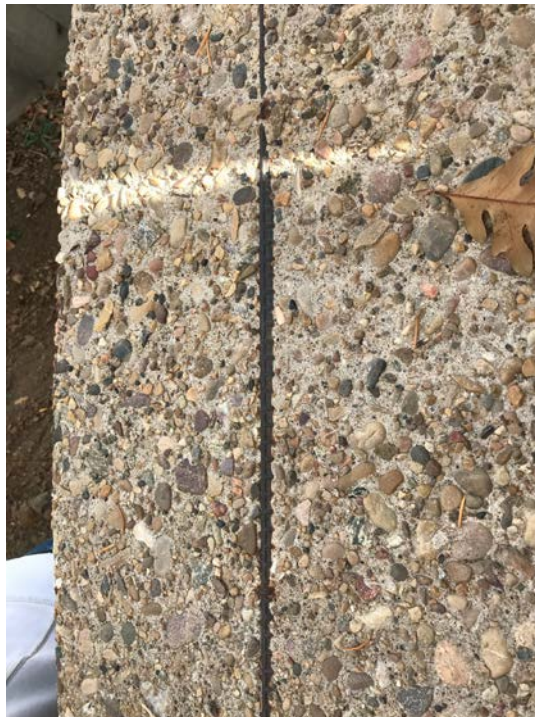
Another related sign of wear was that of exposed rebar on the South tank (see picture below).

We do not know if these defects will directly lead to the failure of the tank, but it is cause for concern.

Another option that would require further research in order to justify would include refurbishment beyond the application of Xypex. This expanded refurbishment could include new piping that could accept water from multiple springs simultaneously, new mesh lining for the overflow valves, and a protective coating that would cover the exposed rebar.
