CEEn-2017CPST-001

Structural & Geotechnical Report

# ARROWHEAD CENTER

KADD Engineering

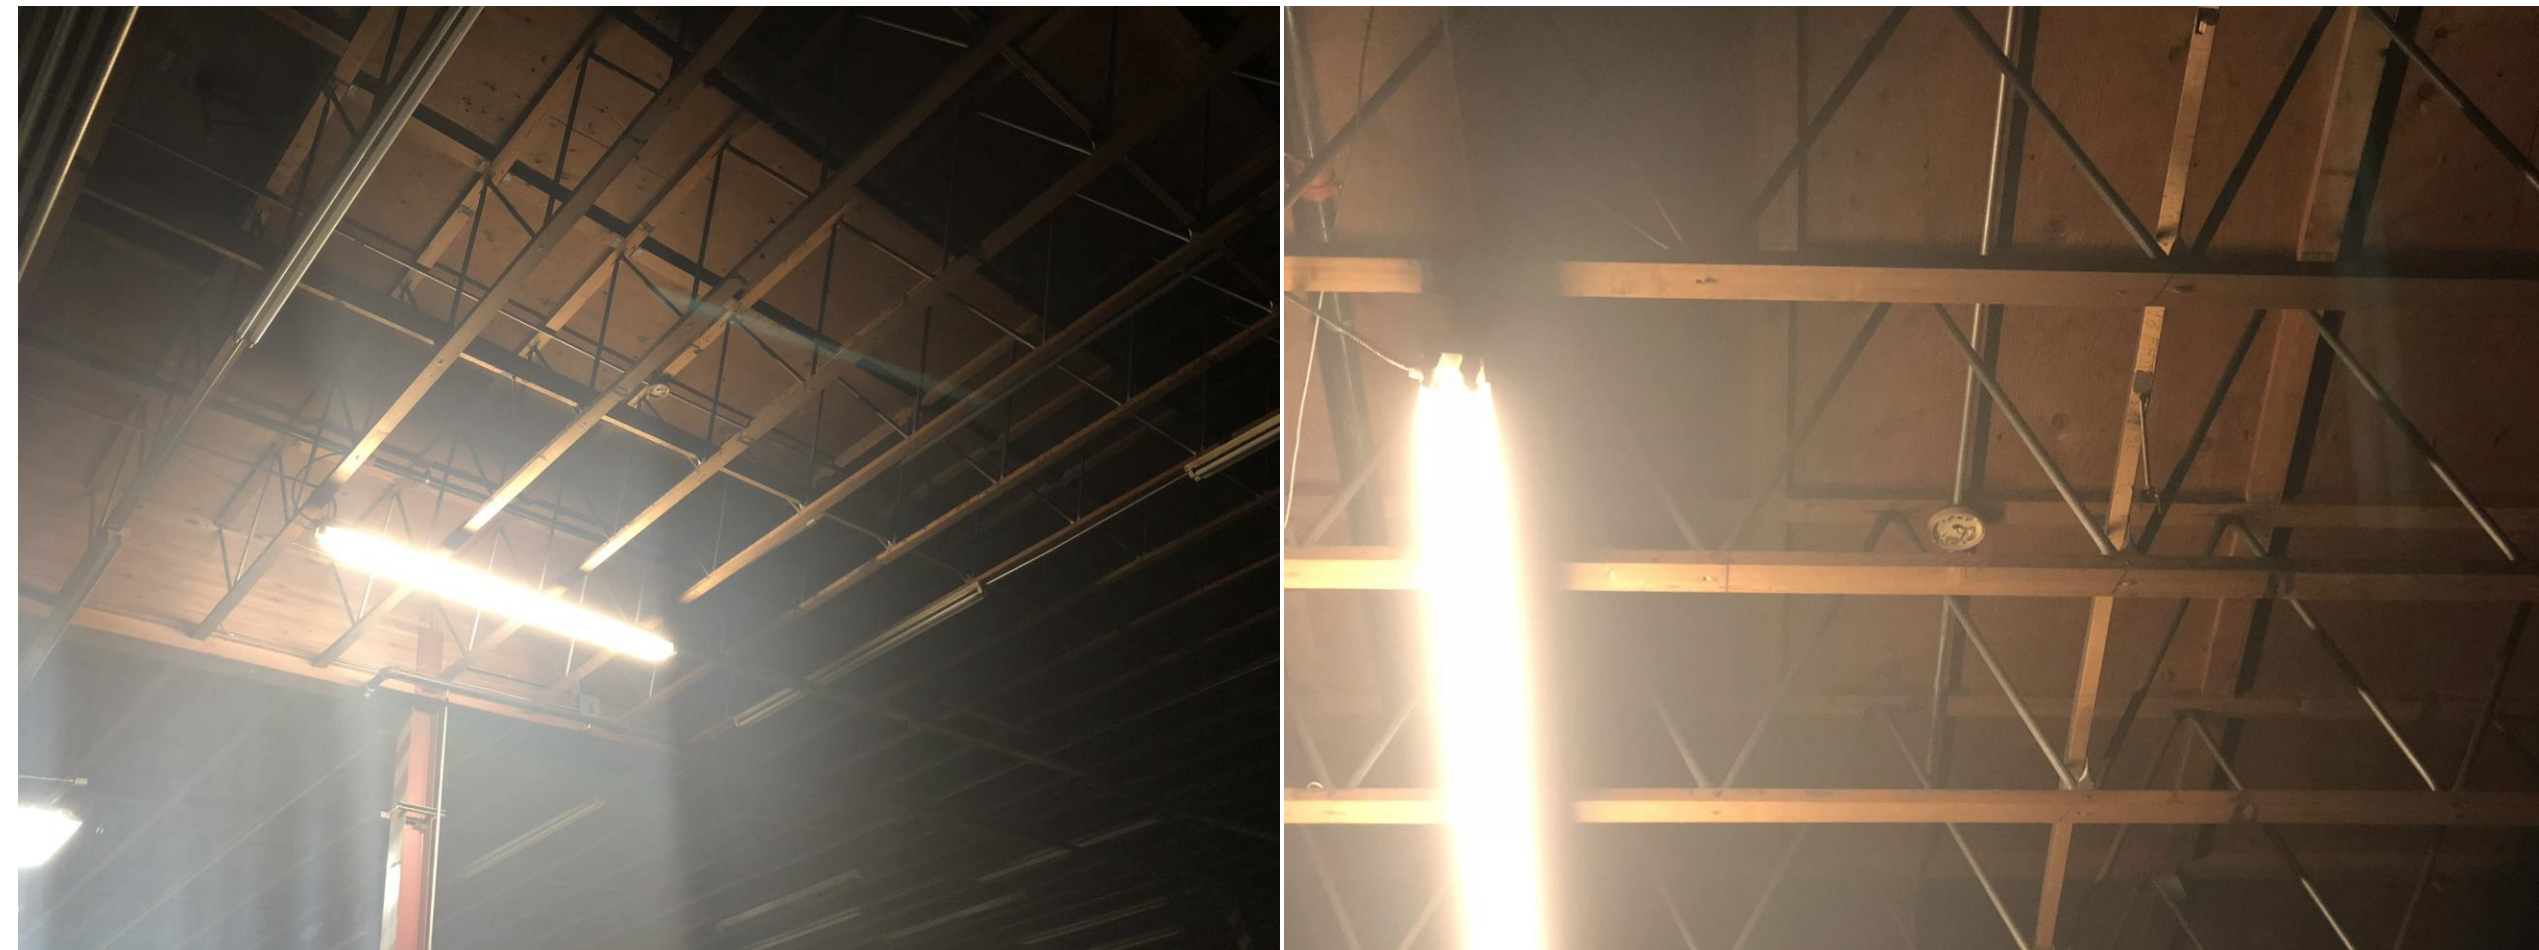
## EDSCO (Open web truss roof)

Snow Load	28	psf
Dead Load	10	psf
Total Load	38	psf
Roof Trib	3	ft
(TL)(Trib)	114	plf
Joist Capacity	129	plf

since  $TL < \text{Joist capacity}$ , the  
joists are sufficient

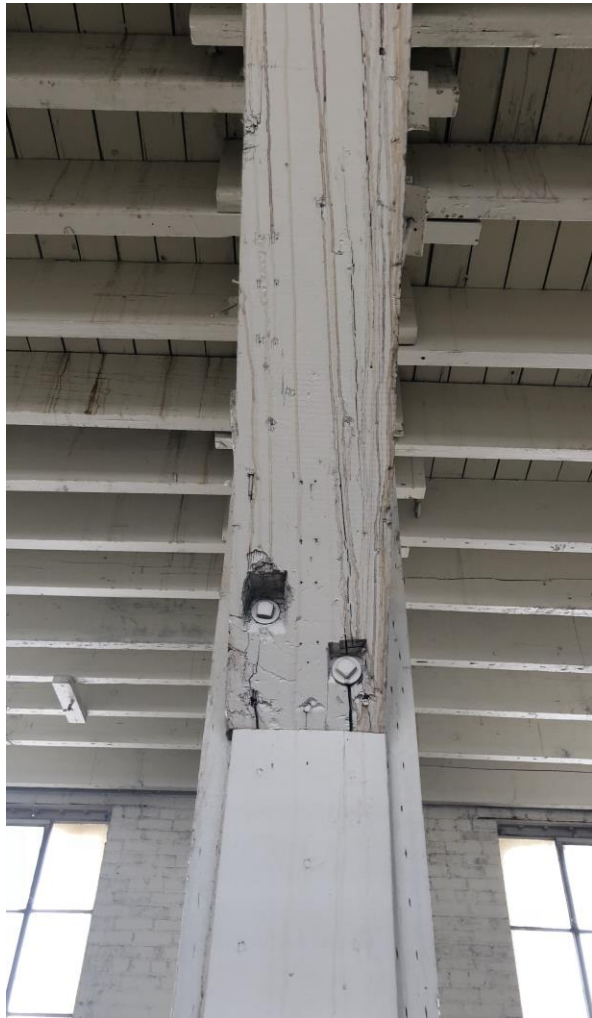
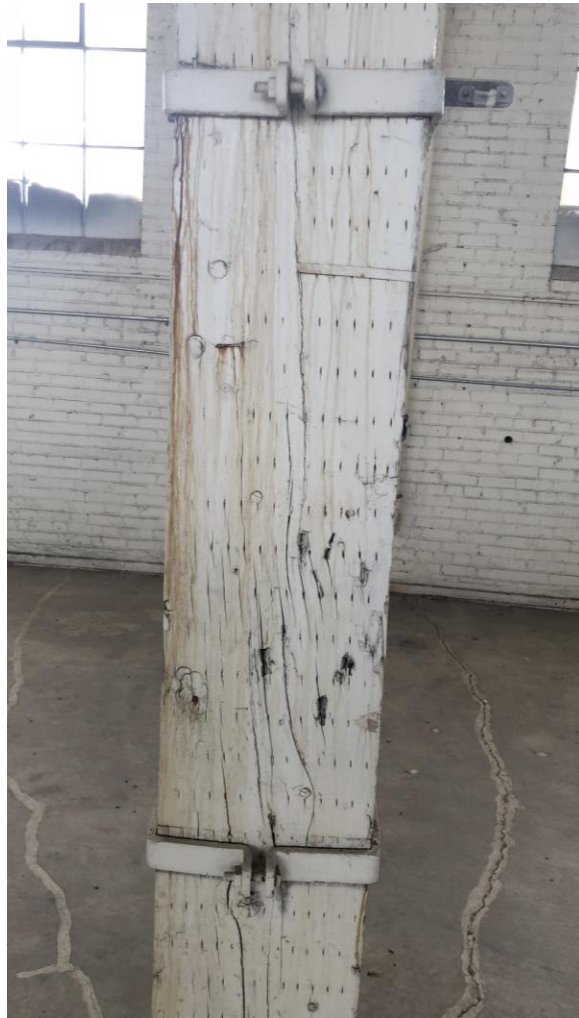
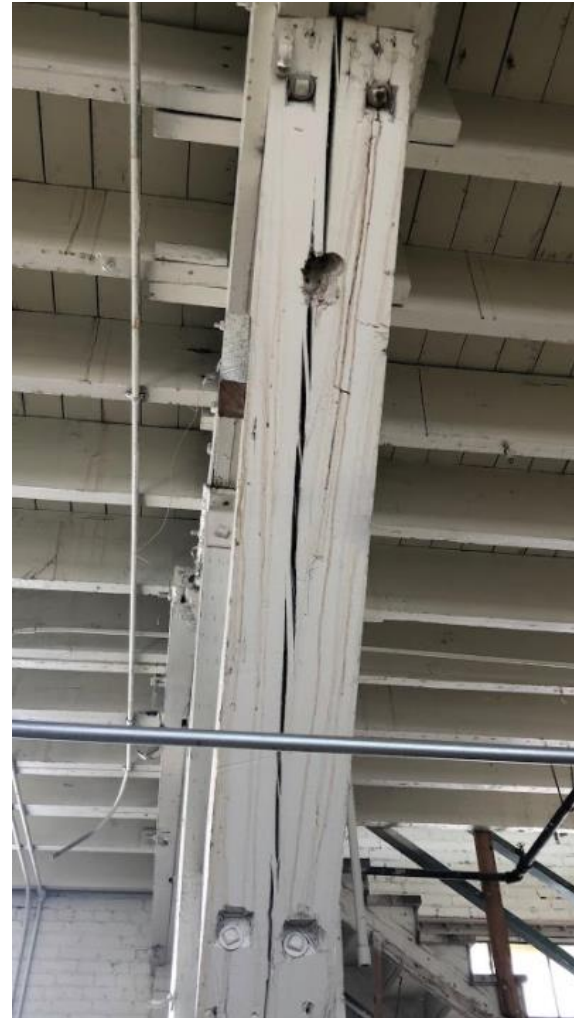
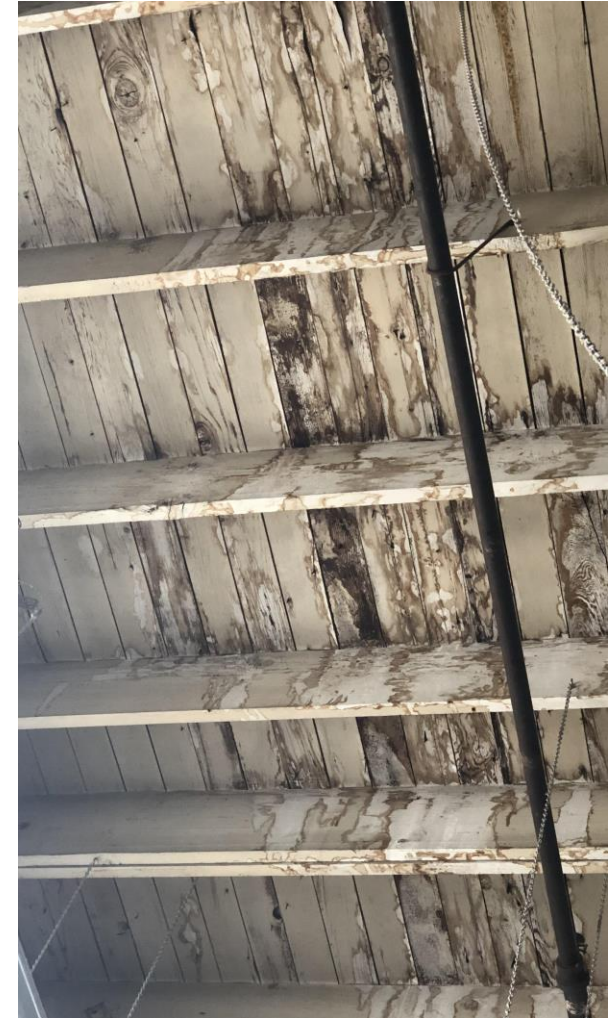
Retrofitted Split Members/Apparent Water Damage to Ceiling Deck & Rafters

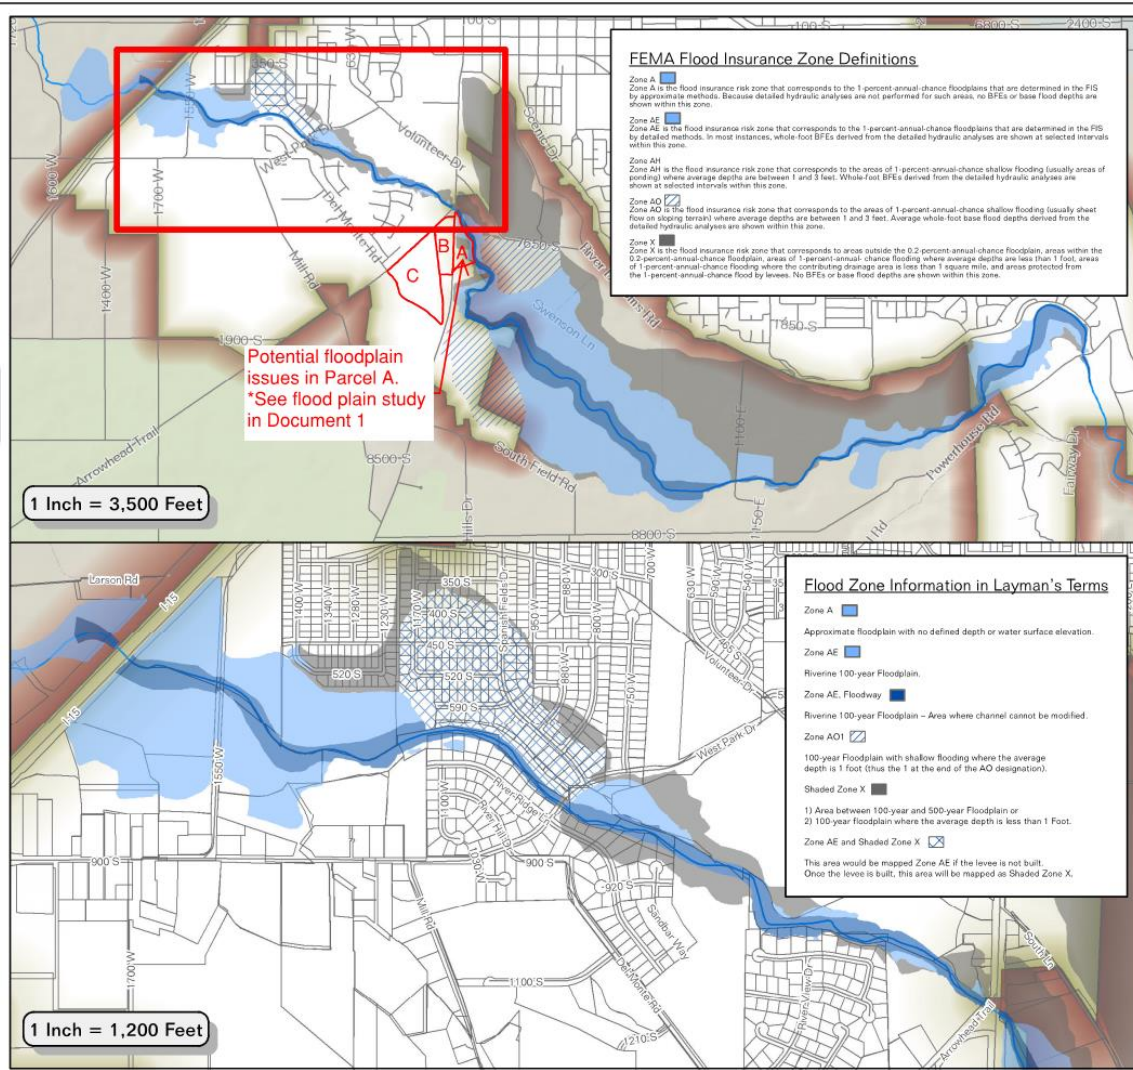
- Potential issues in Parcel 1
- Proper drainage must be implemented (refer to recommended drainage solutions in geotechnical report), but the risk of flooding will always remain.
- Spread footings on compacted fill is suggested for foundational support on this plot.
