**ARROWHEAD STRUCTURAL/GEOTECHNICAL**  
**Project ID: CEEEn\_2017CPST\_001**

**A Capstone Project Final Report**

**Fritzi Realty**

**PROJECT TITLE:** Arrowhead Structural/Geotechnical

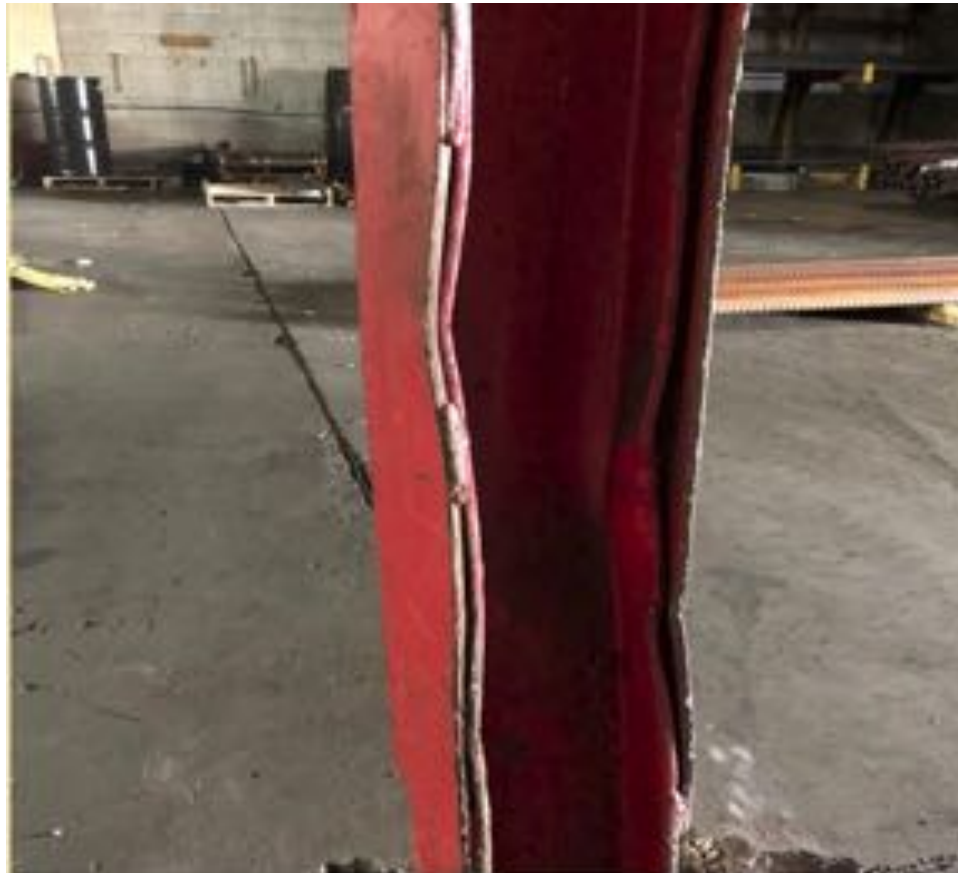
Many steel columns have been damaged, as shown in Figure 1. It is possible that these members are sufficient to support the loads according to the current building code. However, if the columns have yielded all the way through the cross section, they may prove unstable. The visible buckling of the flanges may also be problematic. It is therefore our recommendation to have these columns analyzed by a licensed structural engineer.

**Figure 1. Damaged column in the EDSCO manufacturing facility.**

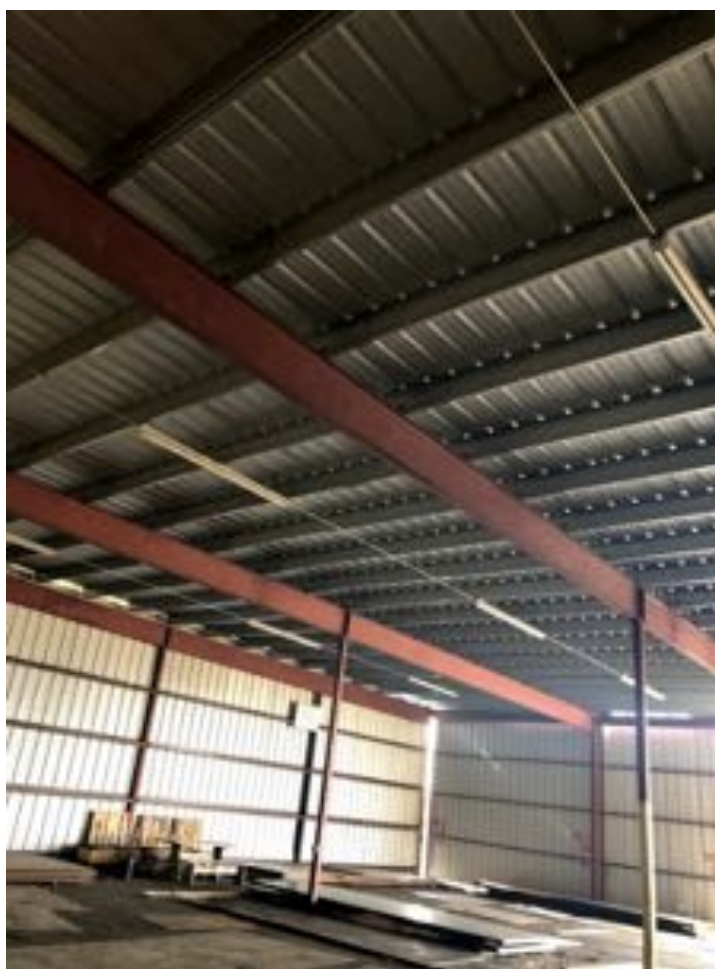
**Figure 2. EDSCO shed.**

RISA 2D was used to analyze the steel Z-purlins supporting the metal deck roof in the EDSCO shed structure (shown below). A roof live load of 20 psf and a dead load of 3 psf were assumed. (Only supporting metal seam and weight of beam is included in RISA automatically.) Using ASCE 7-10, a ground snow load of 45 psf was reduced to a roof snow load of 33 psf (see Figure 22 in Appendix A). These loads were converted to linear loads of 70 plf for the roof live load (L), 10.5 plf for the dead load (D), and 116 plf for the snow load (S). Calculations for this conversion can be found in Figure 23 in Appendix A. The governing LRFD load combination was  $1.2D+1.6S$ . With these loads, the Z-purlins of the roof structure in the EDSCO shed were found to be adequate to support the factored loads according to the International Building Code, 2015 and ASCE 7-10, supporting 86% of their factored capacity. The RISA analysis of these members can be seen in Figure 24 in Appendix A. Due to inadequate information, the supporting beams and columns of the EDSCO shed were not analyzed as a part of this project.

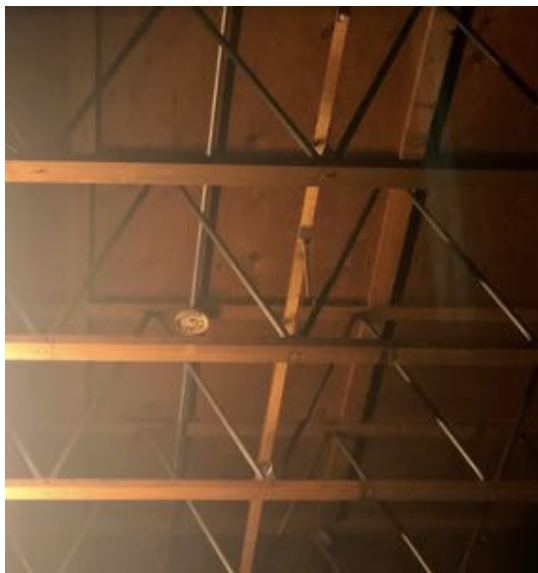
**Figure 3. EDSCO open web roof structure.**

For the open web roof structure in the south portion of the EDSCO building (Figure 3), an assumed dead load of 10 psf was used. Using ASCE 7-10, a ground snow load of 45 psf was reduced to a roof snow load of 28 psf (see Figure 22 in the appendix). With these loads, the open web roof structure in this section of the EDSCO warehouse building was found to be adequate to support the loads according to the span table provided by RedBuilt (shown in Table 1 in the appendix). Since building plans were not provided and we were unable to determine exactly which open web

truss type to use, we conservatively used the weakest open web joist type with the appropriate measured depth. From the table, it has been determined that even with these conservative estimates, the joists are adequate to support the existing loads. However, it is our recommendation to have a licensed structural engineer inspect these members as the trusses may have been manufactured by a different company other than RedBuilt and may therefore have less capacity.

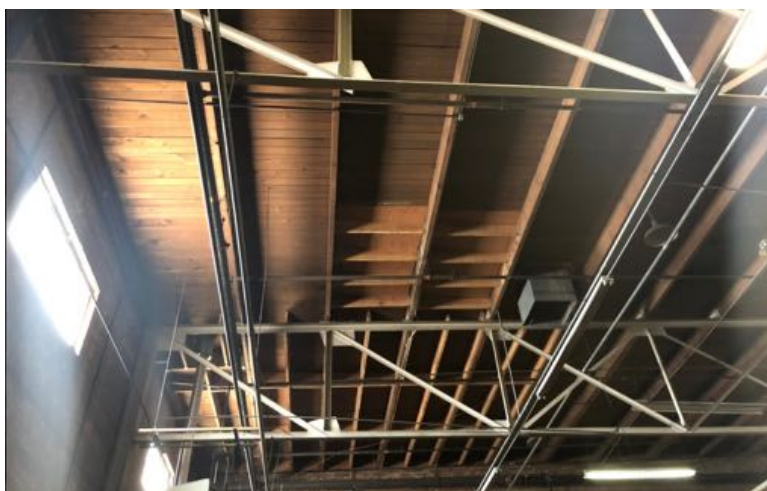
The north portion of the EDSCO Building was not analyzed due to insufficient measurement of the truss members. It should be noted that a failure occurred in the northwest corner of the roof structure of this section in recent years (exact location noted in Figure 18 in the appendix). It has since been reinforced as shown in Figure 4. This failure may have been an isolated event, but if the collapse occurred due to overall inadequacy of the roof structure, adequate reinforcement should be added to prevent further problems. As such, a more thorough analysis of this portion of the EDSCO warehouse, if not already done, should be performed to ensure the stability of the remainder of the roof structure in this area. The overall roof structure is shown in Figure 5.

**Figure 4. Reinforcement at location of roof failure.**

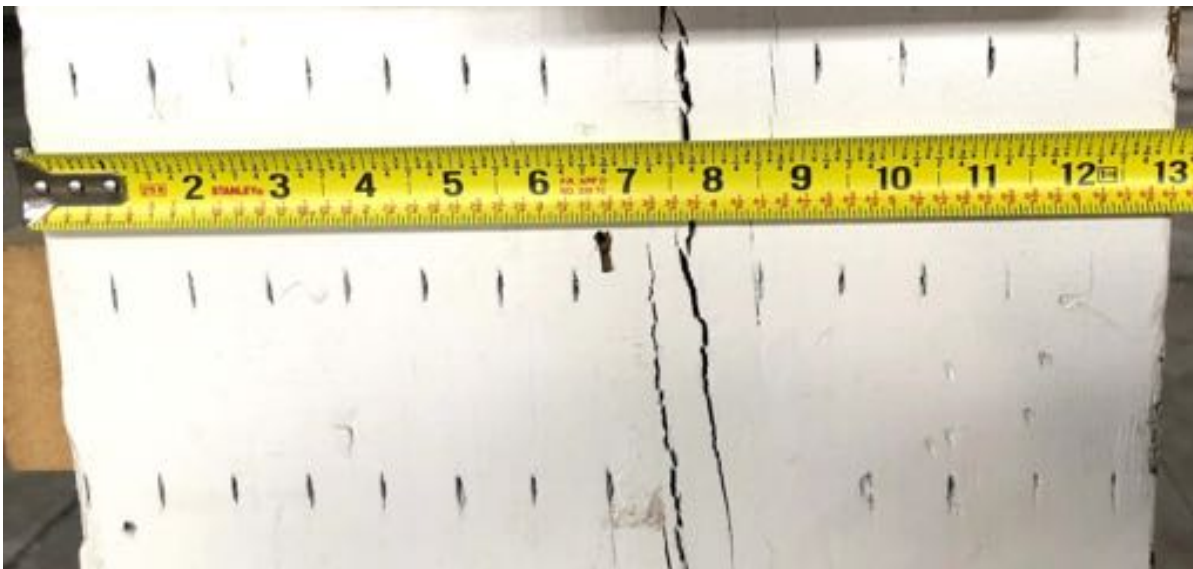
Many of the wooden members in wood framed portion of the Arrowhead Center have been split, displaced, or experienced potential water damage, as shown in the figures below. It is our recommendation that these members be closely inspected and analyzed by a licensed structural engineer. Members that are determined insufficient should be retrofitted or replaced to meet the standard of the current building code.

**Figure 6. Split column in East Building.**

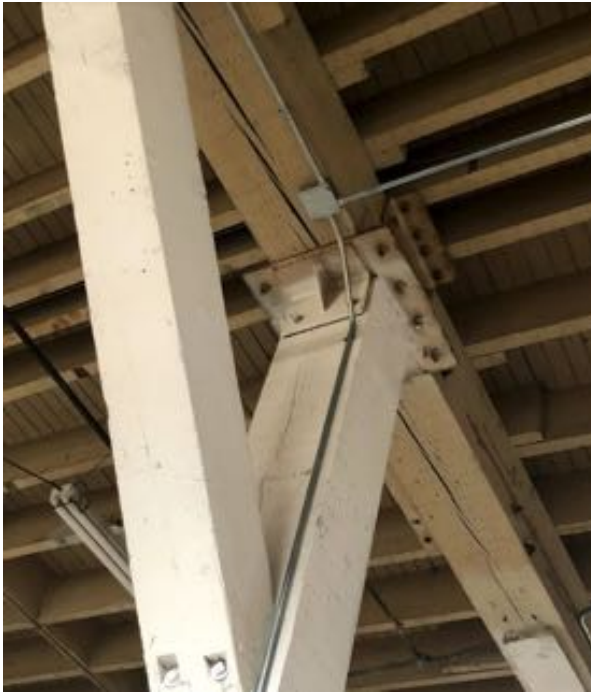
**Figure 7. Split beam in East Building.**

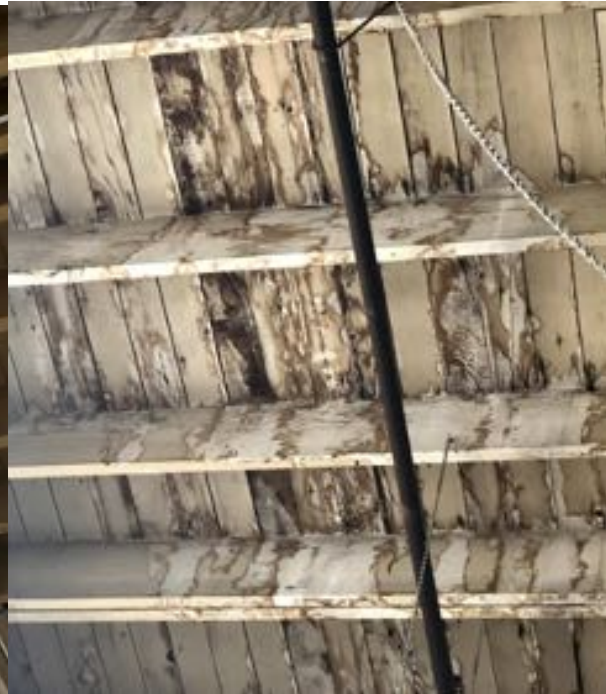
**Figure 8. Potential water damage in East Building.**

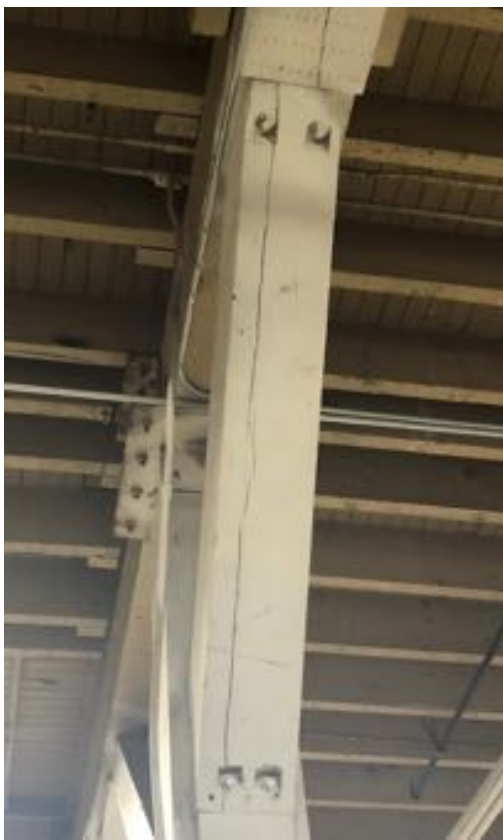
**Figure 9. Split bracing in East Building.**

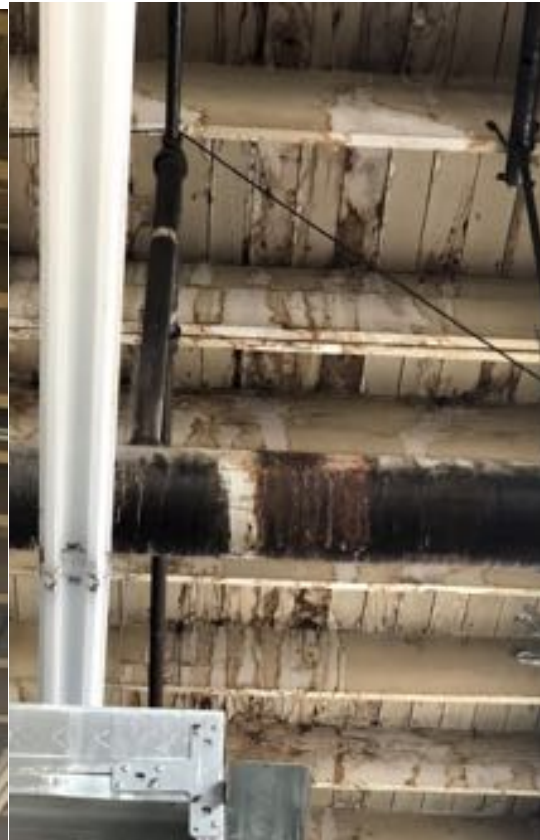
**Figure 10. Potential Water Damage in East Building.**

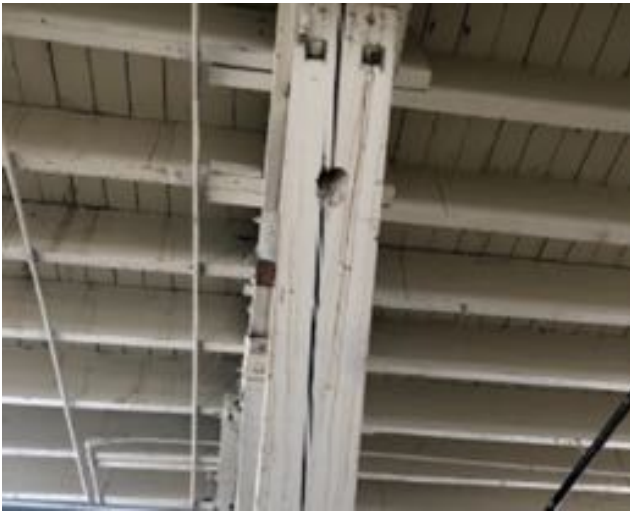
**Figure 11. Split bracing in East Building.**

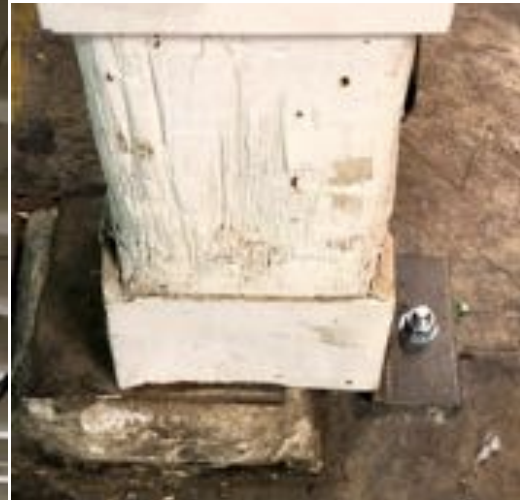
**Figure 12. Displaced column in West Warehouse.**

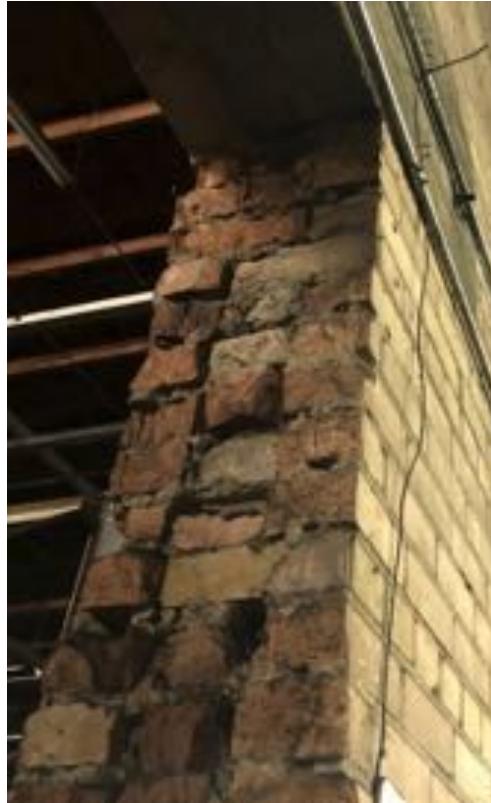
There is evidence that the masonry walls are not reinforced, as shown in Figure 13. These walls may need to be retrofitted or replaced to include proper seismic reinforcement. Retrofits may include internal or external reinforcements. Internal reinforcement may include drilling holes in plane of the wall and filling with rebar and epoxy. External reinforcement may include attaching steel angles to the unreinforced walls. All walls should be analyzed and level of reinforcement should be determined before any adjustments are made.

**Figure 13. Unreinforced masonry wall in the EDSO portion of the building.**
