CEEn-2017CPST-006

TEMPORARY SLOPE REPAIR FOR HIGHWAY EXPANSION

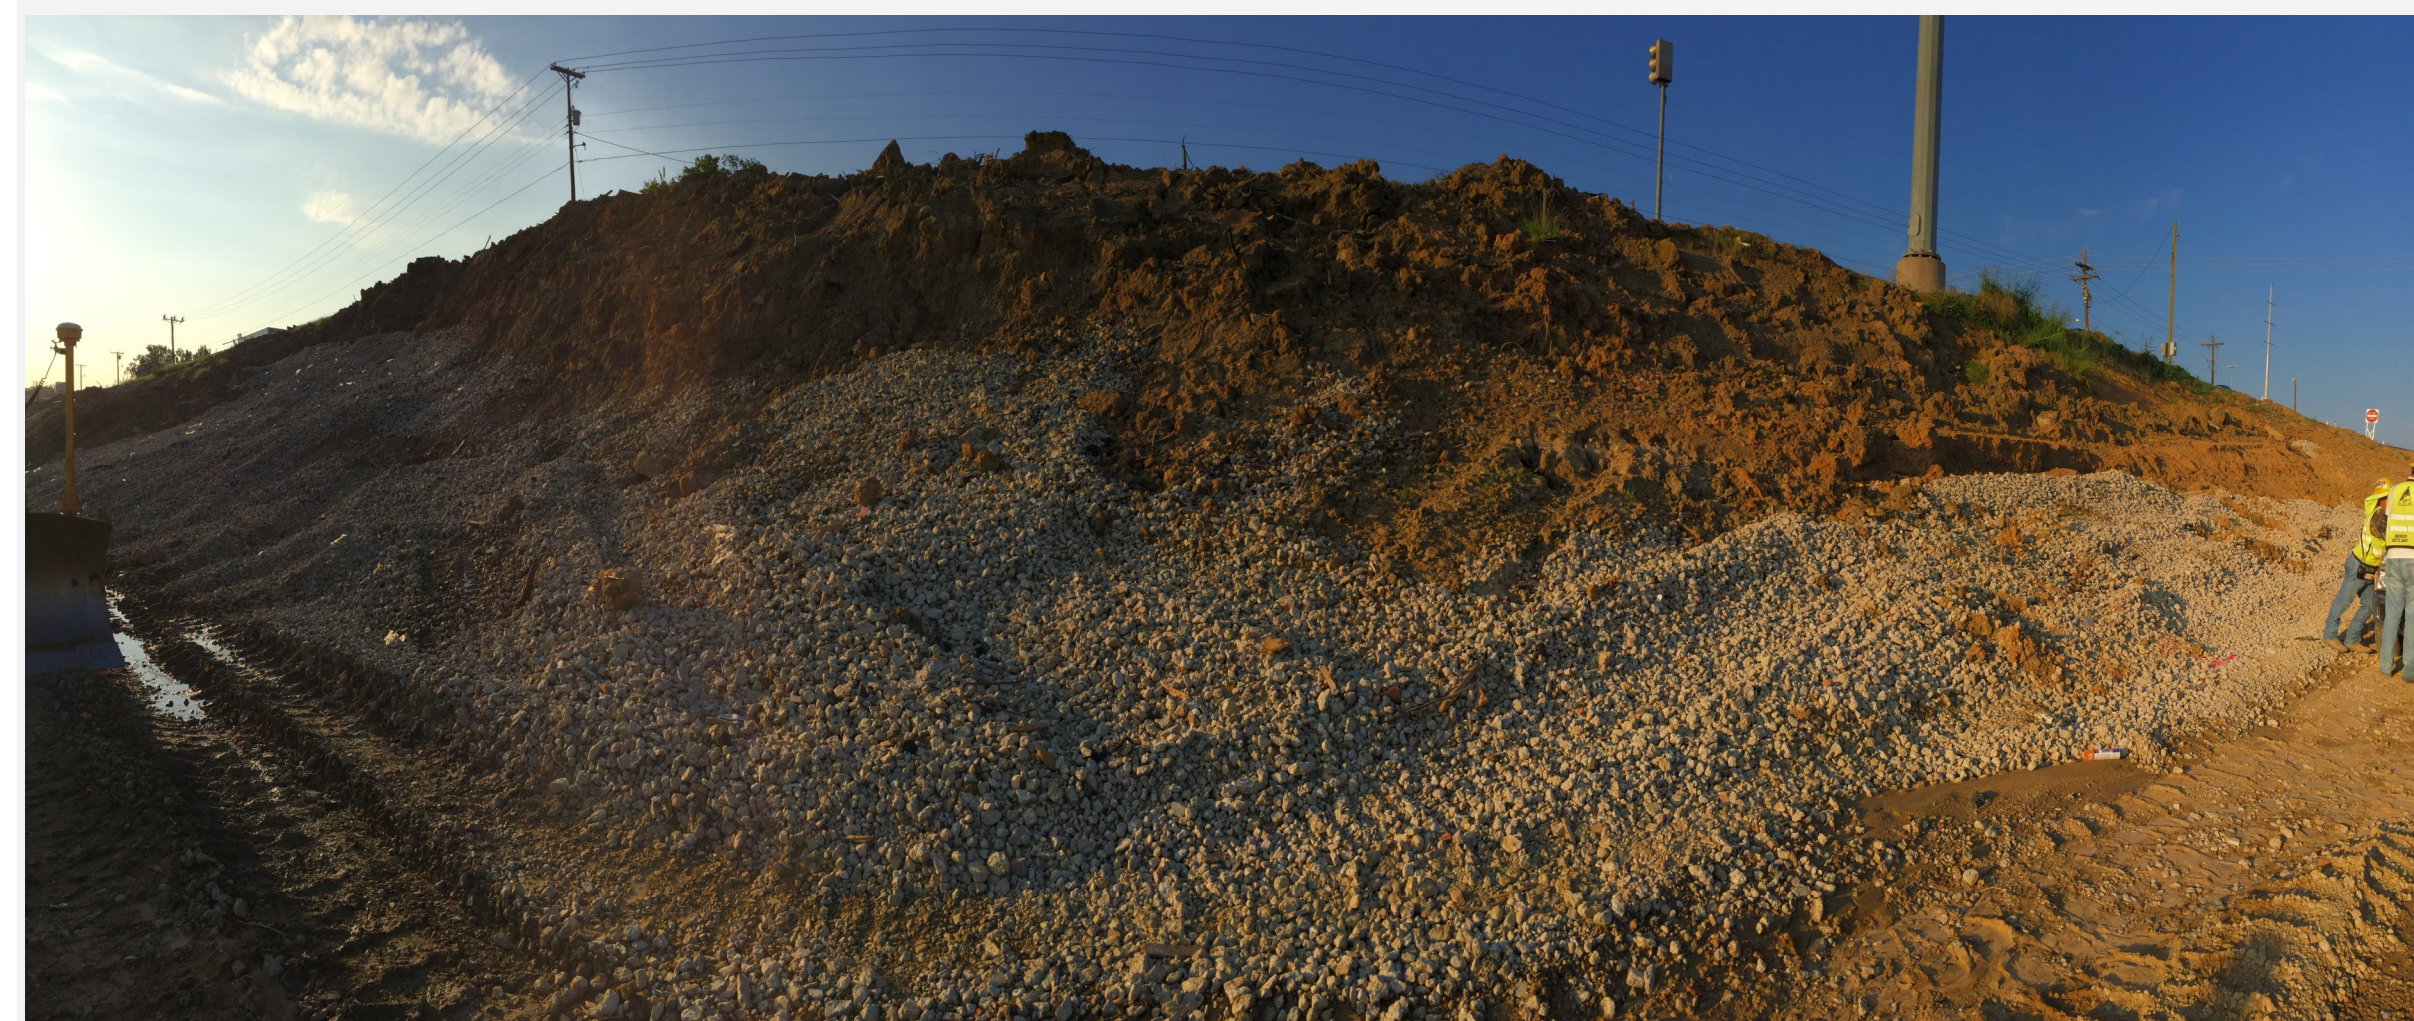
During construction of a road widening project near Irving, Texas, a temporary cut slope slumped and required a temporary repair.

A picture showing the site conditions after failure is shown below. It was observed that the failure daylighted approximately mid-way down the slope, and a high moisture content existed in the soil.

The method chosen to repair the slope was a combination of soil nails every 5 ft. down the slope and 4 ft. across the repair width, with initial and final shotcrete facings to hold the soil and nails in place. The project is estimated to be completed in one month and will cost \$167,000. The construction drawings are shown below.

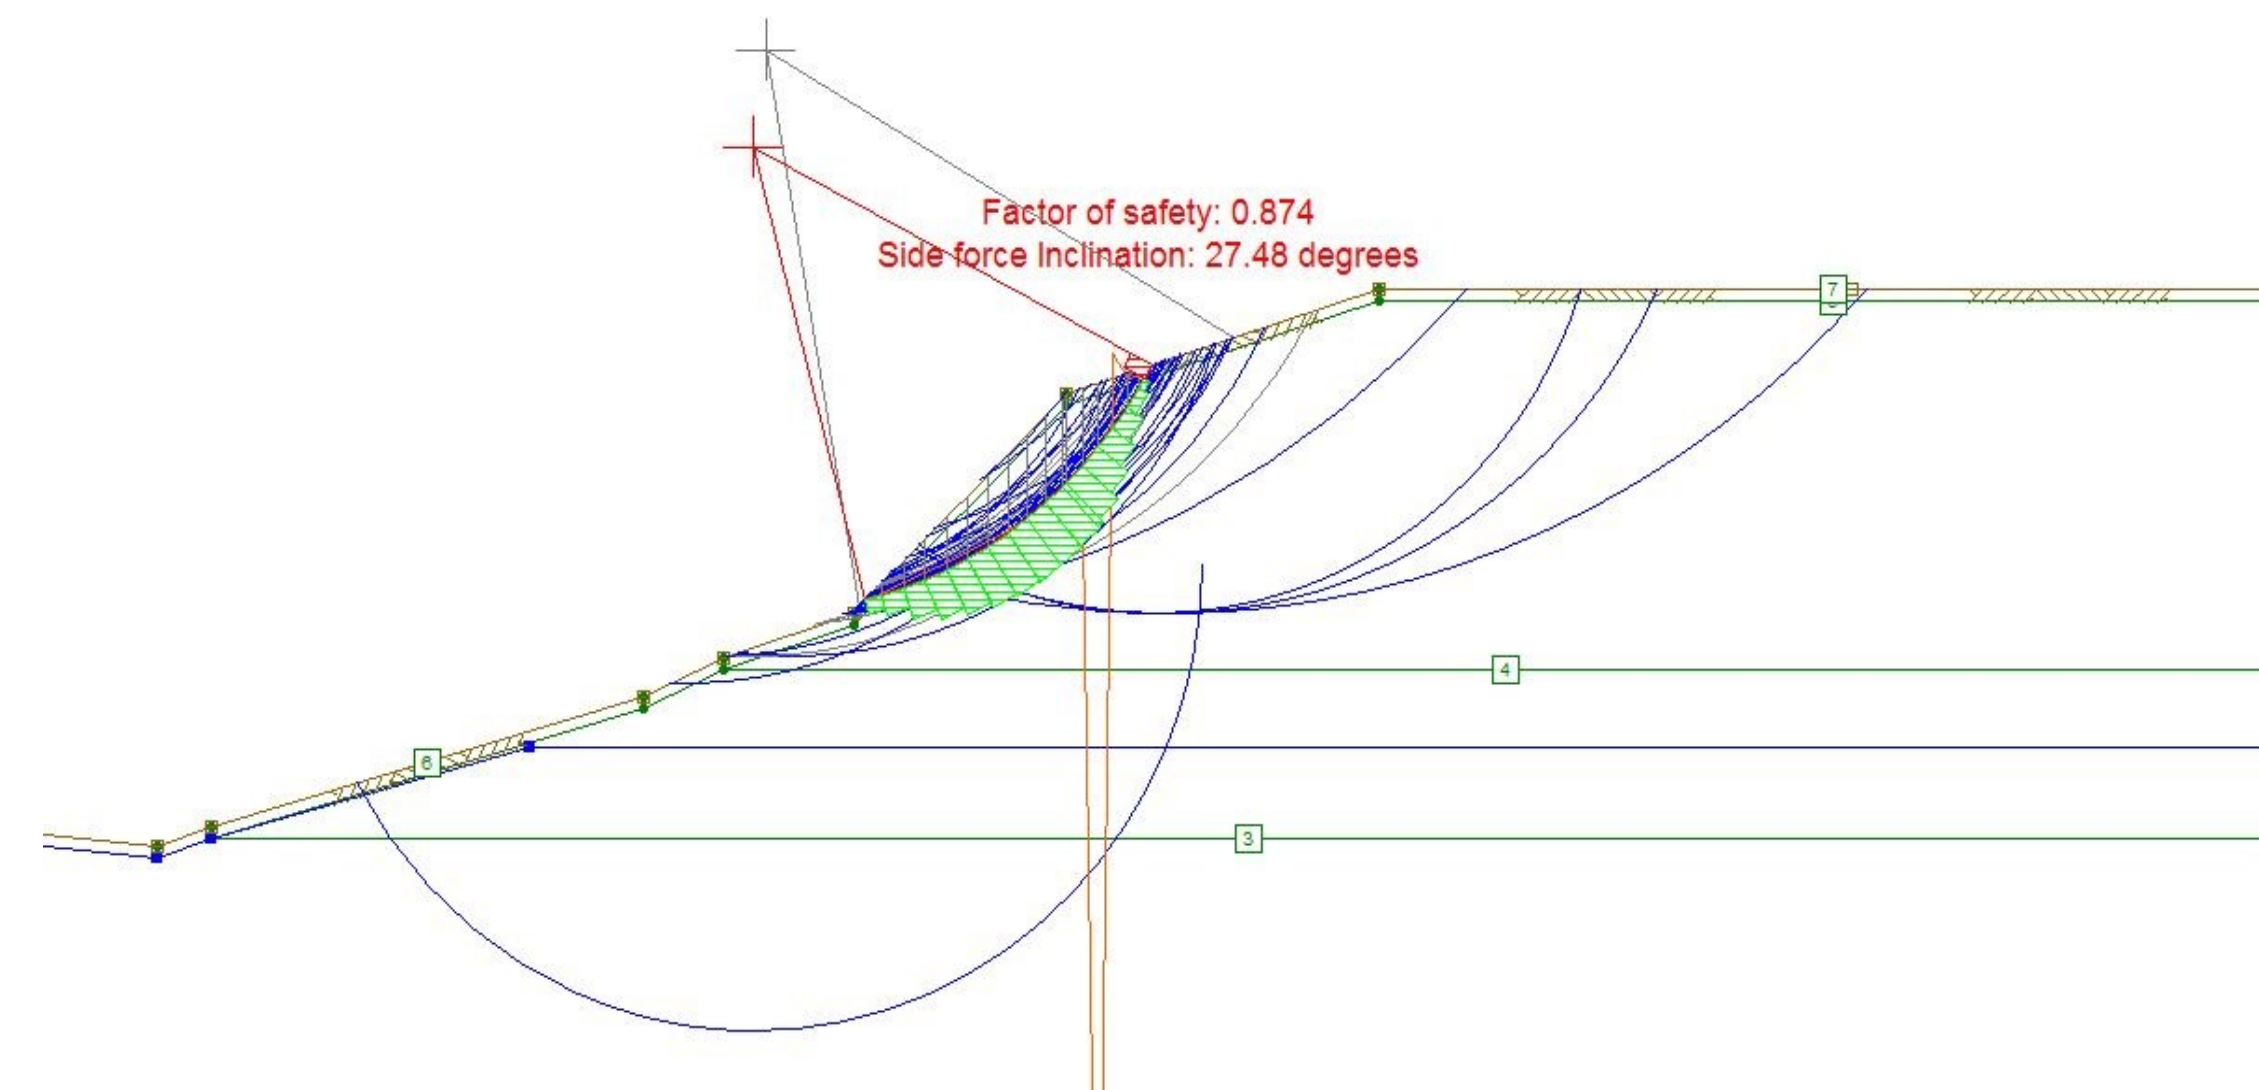
The slope was analyzed in 50 ft. increments within UTexas, a slope analysis program, to determine a factor of safety against sliding. The minimum factor of safety found during analysis was located at station 489+50, and was 0.874. The analysis from that section is located below.

The analysis of the slope indicated that the slope failure was located approximately at the midpoint of the slope, which confirms the on-site observations at the time of failure.
