Crookston Slope Stability

BYU CE EN Capstone
Project, Final Report

Obelisk Engineering

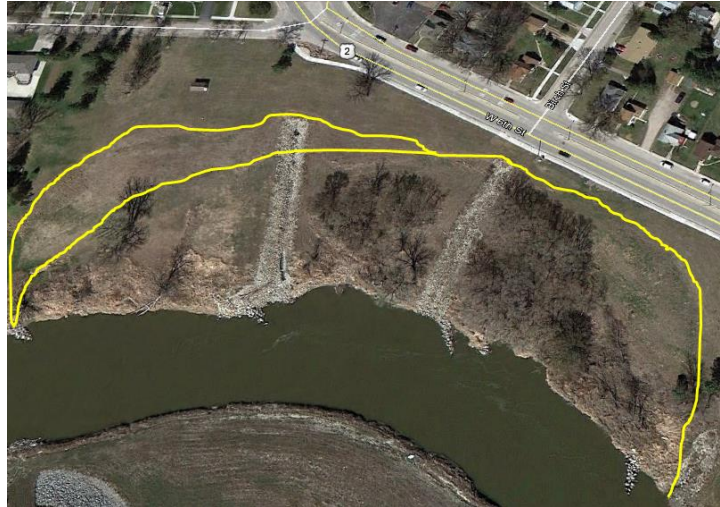
Figure 2: Limits of slope failure

The city of Crookston is located in Polk County in northwest Minnesota, and has a population of around 8000 people. Trunk Highway 2 passes through the center of the city, and is a major arterial highway for transportation in the area. The Red Lake River passes through the city, winding around residential areas of the city. The slope failure is located between Red Lake River and Trunk Highway 2 where these two features are parallel to each other, as can be seen in Figure 1. The distance from the highway to the river at its closest point is 260 feet, and the distance from the highway to the top of the failure is 35 feet. Almost 800 feet of slope adjacent to the highway has failed. The extents of the slope failure for this site can be observed in Figure 2.

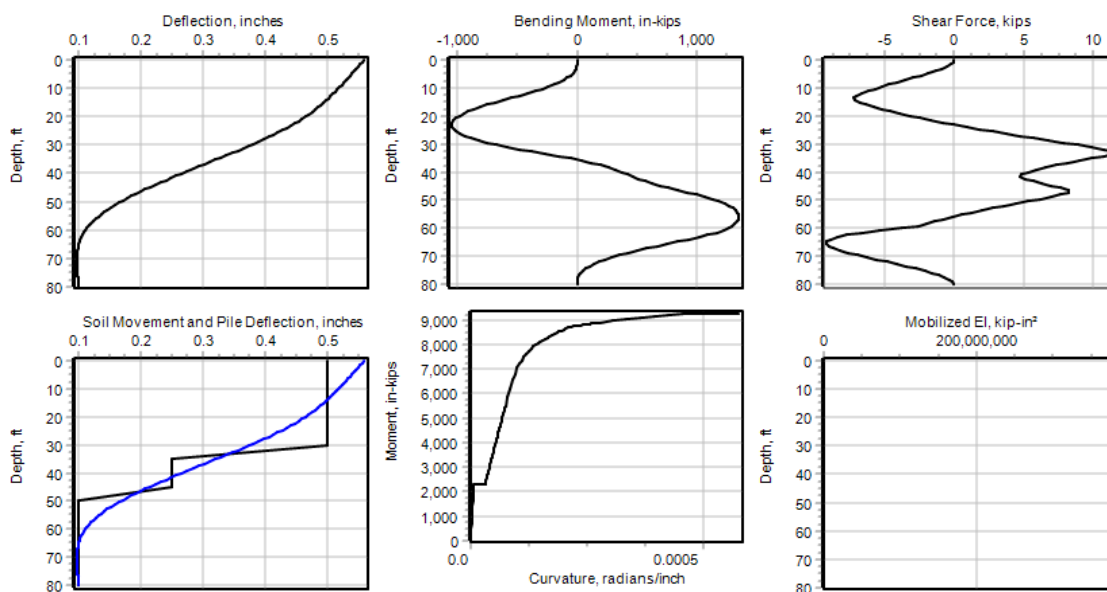
Figure 10: Deflection, bending moment and shear force diagrams from L-Pile output

drilled shafts for foundations and can easily be utilized for this project. A very simplified cross section based on the parameters entered into UTEXAS was input into L-Pile, along with the appropriate soil properties as shown in Table 1. The alluvial deposits, Huot clay, and glacial till were modeled with the sand (Reese), soft clay, and API at depths of 10, 60, and 100 feet respectively. A drilled shaft was inserted into the model with the parameters defined as in Figure 11. Lateral displacements were entered in the soil layers to determine the resisting forces that would be exerted on the soil from the shaft. By entering the lateral forces as reinforcement lines in UTEXAS, the factor of safety for any given pile parameters can be determined. Multiple iterations of the design were performed before final dimensions were determined. Various plots for the forces and displacement of the shaft are provided in Figure 10.

From these plots it can be determined that the max pile deflections that can be expected is less than 1 inch at the top of the shafts. Final factors of safety for cross-sections A, B, and C were 1.471, 1.326, and 1.467 respectively. These values are above the minimum value of 1.3 that was decided for this design. Cross-sections for these final safety factors can be observed in Figures 16, 17, and 18 in the appendix.

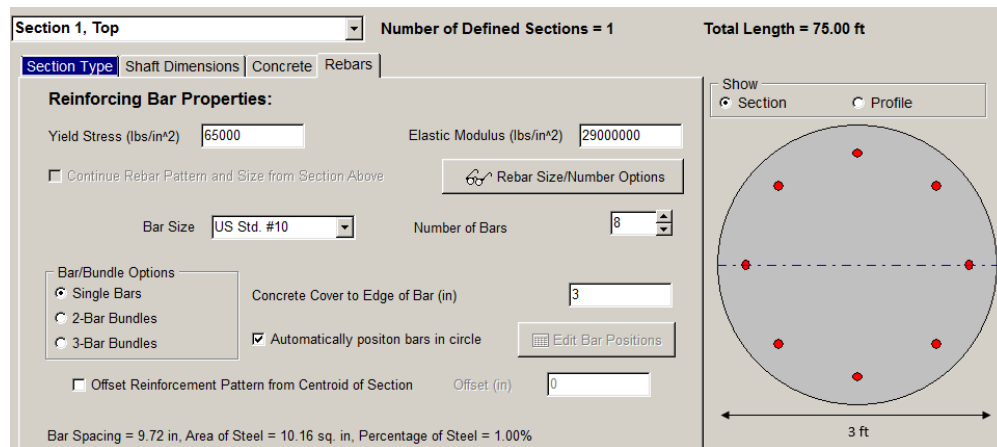
Figure 11: Concrete shaft parameters and cross-section

Normal weight concrete is assumed for the shafts. Steel rebar is to be spaced symmetrically at a distance of 9.72 inches in the column as single bars, with a minimum edge cover of 3 inches to protect against corrosion of the steel, and 8 #10 bars will be used. This provides a 1.00% percentage of steel to area of the column. Further information is provided in Figure 11.
