**LID APPROACH EFFECTIVENESS &
FUNCTIONALITY STUDY FINAL REPORT**

Project ID: CEE_n_2016CPST_003

A Capstone Project Final Report

Spanish Fork City Public Works

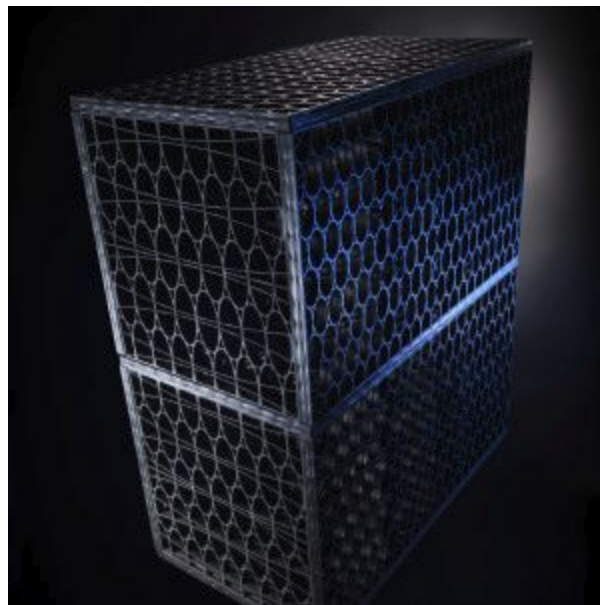
Figure 1. R-Tank image from ACF Environmental website.

The current LID system in use consists of rows of R-Tank structures (Figure 1) that are stacked two deep and lined in shallow trenches (about 4 feet deep), covered with geotextile fabric, and then backfilled, with about a foot of cover on top. The R-tanks are backfilled along the sides with a layer of sand to improve permeability. Storm drains along the street provide inlets to the system, allowing runoff to enter these R-Tank structures and then percolate into the soil, replenishing the aquifer. See Figure 2 for the standard drawing of the system.

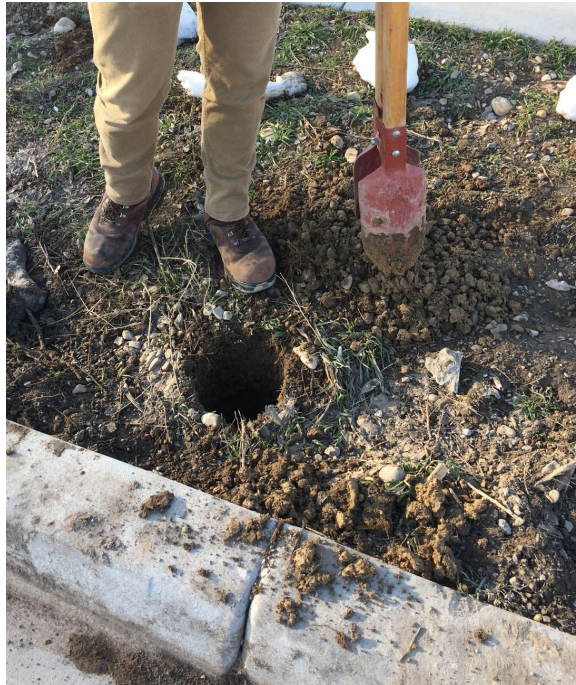
Figure 3. Hole dug for percolation tests

- According to the EPA standards, three holes 6 inches in diameters should be dug at each site. For our tests, three holes were dug at site 1. One hole was dug at the other two sites because high permeability. The weather also limited the length of time that we could work on the sites. The holes are also dug with 7 in diameter. This is done because the tool that we have access to can only allow us to have a 7 in diameter hole.

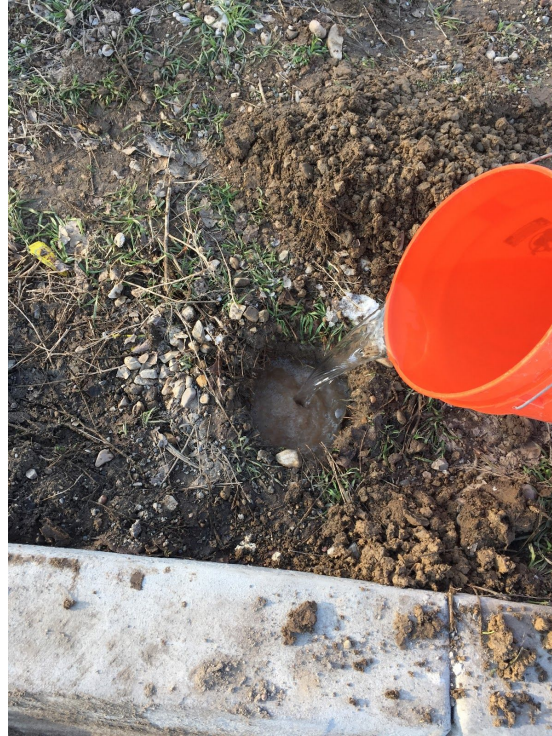
Figure 4. Filling up the test hole with water

- All the holes are then filled with about 12 in of water. For the more clayey area, the holes have been soaked until water maintains its height. For the sites 2 and 3, which are mainly sand and gravel, holes were filled with water more than 4 times. After these preparations, the percolation tests are ready to proceed.

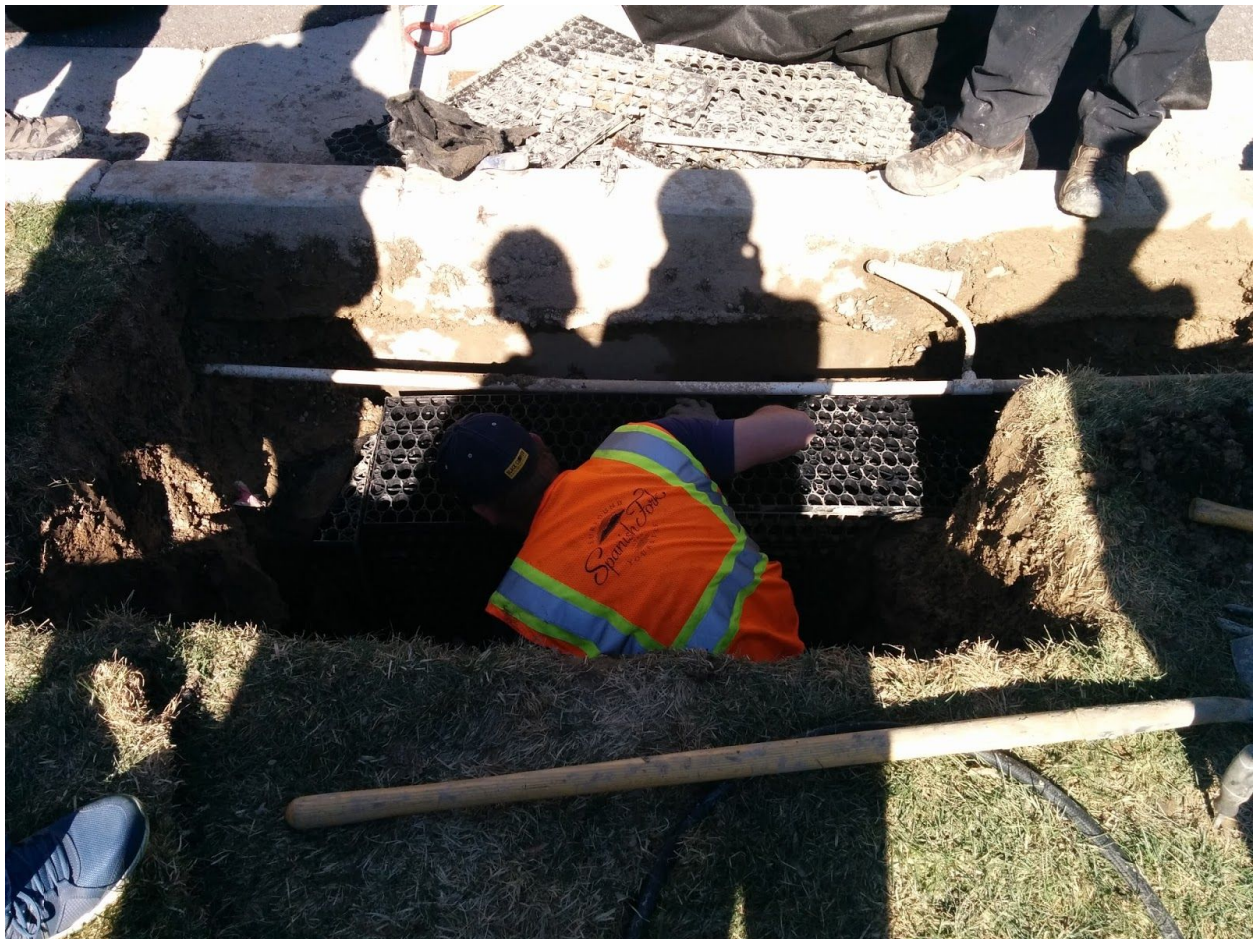
Figure 6. The excavation of the R-tank.

The process of how the R-tanks were inspected was by digging down to where the R-tanks were located directly behind the storm drain as shown in Figure 6. Once the soil was removed the fabric surrounding the R-tank was removed. The R-tank directly connected to the storm drain pipe was then opened and inspected. The following are the

first visit we found that there were issues with leaves getting past the Oil-Water-Debris Separator, blocking the entrance to the R-tank. Furthermore, this first system had the entrance pipe butting against the outside of the R-tank, yet the standard drawings showed that the a hole was supposed to be cut in the side of the R-tank to allow the entrance pipe to penetrate the R-tank by a couple of inches. We learned that this was an older design that had later been improved upon in order to prevent this type of blockage in the entrance. The problem with the new design that allows the entrance pipe to penetrate the R-tank is that these leaves would still collect in the main chamber of the entrance R-tank and possibly fill it up. We also observed that the entrance pipe was not properly centered on the entrance R-tank. This seemed to be a recurring issue, as the second site also had this problem.
