Development Accommodation Realignment Study – Riverton City

CEEn-2016CPST-01

February 27, 2017

X-Stream Engineers

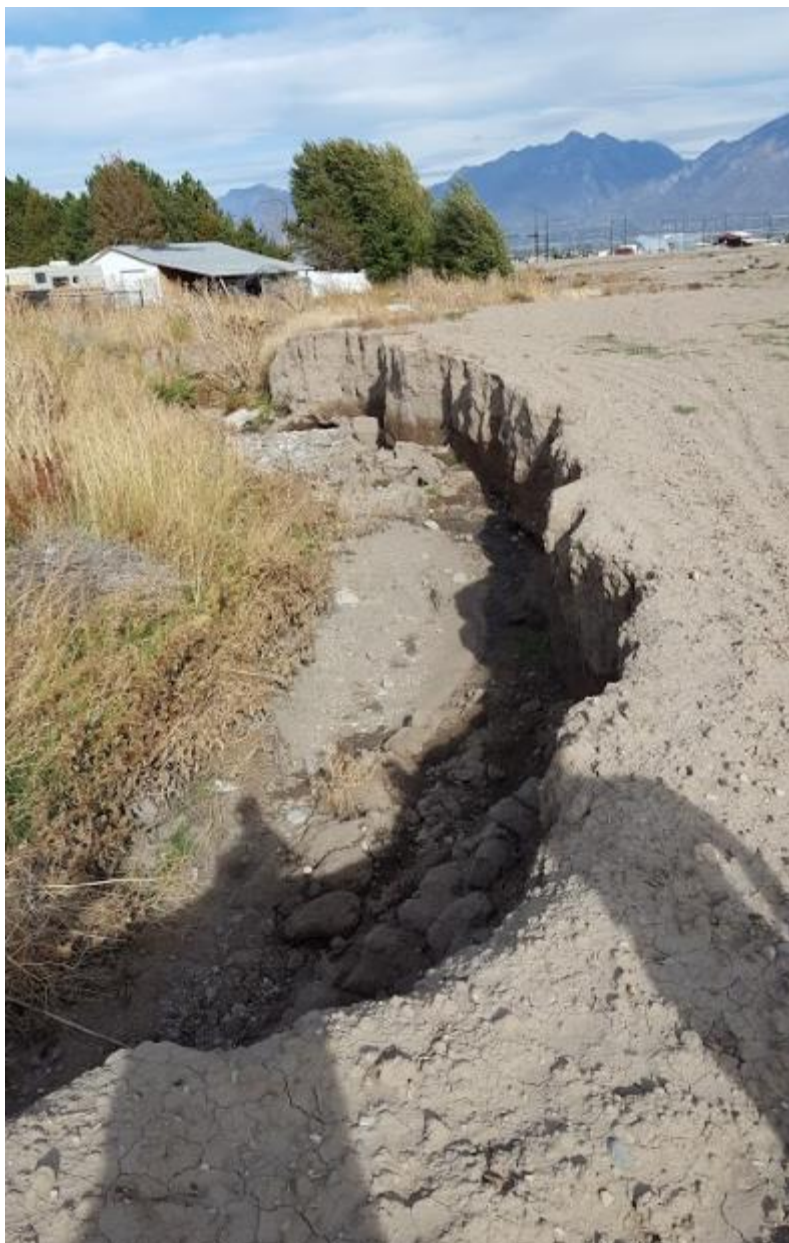
Current conditions of Rose Creek have been observed on two separate occasions. The initial observation occurred October 13, 2016 with Trace Robinson from Riverton City. Upon walking the stream line, we observed large amounts of erosion despite the stream being currently dry. Rose Creek was visited again February 15, 2017 to observe the creek and also take various measurements of the channel. Further erosion had taken place as snow runoff has been flowing through the creek during the winter months. The heaviest amount of erosion has been taking place on the south side of the creek which is in the direction of the original stream path. It appears that the creek is trying to push its way back to its original path. Small puddles were sighted in different parts of the creek bed which indicates that the creek bed is not constant in its downward slope, creating areas of standing water.

Figure 1. Image of erosion taken in October, 2016

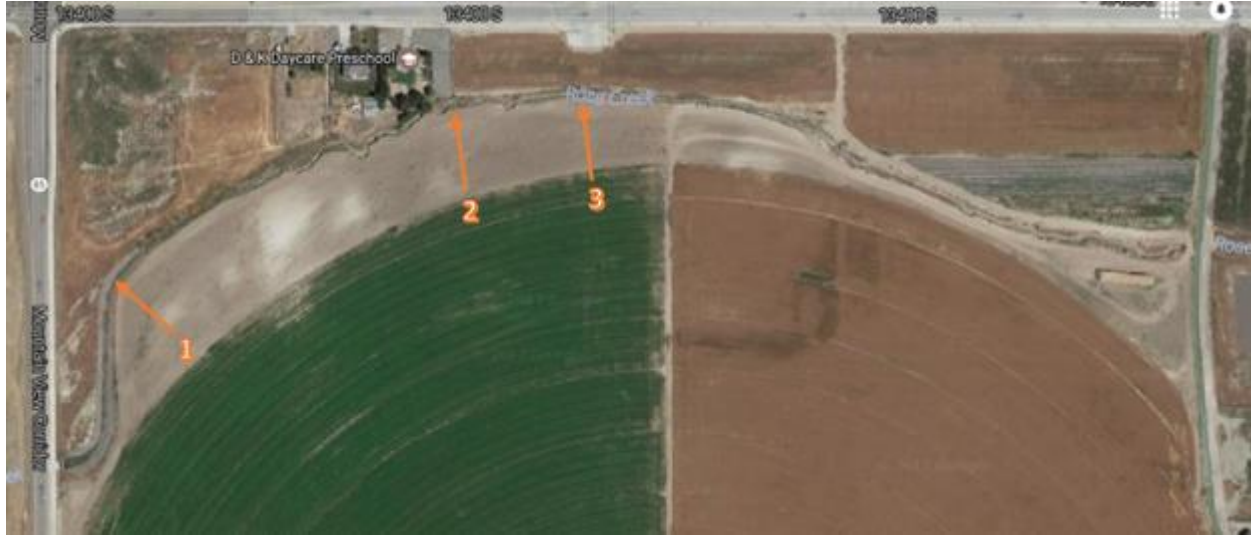
Three separate cross sections were taken of the creek in its current state to analyze the current state assuming 500 cfs flow rate (as requested by the city of Riverton). The assumed design flow rates will be later examined by creating watershed models in WMS to ensure a sufficient design for Rose Creek. The cross sections were analyzed using the hydraulic tool box and two of the three cross sections were found to have super critical flow based on the froude number. Based on observations the creek width was consistently 18-20 feet wide at the top and 8-10 feet deep, while the cross sections of the stream matches that of cross section 2 (see Appendix for hydraulic tool box analysis of cross-sections) for more than two-thirds of the channel distance. The design flow given from Riverton City was 500 cfs, watershed modeling is being done to verify that number and will be explained in the following sections.

Figure 3. Locations of original cross sections for analysis

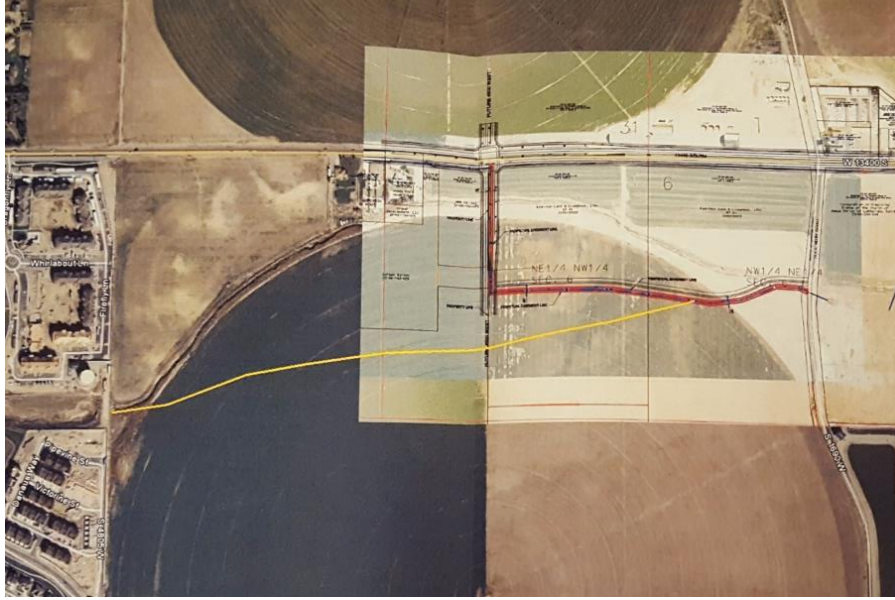
The new design path was chosen to match the original path of Rose Creek before it was diverted. To accurately place the proposed path, old maps were found in the Harold B. Lee Library that show where Rose Creek was originally located before diversion. Riverton City also hired surveyors to design a proposed path with elevations as close as possible to the original path. Topographic maps were studied as well which indicate where the original path most likely was. Using Google Earth and ArcGIS, the team mapped out the new proposed path and created an elevation profile for the new layout. The new elevation data provided shows that a constant downward slope between 1.4-2.2% is achieved.

Figure 5. Proposed new path for Rose Creek

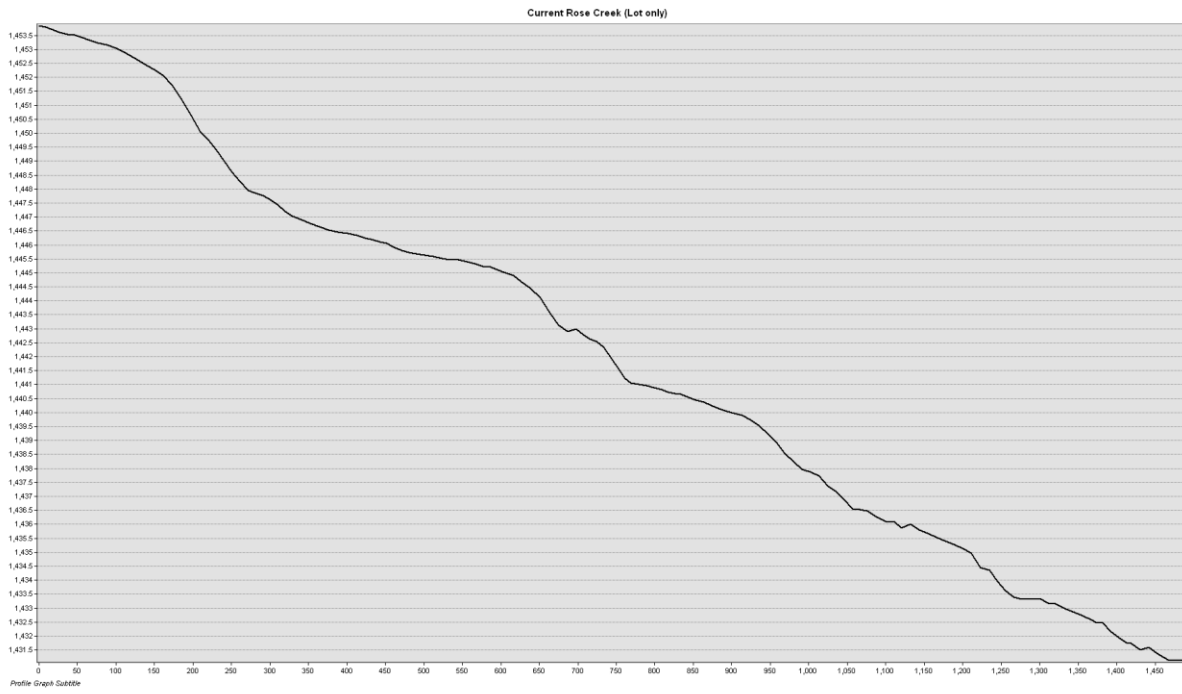
Current elevation profile of rose creek

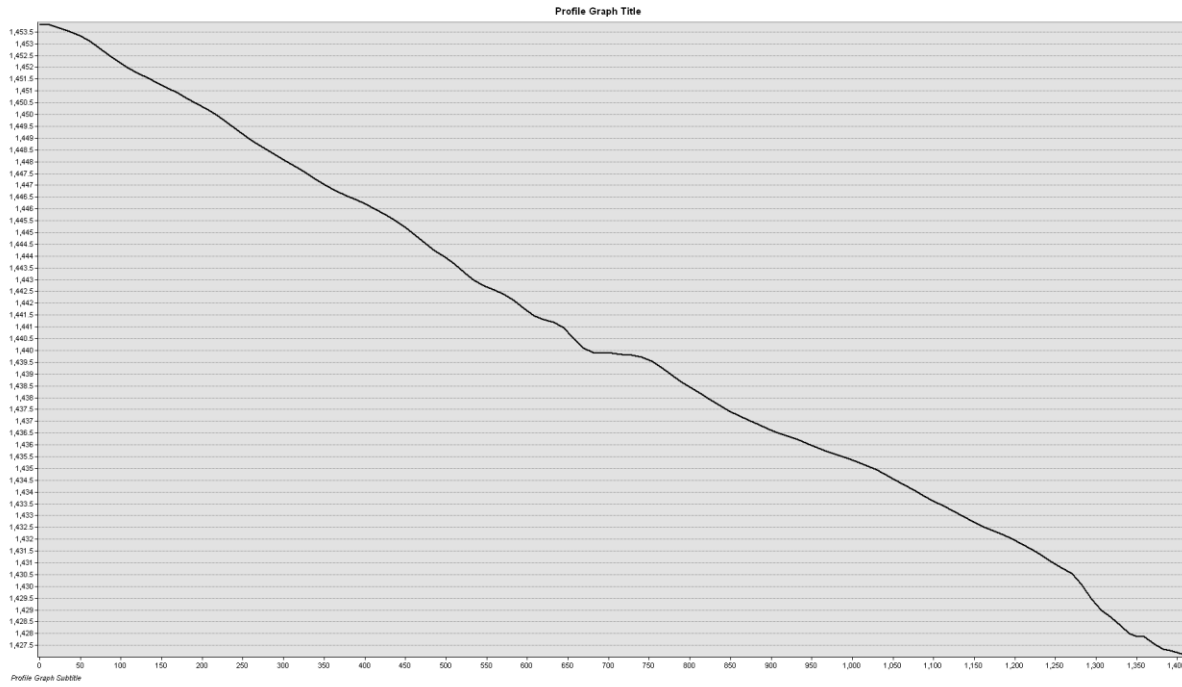
Elevation profile of new proposed path
