CEEn-2016CPST-012

Team Members: Joshua Reidhead, Daniel Schwicht, Jeffrey Schwicht, PM Jake Nelson

North Union Canal Feasibility Study

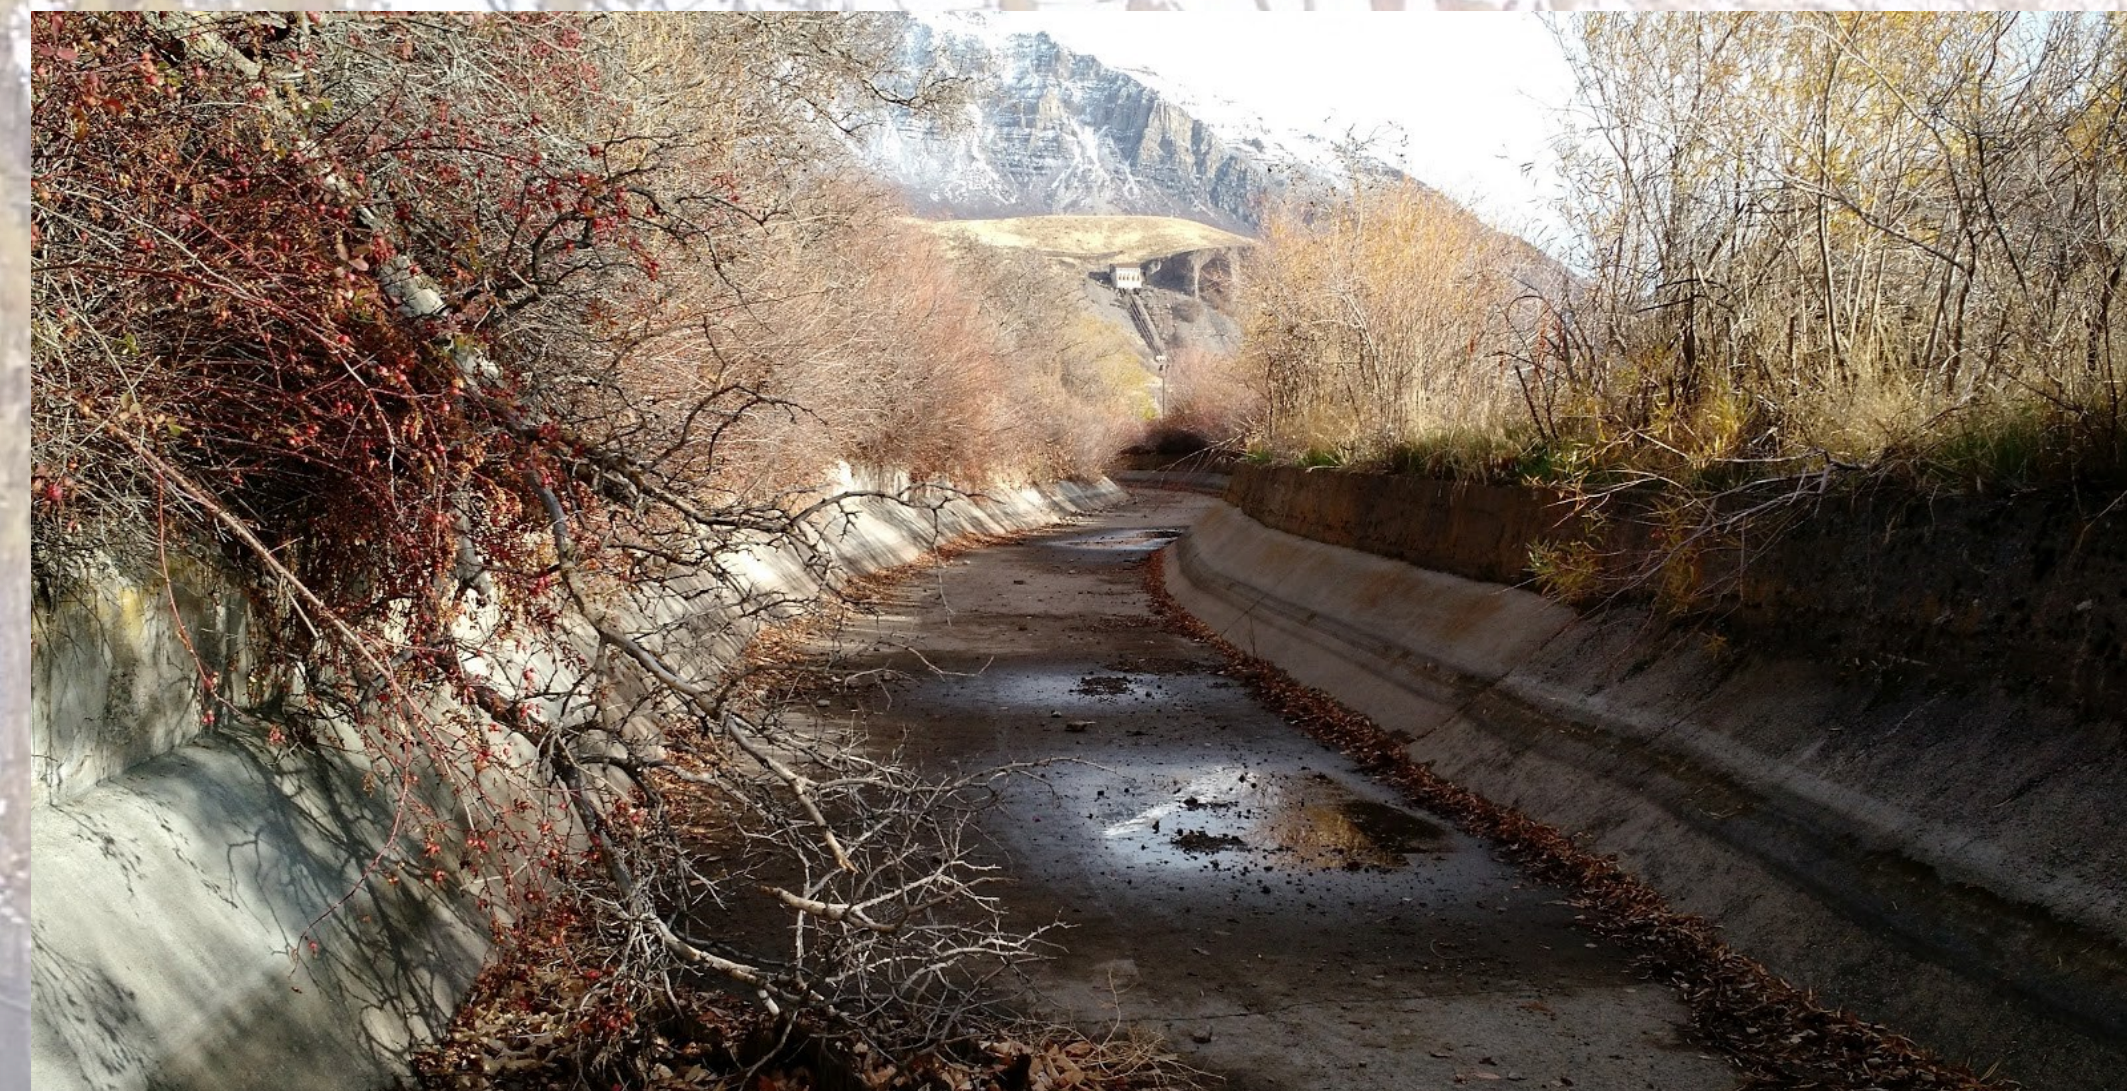
Canal segment is 3.7 miles in length

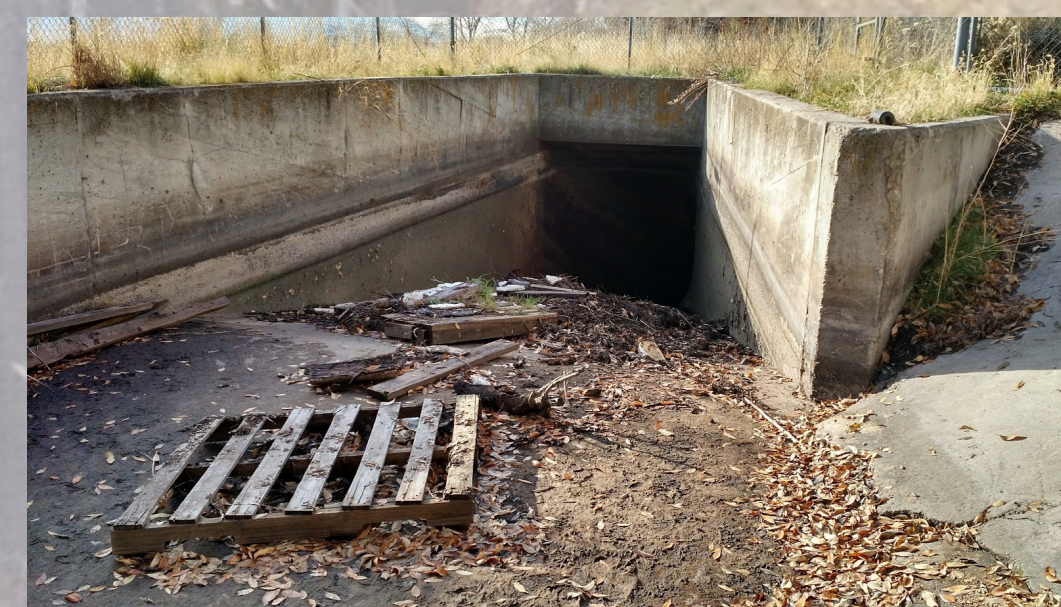
Siphon structure crossing under Orem Center Street

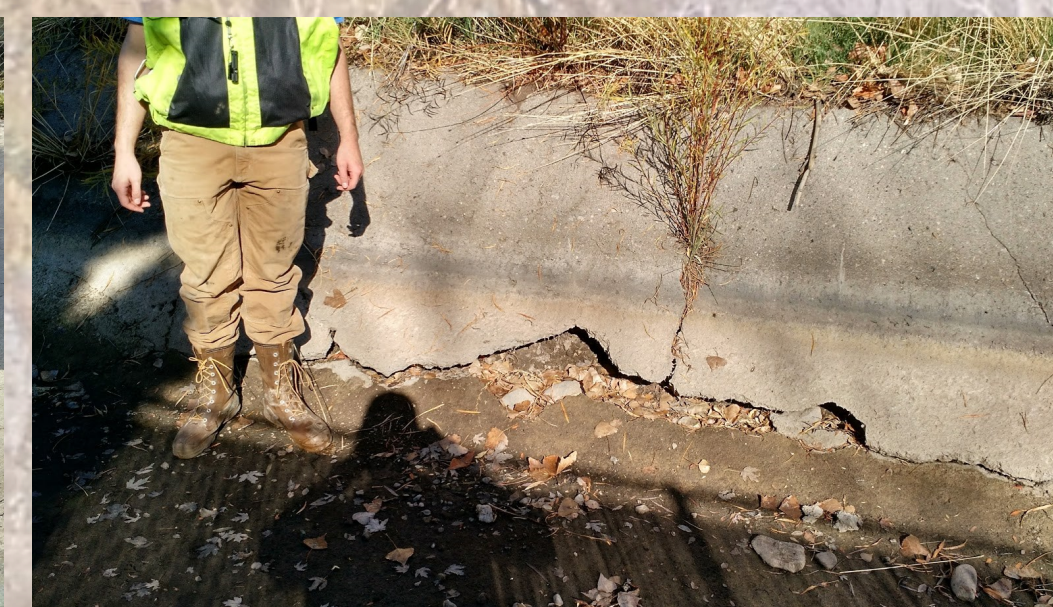
Block Faulting and erosion undermining canal lining

The canal runs through several areas of expansive clays, which have caused significant damage to the concrete lining many times over the last 60 years. Cracking of the lining allows water to escape and further feed the problem with expansive soils, leak into nearby basements, and potentially cause slope stability problems. The current water losses have been measured at over 90%. As an open-top canal, it suffers significant losses due to evaporation, there is a vulnerability to water theft from homes and property lining the canal easement, and there are frequent instances of canal structures being jammed and clogged by illegal dumping of yard waste and trash. Most troubling is the risk to life that the canal presents due to its being an attractive nuisance. Bodies of water are a magnet for the curious, particularly during hot summer months, and the risk of even strong swimmers drowning due to rapidly moving water and various hydraulic structures can be high.

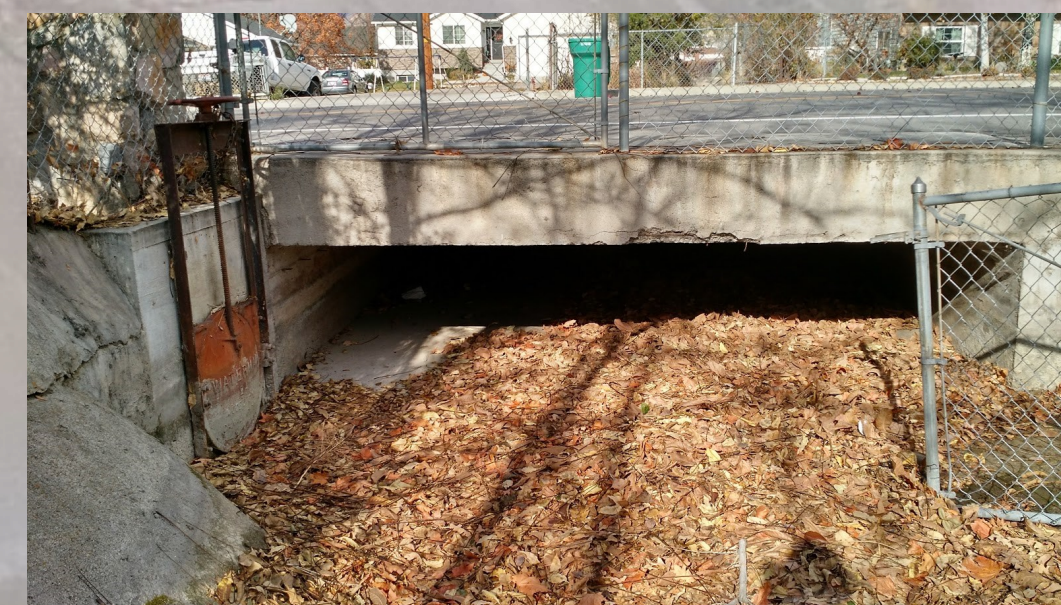
Debris clogging canal and decaying bridging structure

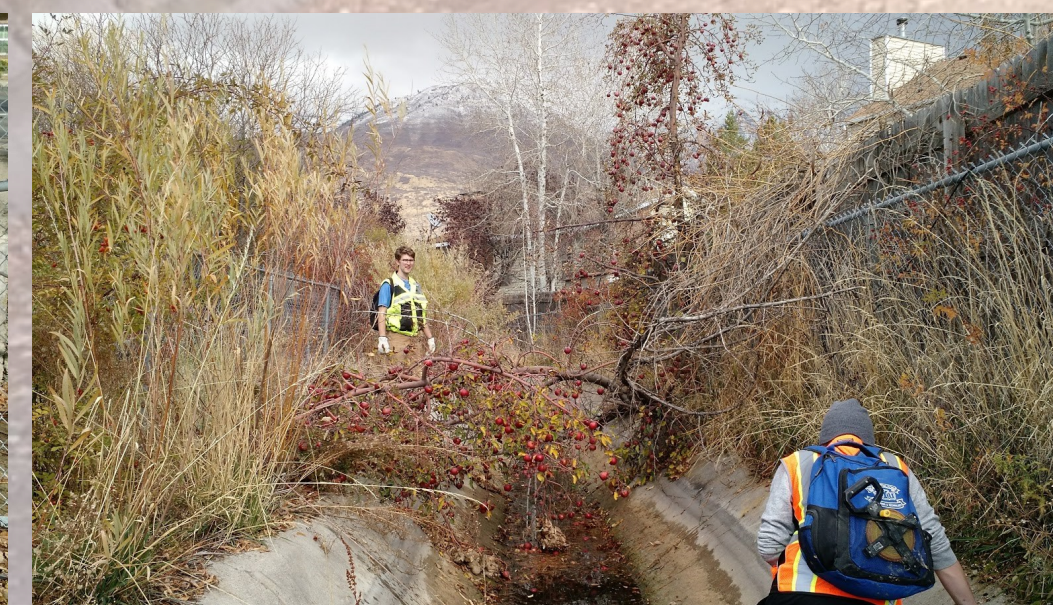
Overgrown easement encroaching on canal

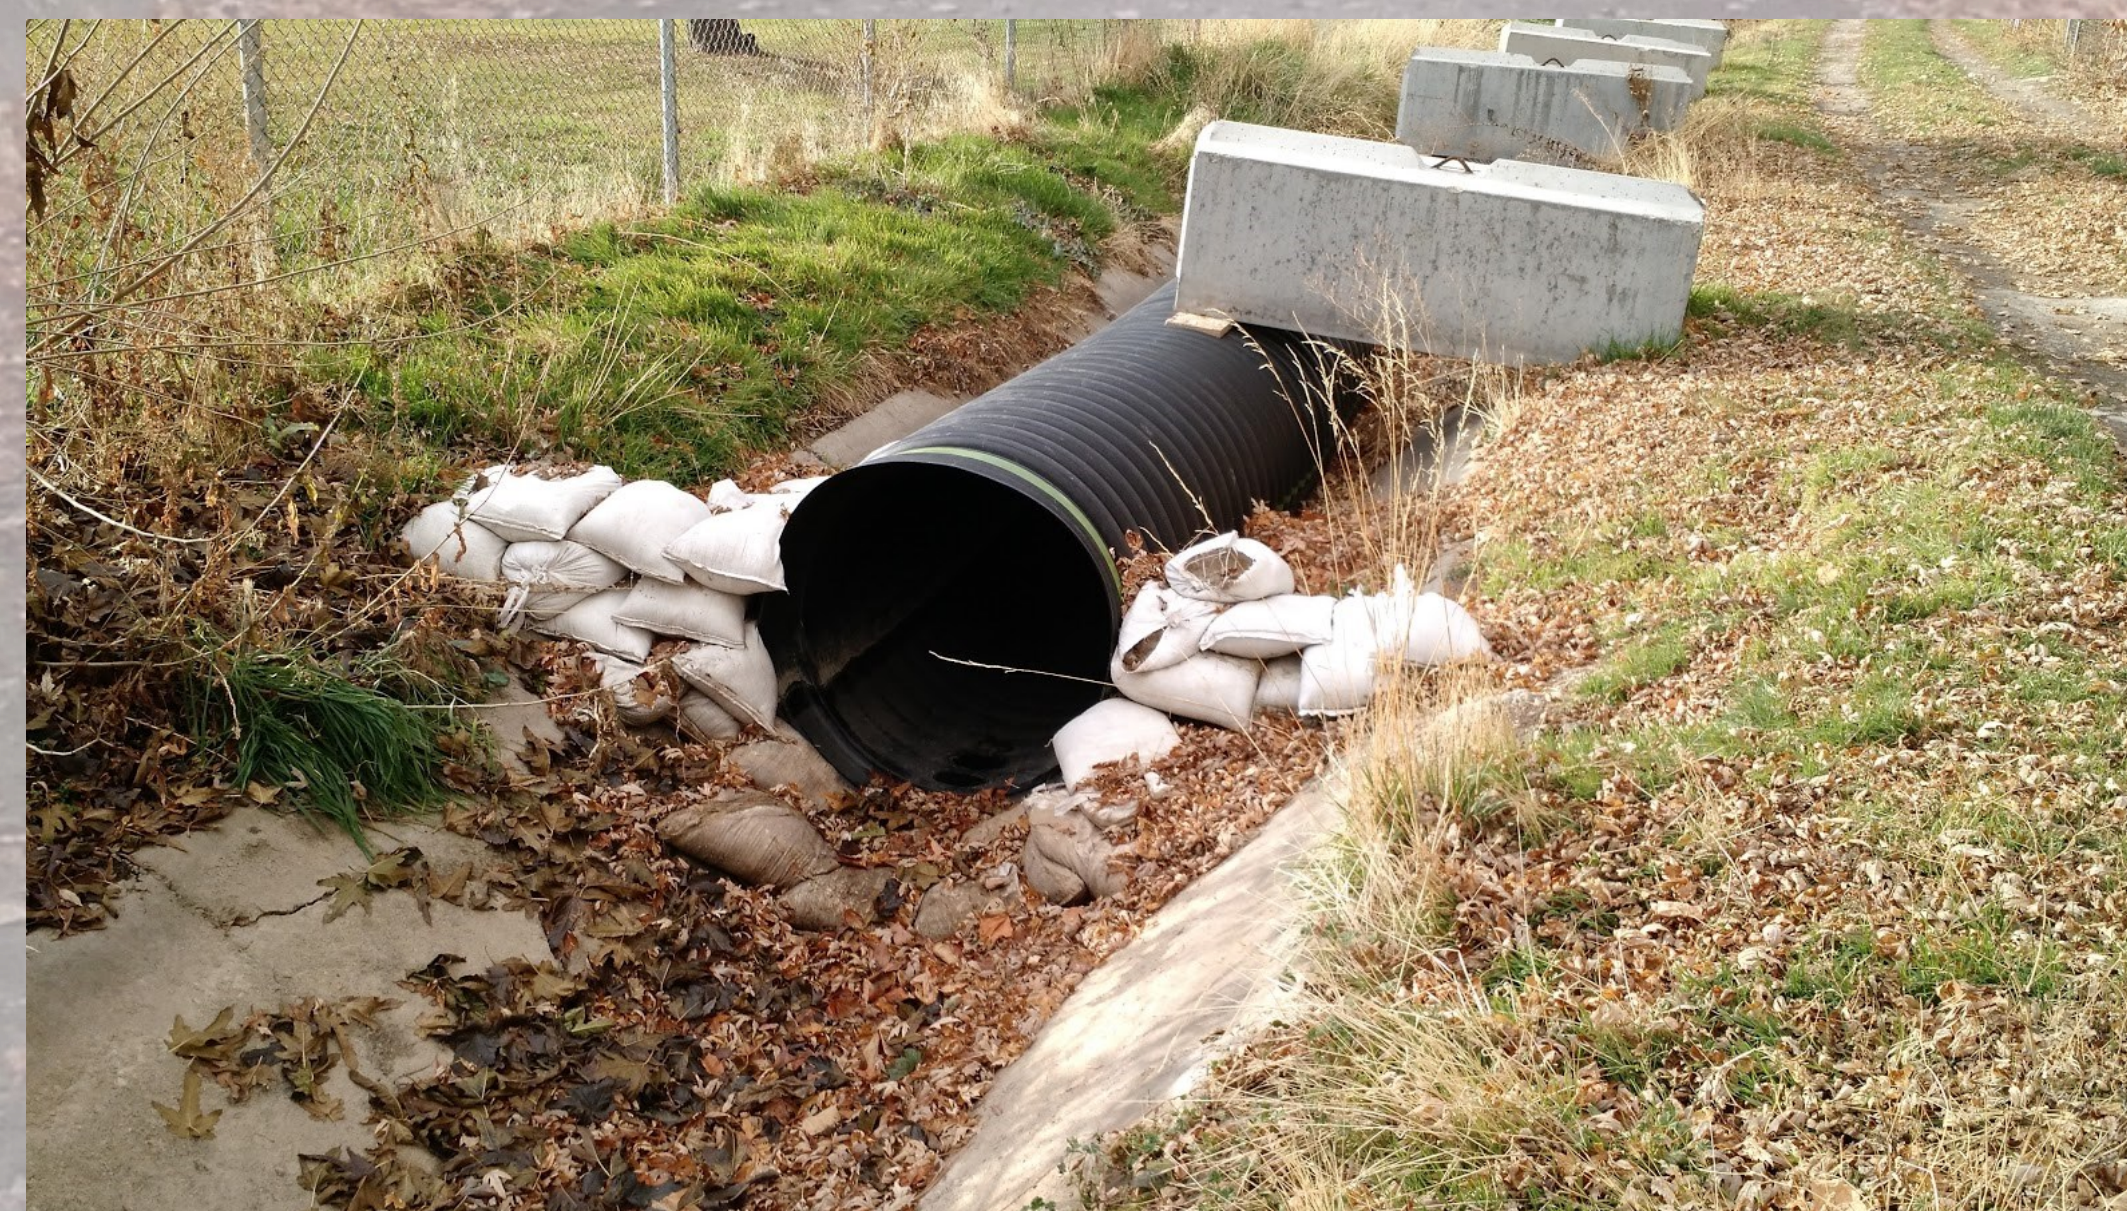
Severe canal damage in expansive clay soil with temporary fix

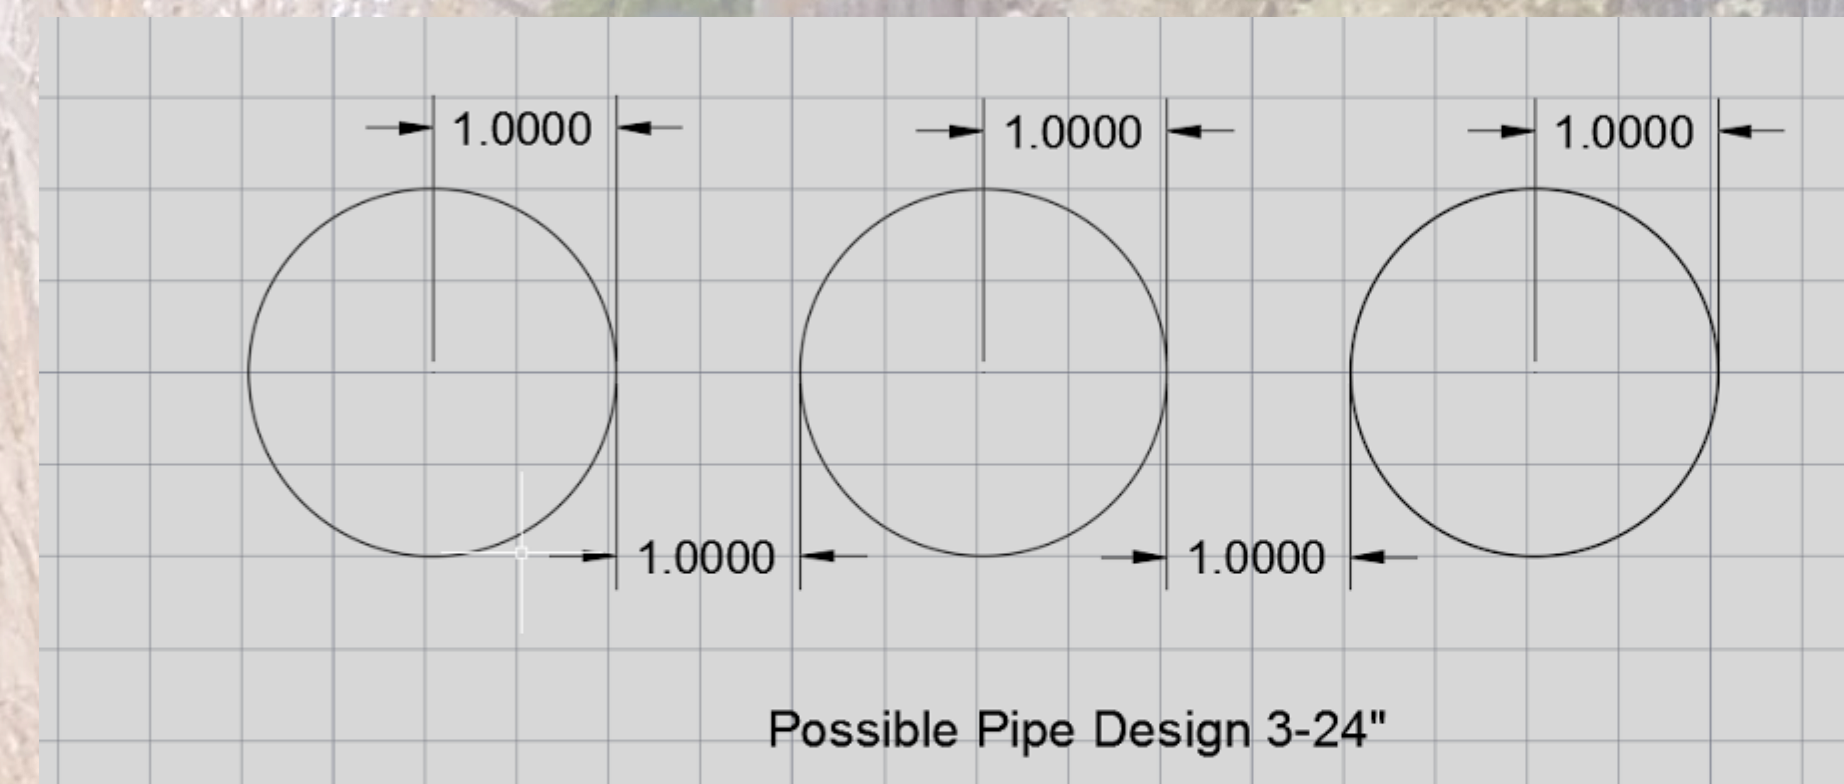
**Concrete Pipe**

Piping the canal is estimated to have an upfront cost of \$3,125,760. Piping is desirable for safety reasons and decreased losses to evaporation and seepage, reducing from 90% losses to around 0.5%. Piping also allows for creation of a trail along the canal. A downside to piping is severely decreased access, complicating future maintenance.

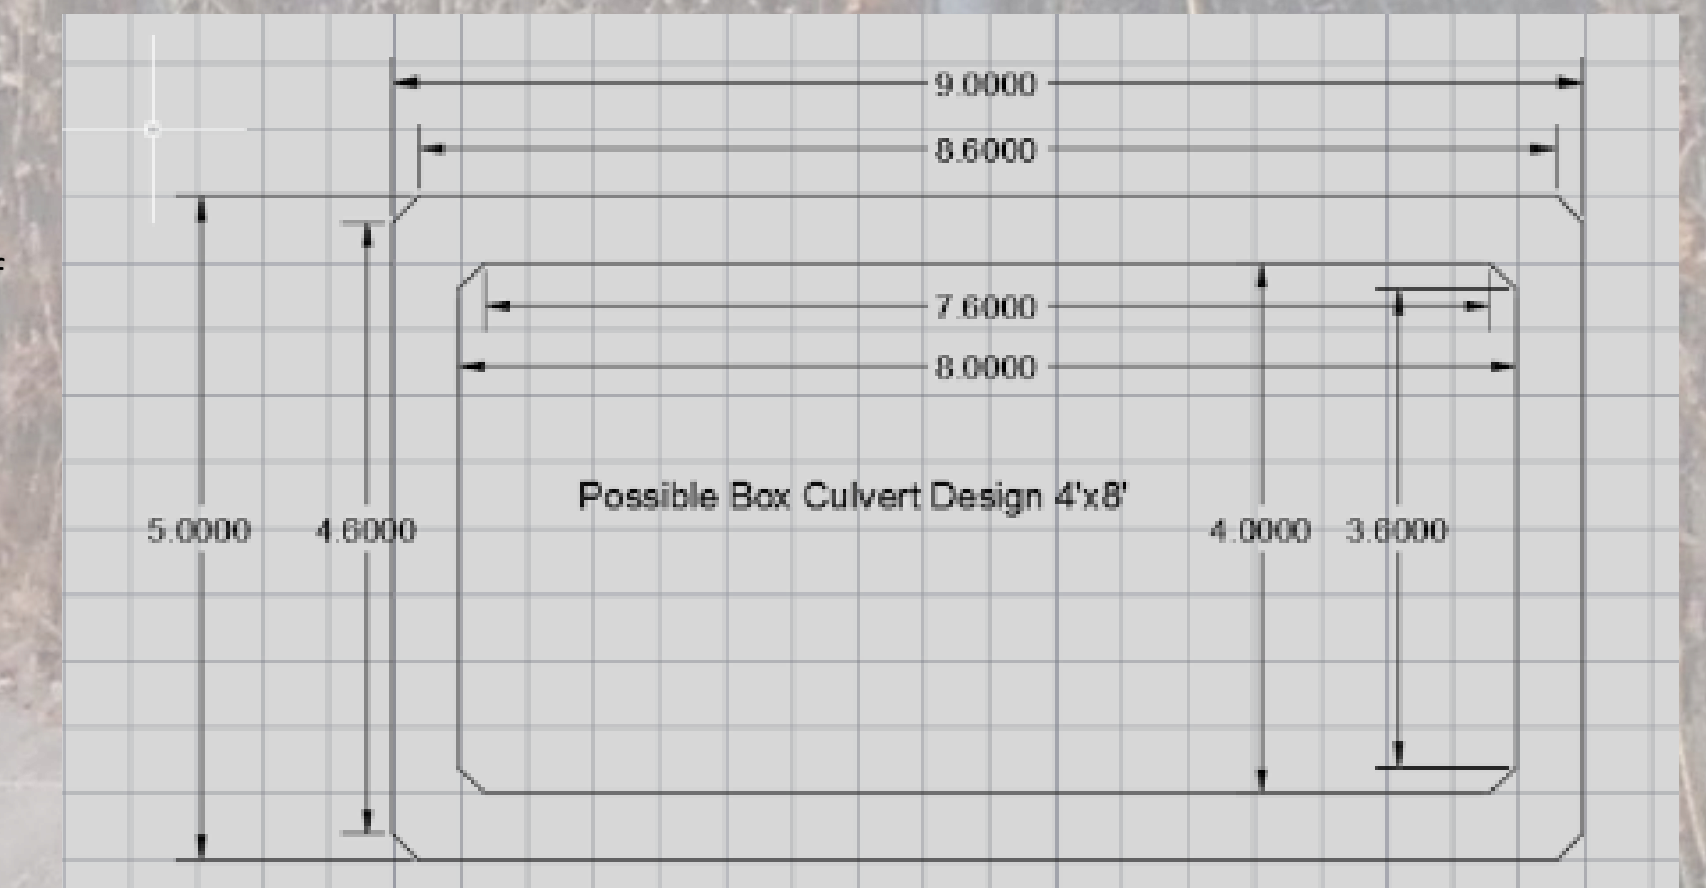
**Box Culvert**

The box culvert is estimated to have an upfront cost of \$2,910,864. Improved safety, elimination of evaporation and seepage, and the possibility of creating a trail make a box culvert desirable. Reducing losses from the current 90% to approximately 0.85%. Additionally, though access is decreased from an open canal, access is superior than that offered by a pipe.
