Woodland Hills

— Pavement Management —
Program

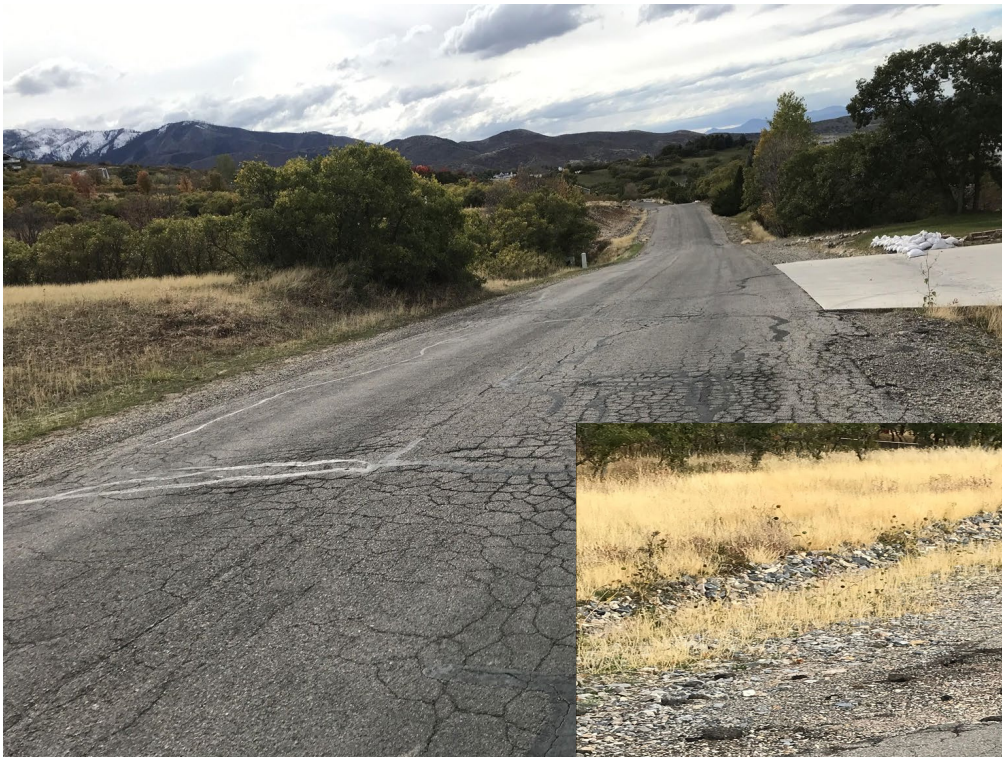
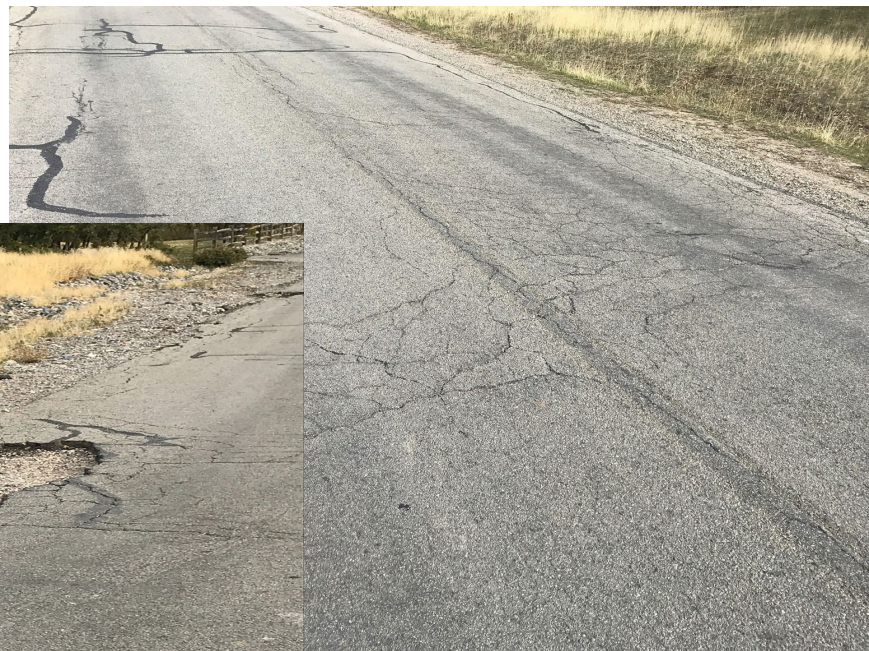
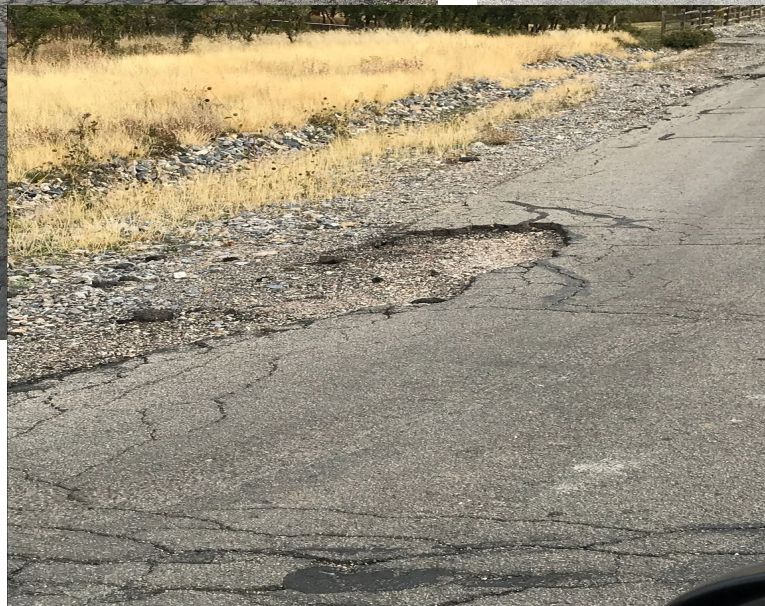
The Problem

Subbase, Base, & Drainage

HMA pavements can fail because of subgrade support deterioration as a result of excessive moisture or other water-related issues.

The subgrade must be able to support loads transmitted from the pavement structure, often affected by degree of compaction, moisture content, and soil type.

HMA pavements also need a permeable base to provide for rapid removal of water which enters the pavement structure to avoid weakening of pavement structure.

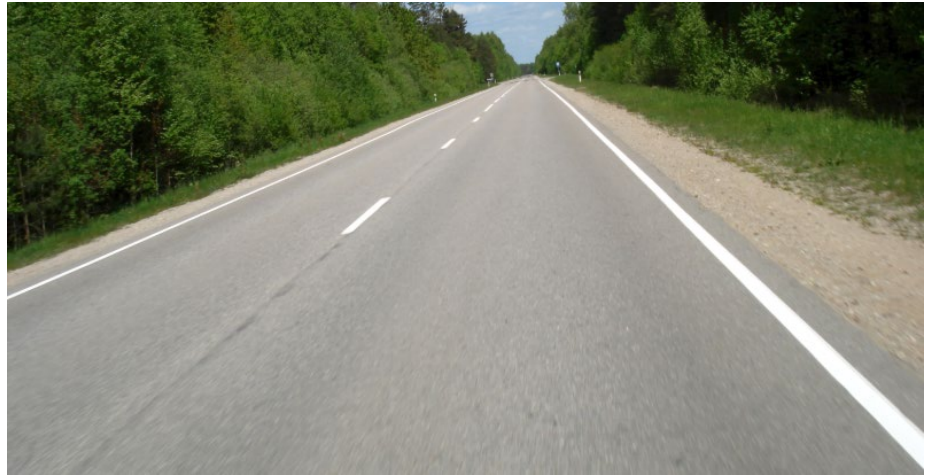
... Which Leads to Better and Cheaper Roads

- Roads are kept in good condition.
- Allows for pavement budgeting.
- Saves money in the long run.
