**RIVERTON RE-PURPOSING SEWER TRUNK LINE TO GROUND  
WATER SUB-DRAIN**

**Project ID: CEEEn\_2018CPST\_011**

**A Capstone Project Final Completion Report**

**Riverton City**

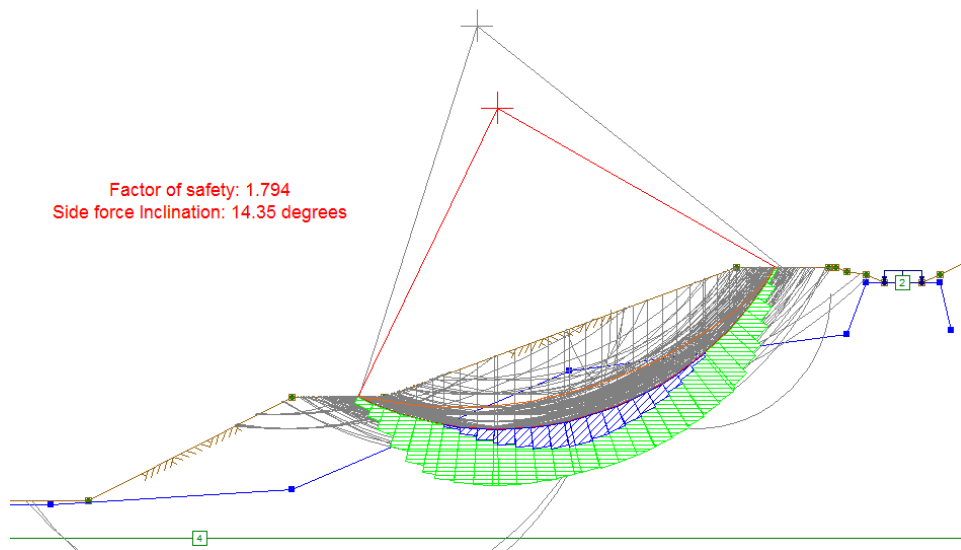
**Figure 1. Slope Stability Analysis**

Based on site visits, soil properties, and location, it was determined that the seepage from the canal is one of the major causes of instability of the hillside. Existing drains in the hill are continually draining water, but many of these pipes are clogged or deteriorated. The soil in the hillside consists mostly of silty sand and fill, which provides low stability strength. Altering the slope is not in the plans for the city at this time. Based on this information, the team’s purpose was to propose a solution for the instability in the hill caused by the excess of groundwater. Three possible solutions were considered as proposed solutions. For this report, each scenario received a preliminary analysis of cost, benefits, and design, but only the option is chosen as a final recommendation received more in-depth design and cost analysis. A slope stability analysis was performed on options for the hill, as seen in Figure 1.

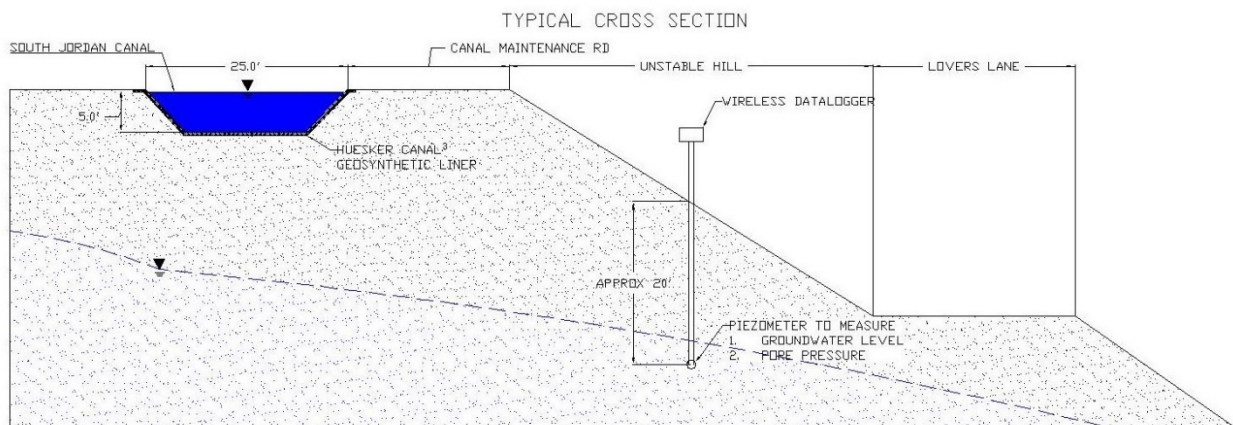
**Figure 2. Typical Cross Section of Implemented Recommendations**

It is recommended that Riverton City address the source of the water seepage, the South Jordan Canal. This includes lining the South Jordan Canal with an impermeable membrane to prevent water seepage during the irrigation season. This option may be complicated by the fact

the Canal is not owned by the City of Riverton. The canal is owned by The South Jordan Canal Company. Therefore, any project involving lining the canal will only be possible depending on the coordination of Riverton City and South Jordan Canal Company, and the willingness to work together of each. In anticipation of this possible issue, the team has contacted the canal company, and they have communicated that they would be willing to work with the City to line the canal. Based on our analysis, this is the most effective means of stabilizing the hillside. Lowering the seepage rate from the canal will increase the stability of the hill significantly. It is recommended to use a synthetic lining, such as the Huesker Canal<sup>3</sup>. This lining has been used on other canals in the area and has proven to significantly decrease the seepage in those areas. This lining is also cost-effective, easy to maintain, and able to be custom made to fit the canal (see appendix for more detail on the product). The canal lining is flexible enough to allow shotcrete to be applied over the lining, if necessary. Based on the team’s analysis, using shotcrete over the liner would not be necessary for this application, but may add several years to the lifetime of the lining.

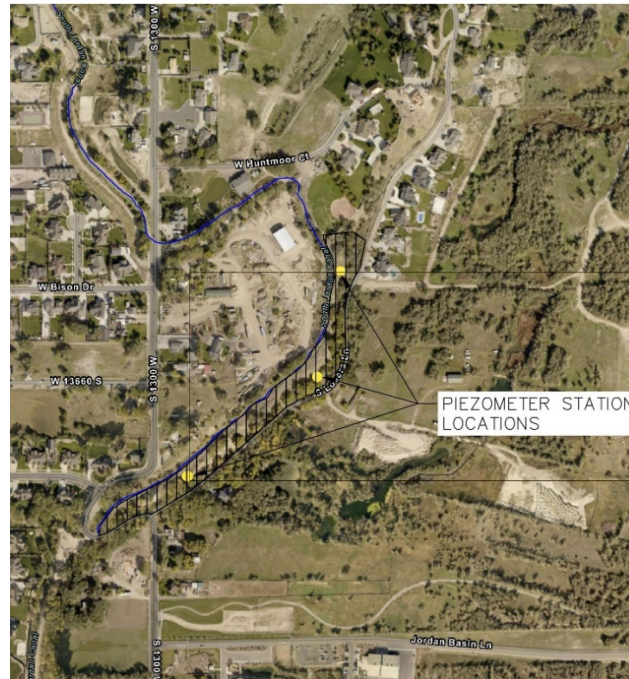
**Figure 3. Locations for Piezometer Stations**

It is also recommended before the installation of the liner for the Canal that the City install three wireless piezometer measuring stations in the hillside. These stations would act as a monitoring system for the hill. At these stations, the pore pressure and groundwater level of the hill would be reported. The center station would act as a data logger, as the two outside measuring stations report to it. The data logger would publish data that could be accessed through a computer or a smartphone. Readings would be taken before the installation of the canal liner, and at least a year after implementation. Based on the effect the liner has had on these

readings, the hill should be reevaluated, and as necessary, further mitigation may be considered at that point. Figure 3 includes the locations for the piezometers.

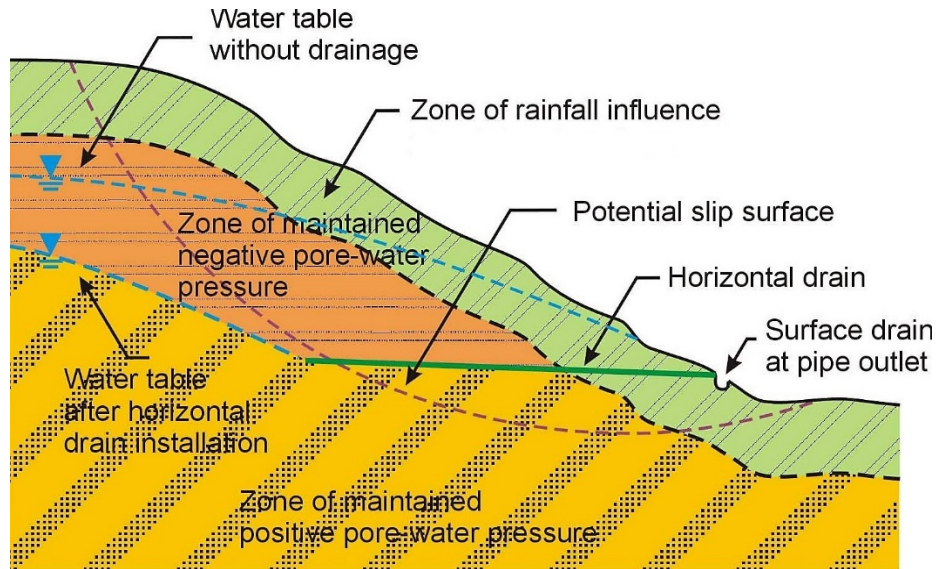
**Figure 5. Theoretical Effect of Horizontal Drains**

A secondary option considered was to install a completely new drainage system in the hillside and connect it to the existing abandoned sewer pipe. This may include removal of the old draining system, installing wet wells, perforated pipe, and horizontal drains to drain the moisture in the hill. This would cost significantly more than any other option. Furthermore, there is a major concern that digging into the hill may initiate movement in the hill and trigger. Because of this, it is not recommended to install a new drainage system into the hill.

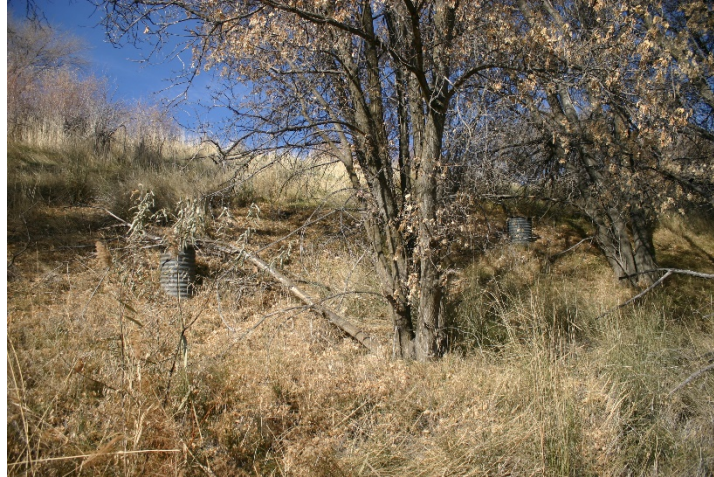
**Figure 6. Existing Standpipes in the Hill**

One of the biggest issues with this option is the fact that the abandoned sanitary sewer pipe is not positioned to capture the flow of the drainage pipes. Based on the limited information the team has on the sewer pipe, it seems it is set at a higher elevation than the existing drainage pipe system is currently. One way in which this line might still be utilized is to do install something similar to what was suggested before, using a pipe to collect all the water from the existing drainage pipes and pump it up to the abandoned sewer line. But with this, it must be remembered that the existing drainage pipes are in poor condition and may need to be replaced to make this work. Because of this, it is not recommended to connect to the old drainage system. Figure 4 depicts some of the standpipes and drainage systems in the hill currently.

The hillside has an existing system of horizontal drains within the hill. Unfortunately, the system has become inefficient over the years due to corrosion and obstruction of the drains with soil, leaves, and other material. Some drain pipes show signs of drainage, while others seem to be clogged entirely. Due to rich vegetation, clayey soils, and the corrosion of drainage pipes, the current drainage system is inadequate to handle the excessive groundwater in the hill. Also, it is important to note the existing drainage system does not route the water to any facility but instead routes the water to the other side of Lovers Lane. This may present an issue for the city in the future.

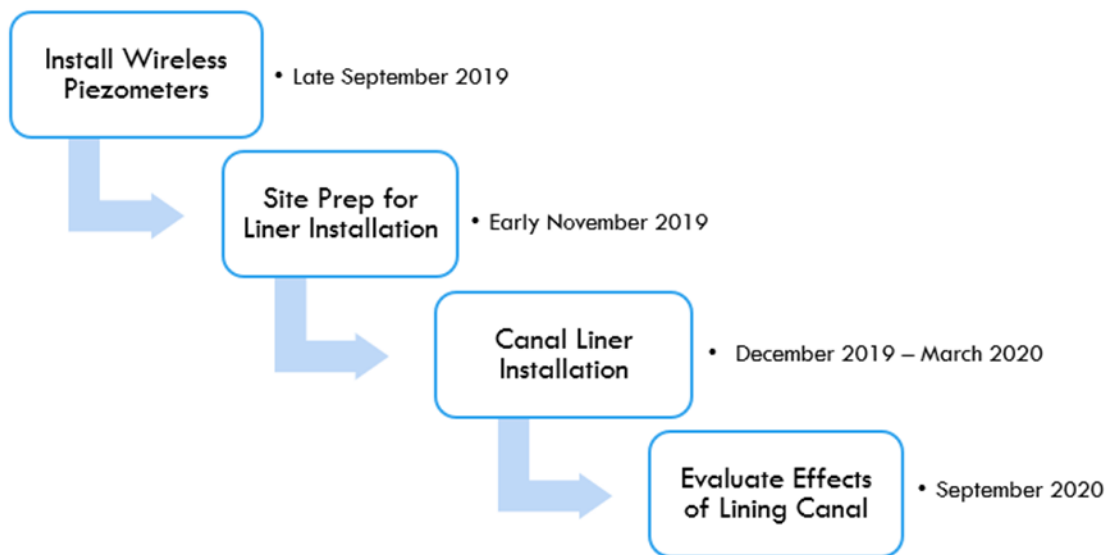
**Figure 7. Implementation Schedule**

The following schedule was made with the assumption as if the project had been funded for the 2019-2020 fiscal year. If the project is not funded for the next fiscal year, the schedule may still be used, and the years adjusted to match the year of funding. The irrigation season for the South Jordan Canal is April 15 – October 15, and the schedule is built around this fact. The schedule is separated into phases of the recommendation.

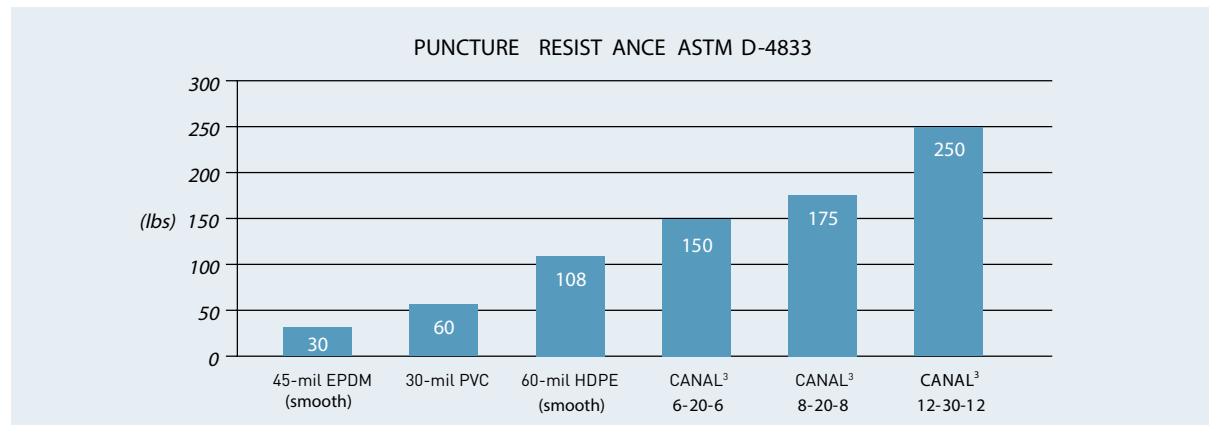
The following chart includes published ASTM D-4833 puncture index test values for typical canal liners. Recently, a thorough field assessment of various types of canals concluded, "Without question, liners with a protective barrier performed the best and have required no maintenance, while the performance on the liners without a protective barrier has varied significantly," (Evaluation of Canal Lining Projects in the Lower Rio Grande Valley of Texas, Karimov, Leigh, Fipps, P.E., 2009.)

**Canal<sup>3</sup>** provides superior puncture properties for various site conditions from smooth to rough subgrades and is available in several styles. Irrigation districts and contractors agree that the ease of installing **Canal<sup>3</sup>** over other liners is not only cost effective but also reduces installation time by using our wider width materials. Installations of **Canal<sup>3</sup>** can be performed by a subcontractor or by irrigation personnel with minimal instructions from a HUESKER technical representative. The following are recommendations for the proper selection of the **Canal<sup>3</sup>** products for various site conditions.

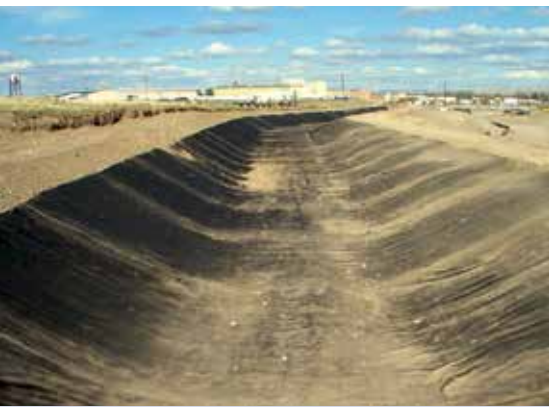
In 2007, the Porter Canal owned by the New Sweden Irrigation District located in Idaho Falls, Idaho was reshaped and lined with **Canal<sup>3</sup>** 12-30-12 by a commercial developer due to seepage onto a proposed commercial subdivision. The project consisted of reshaping 1,400 linear feet of the Porter Canal and installing 157,500 ft<sup>2</sup> of **Canal<sup>3</sup>** geocomposite liner by HK Contractors, Inc. The custom roll size of 25 feet wide x 300 feet long reduced the number of seams and expedited the installation process. The entire project took approximately 2 weeks; 1 week to reshape the existing canal, 4 days to install the **Canal<sup>3</sup>**, and another 3 days to seam and attach to a bridge structure. After construction, the Developer built on the now dry parcel adjacent to the canal.

**Project:** Lining of Porter Canal  
**Location:** Idaho Falls, Idaho  
**Owner:** New Sweden Irrigation District  
**Contractor:** HK Contractors, Inc.  
**Material:** Canal<sup>3</sup> 12-30-12

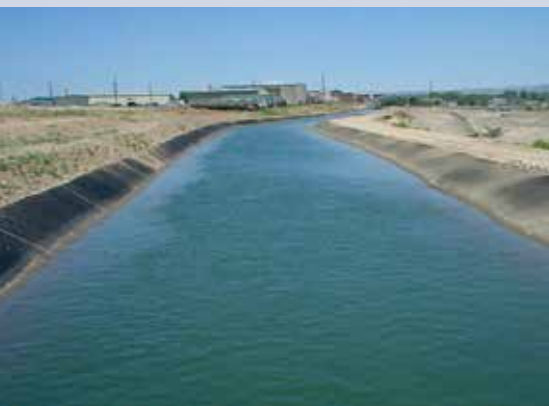
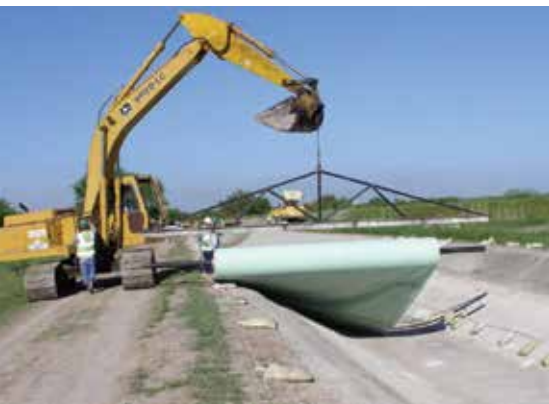
In 2004, after years of concrete repairs, and high seepage rates, Hidalgo County Irrigation District No. 2 located in San Juan, Texas decided to rehabilitate their Lateral "A" canal. The 7.26-mile lateral was drained, and cleaned of loose debris, as well as cracks filled prior to the installation of **Canal<sup>3</sup>** 8-20-8 geocomposite above the existing concrete canal. Approximately 850,000 ft<sup>2</sup> of **Canal<sup>3</sup>** were supplied in standard and custom roll widths to reduce waste along the entire reach of the canal. The Contractor employed a modified shotcreting method for placing the 3-inches of shotcrete above the **Canal<sup>3</sup>** which resulted in placing over 125 yd<sup>3</sup>/day. Incorporating the **Canal<sup>3</sup>** above the existing concrete canal with the shotcrete above provides a "secondary" containment layer beneath the shotcrete layer extending the life of the canal beyond 50 years, according to the 10-year Study written by the Bureau of Reclamation.

**Project:** Rehabilitation of Lateral "A" Canal  
**Location:** San Juan, Texas  
**Owner:** Hidalgo County Irrigation District No.2  
**Contractor:** McAllen Construction  
**Material:** Canal<sup>3</sup> 8-20-8

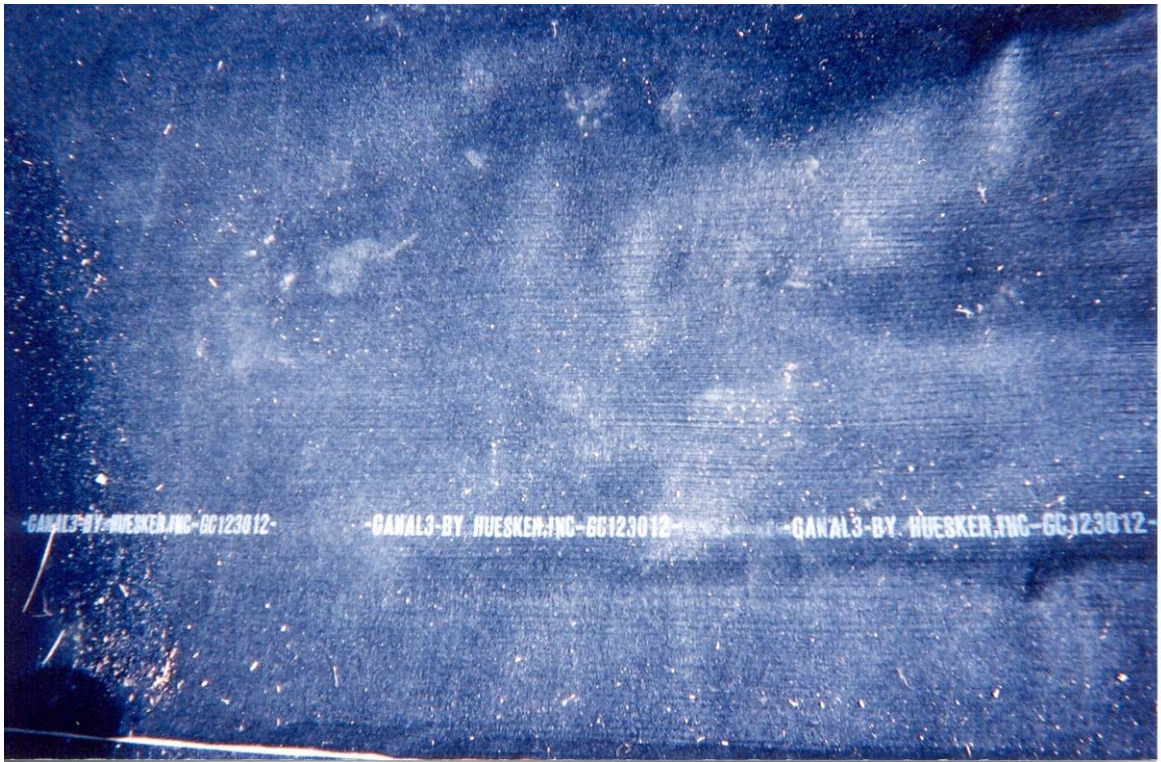
**Product marking/overlap line if required**

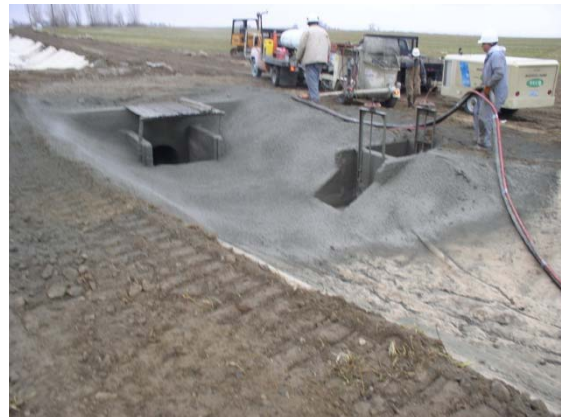
**Canals with Shotcrete cover**

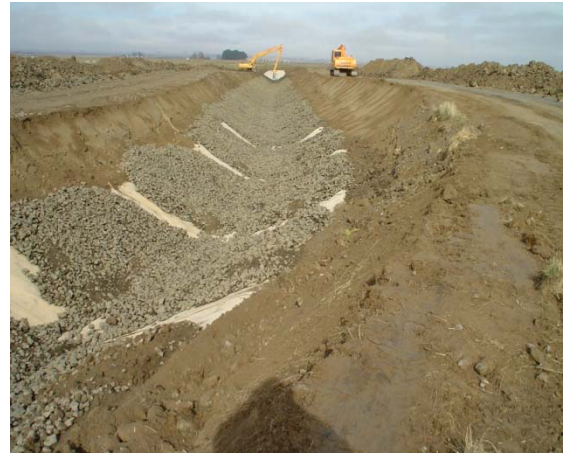
**Canals with earth or rock cover**

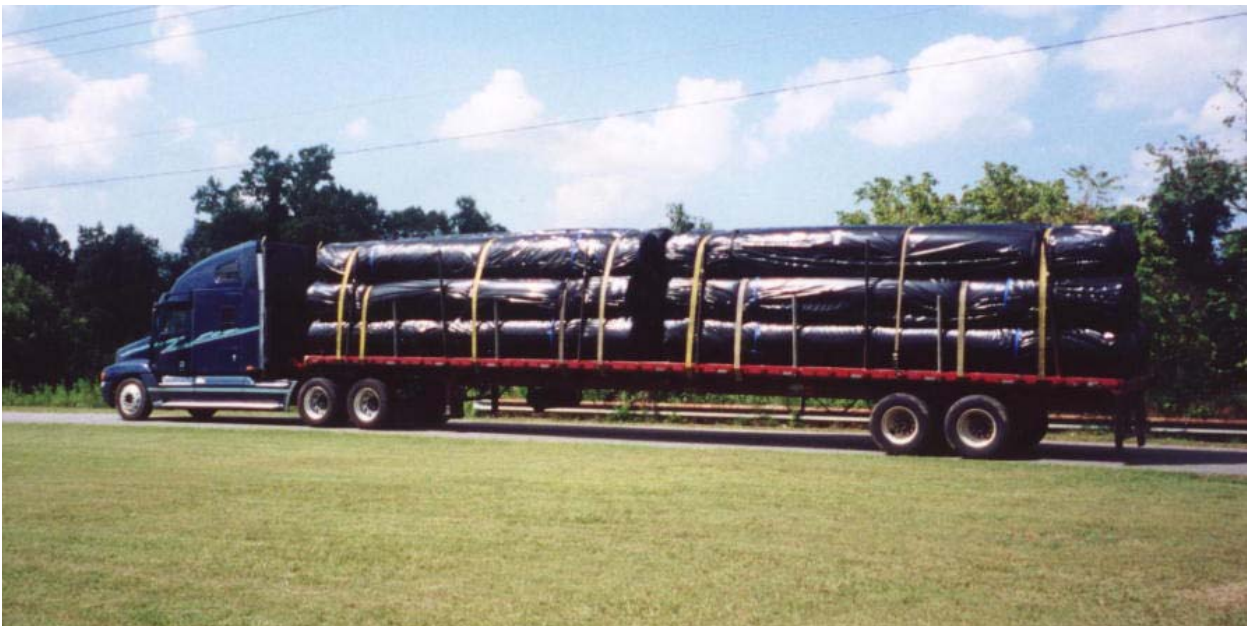
**Canal<sup>3</sup> ready to be off loaded at a jobsite.**

Canal<sup>3</sup> rolls are wrapped in plastic and may be stored on the ground. A tarp should be placed over the material in order to protect it from the elements if stored for a long period of time. Full truck load orders are shipped using flat bed trailers. Care should be taken when off loading the material.

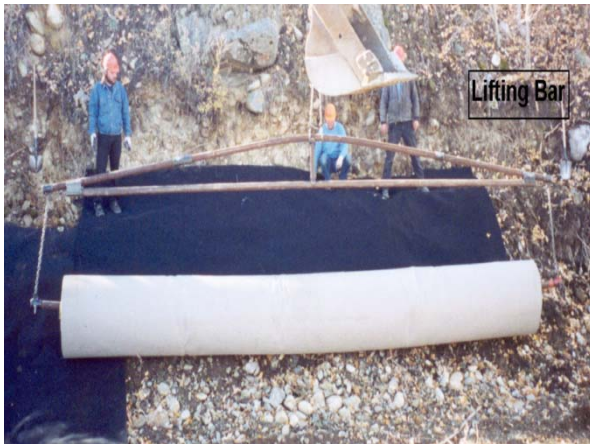
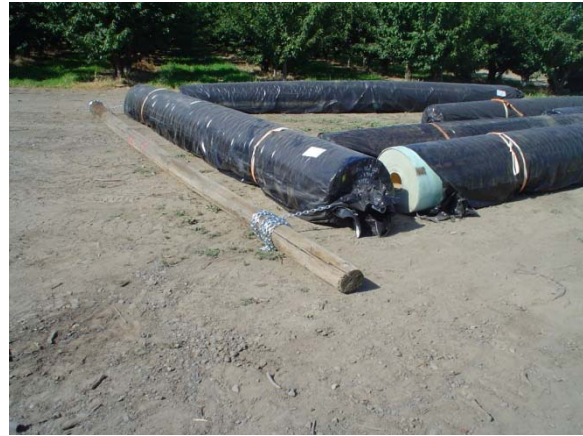
**Simple lifting bars built by the irrigation districts. Minimum pipe diameter is 3 inches**

Special mechanical equipment is necessary to handle Huesker's Canal<sup>3</sup> which has a roll width of 25 feet as shown in the pictures on the next page.

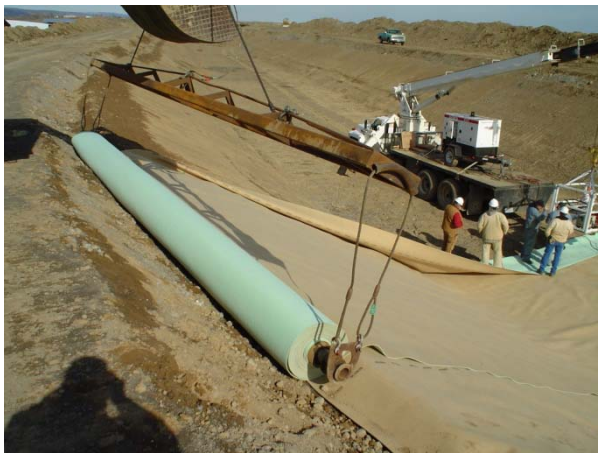
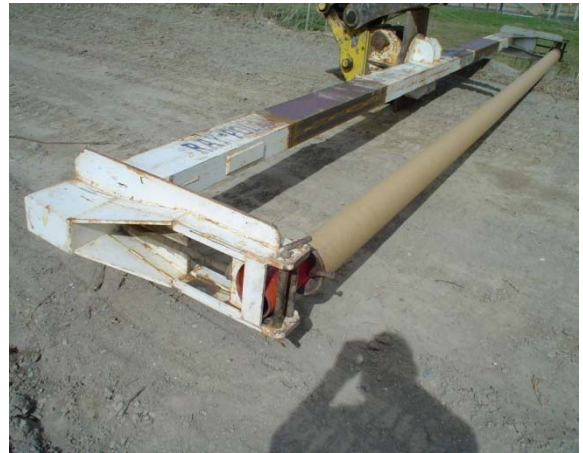
**One lifting bar built by an irrigation district (left) and one built by a contractor (right)**

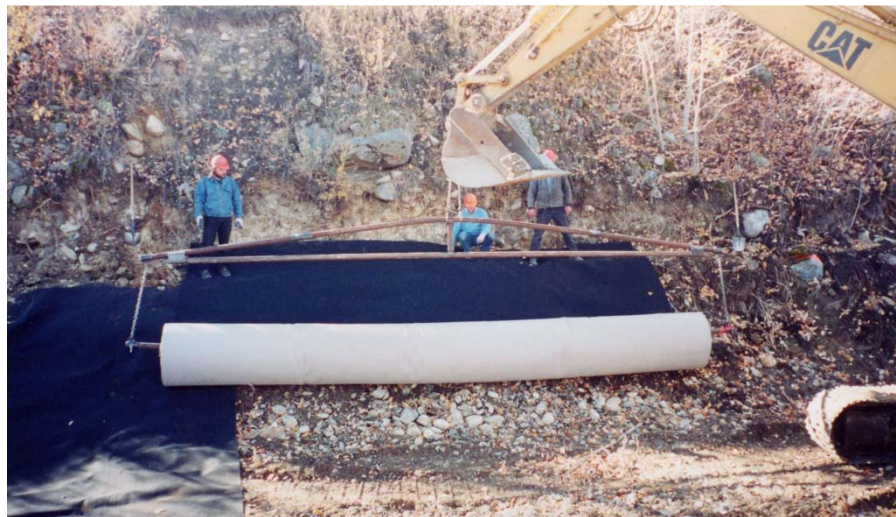
Twenty-five feet wide rolls are packaged with the black polyester textile on the inside so that it is on top when unrolled from a mobile gantry, crane or backhoe.

**Canal<sup>3</sup> being unrolled across the canal**

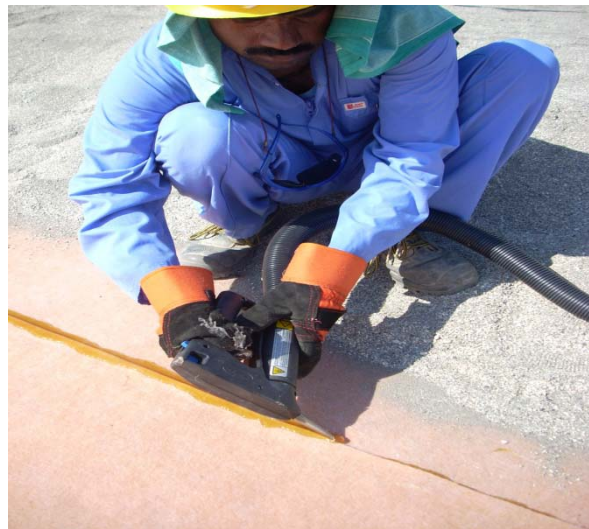
**Canal<sup>3</sup> being seamed with a hot melt adhesive**

Seaming to ensure water tightness should be only done with a hot melt adhesive. The following are recommended methods of installation:

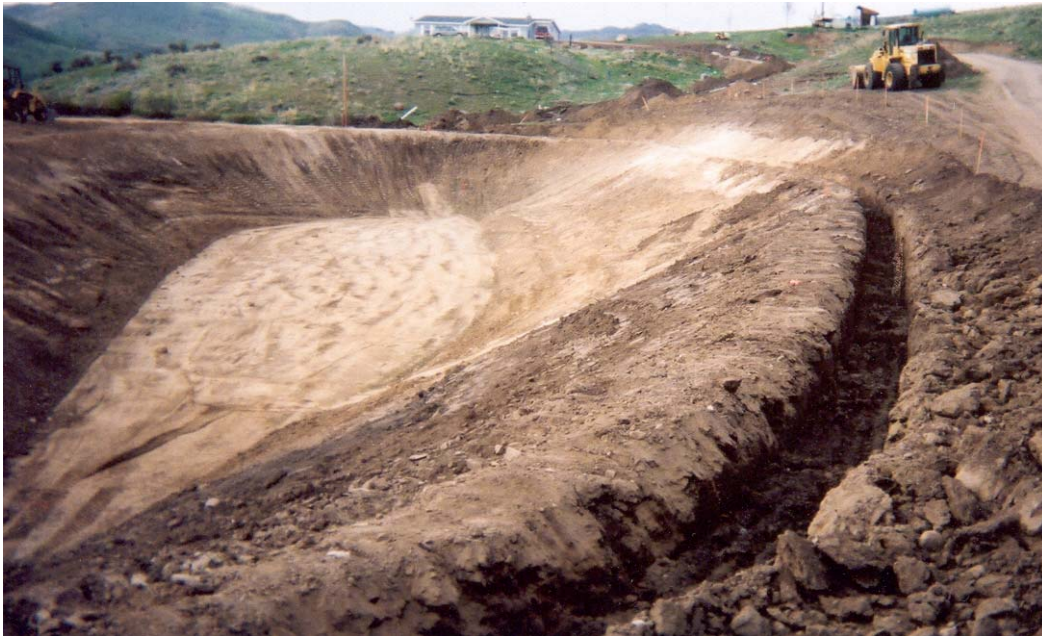
**Rectangular Anchor Trench (10 – 20 ft slope)**

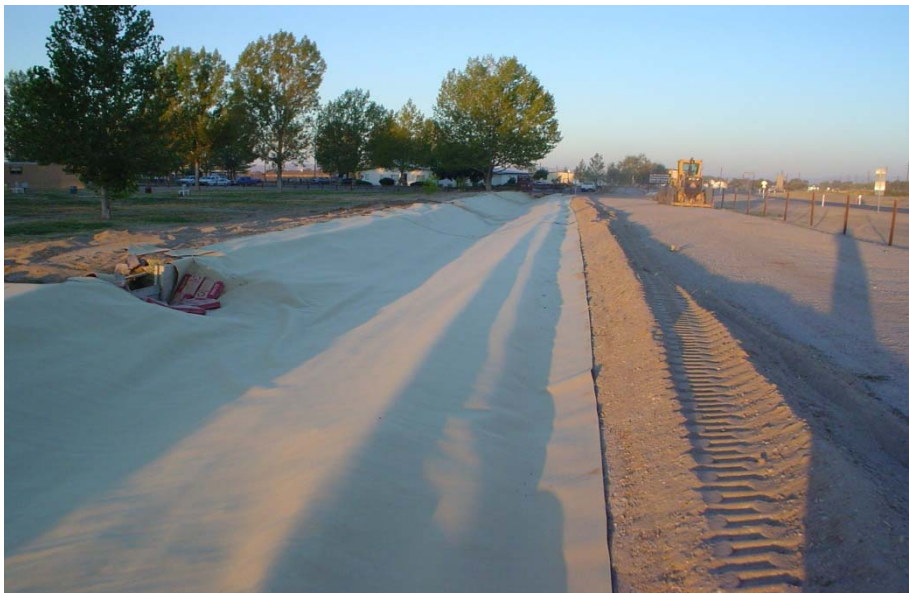
**V-Anchor Trench (2 – 5 ft side slope)**

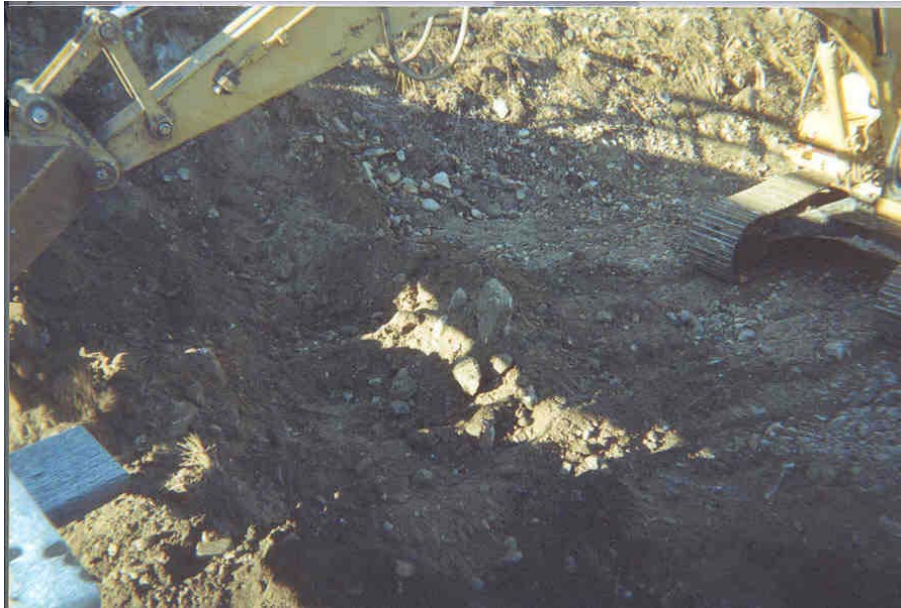
In a concrete canal this trench may be smaller as long as the water is not permitted to get under the liner.

**Cut-off trench excavated across the canal bottom (Earth)**

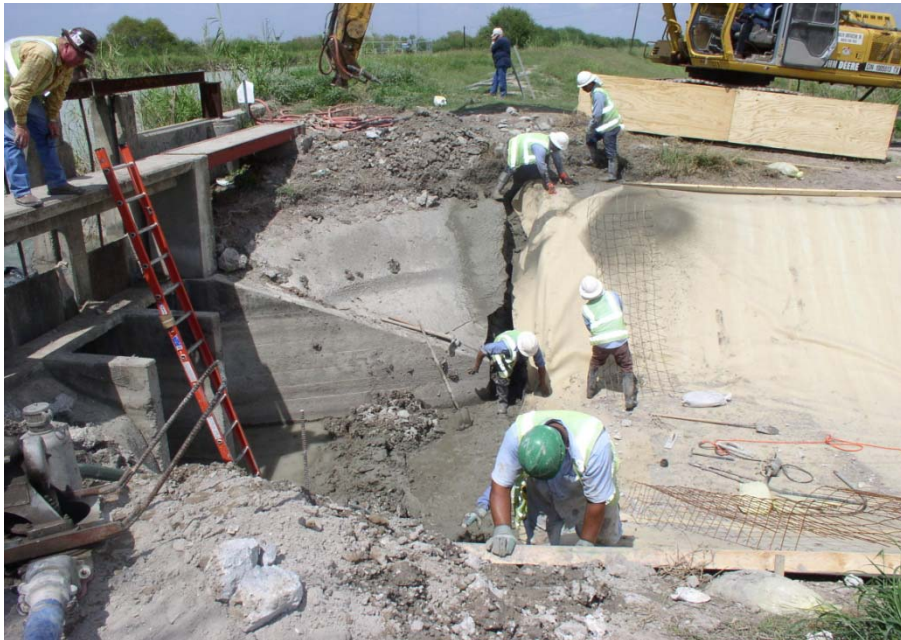
**Cut-off trench excavated across the canal bottom (Concrete)**

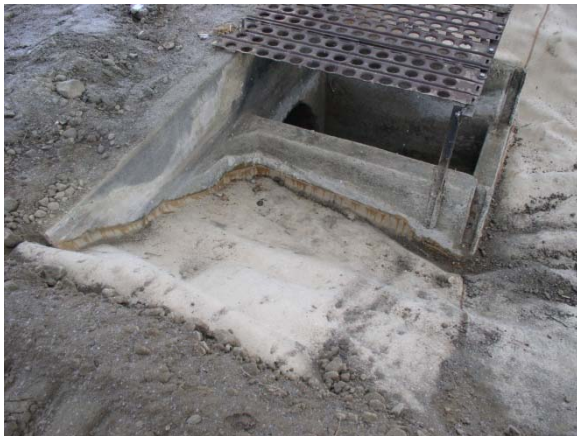
Where Huesker's Canal<sup>3</sup> is to be attached by a mechanical attachment to concrete, the concrete shall be thoroughly cleaned of all scum and scale. The area where the attachment is made shall be six (6) inches in width unless noted otherwise and fastened according to the detail below. Canal<sup>3</sup> can also be glued and mechanically fastened to any structure to avoid leaks. However, to avoid the high cost of this method, premixed concrete bags or sand bags may be placed on the liner next to the structure as tight as possible to stop the large leaks.

**Canal<sup>3</sup> glued to the side of the wall**

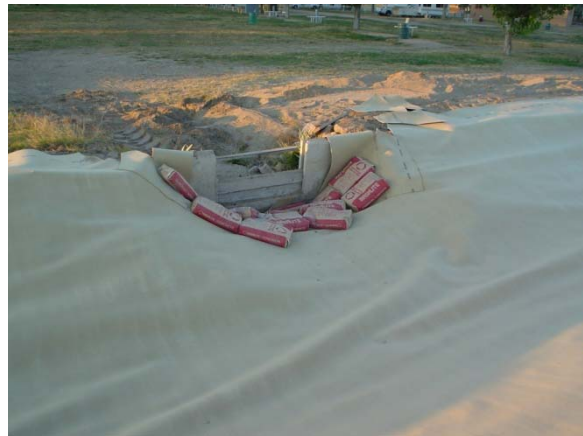
**Concrete bags used to hold material down**

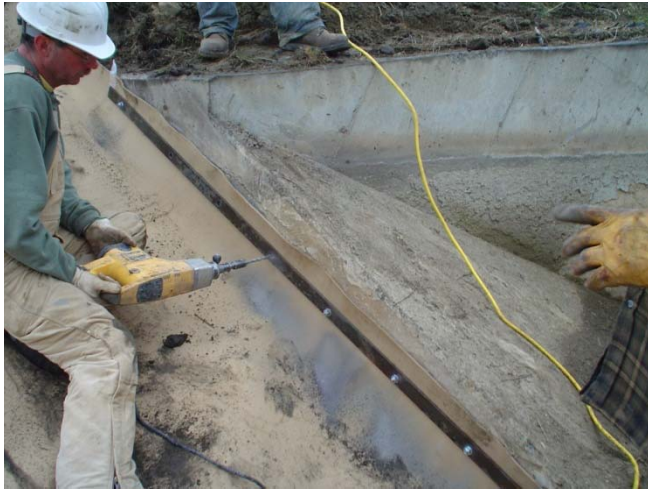
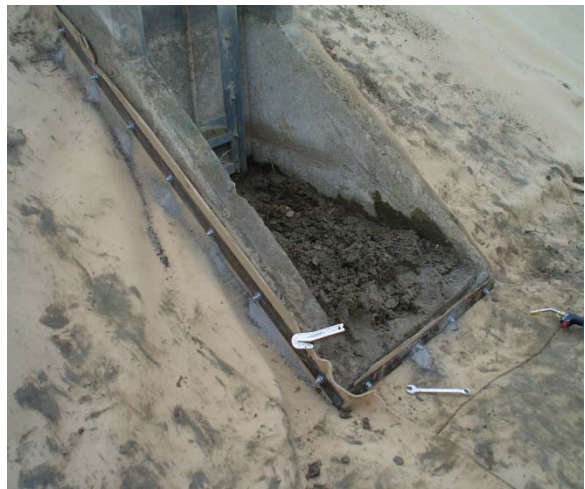
**ATTACHMENT TO CONCRETE (Vertical and Horizontal Walls continued)**

**Two inch steel batten strips anchored to wall with expansion anchors on one foot spacing**

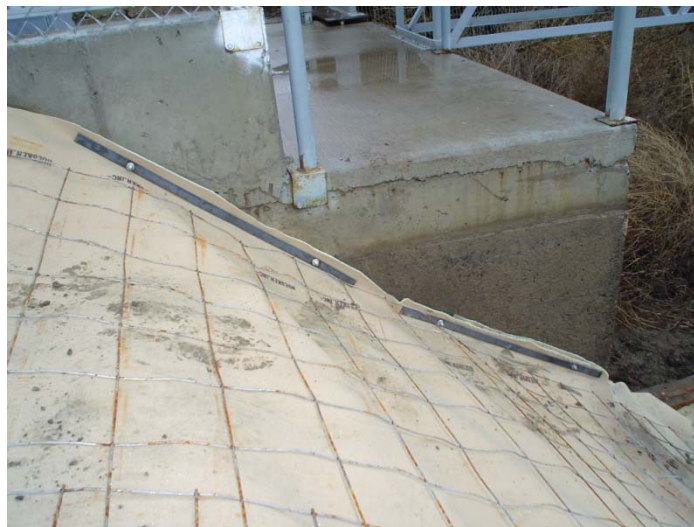
**Steel batten strips anchored to wall with two expansion anchor bolts on each end**

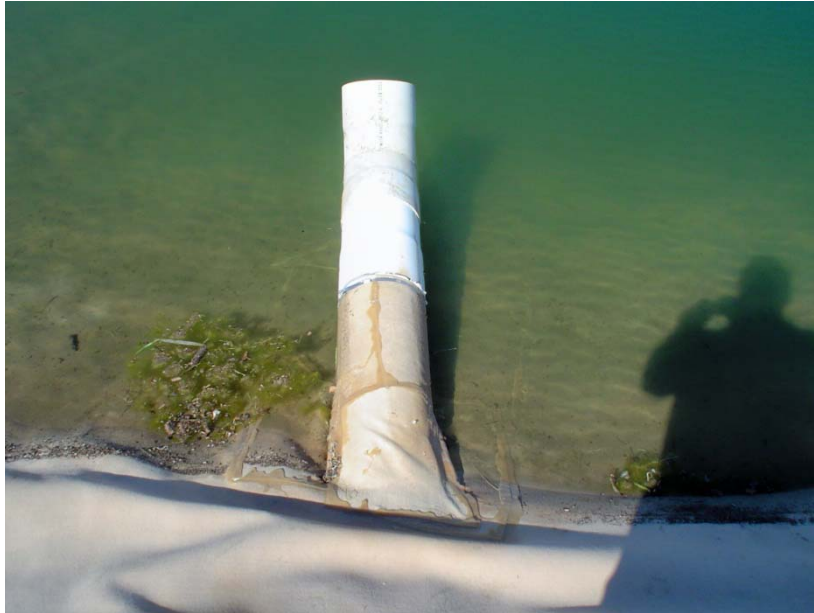
However, to avoid the high cost of this method, a premixed concrete collar may be used if the job was to be under concrete/shotcrete. Sand bags may be placed on the liner next to the pipe as tight as possible to stop the large leaks if the job was to be buried under earth.

**Finished boot around 12 inch PVC emergency outlet pipe**

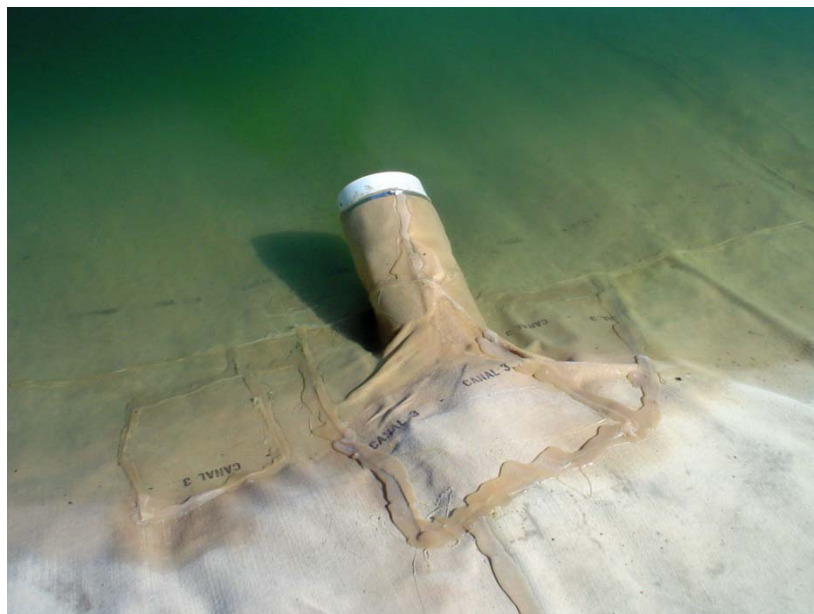
**Finished boot around 10 inch PVC fill pipe**

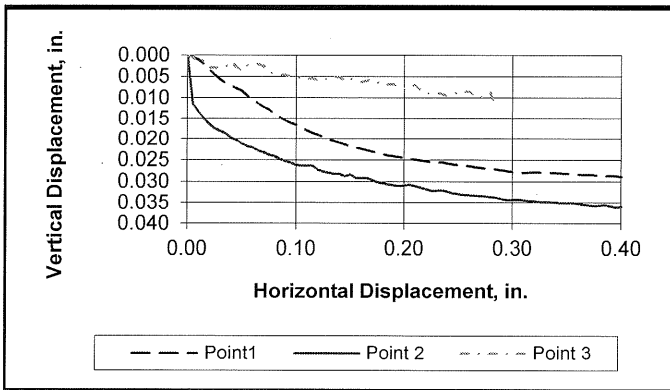
<b><math>c = 520 \text{ psf}</math>    <math>\phi = 28^\circ</math></b>	
Strength Parameters were determined from linear regression of the PEAK shear stress values	
Project and Sample Information	
Project Number	1150135
Project Name	Lover's Lane
Sample Identification	A-2 @ 39'
Sample Description	Fat Clay (CH)

Test No. (Symbol)	1 (▲)	2 (■)	3 (●)
Test Type	Consolidated Drained Wetted		
Sample Type	Undisturbed		
Length, in.	1.00	1.00	1.00
Diameter, in.	1.93	1.93	1.93
Dry Density, pcf	71.9	71.2	69.9
Moisture Content, %	51.1	51.1	51.1
Consol. Load, ksf	4.0	2.0	1.0
Normal Load, ksf	4.0	2.0	1.0
Shear Stress, ksf	2.66	1.58	1.06
Rate of Strain	.001 in/min

Each sample point was wetted when loaded and the sample point was allowed to consolidate. After consolidation, each sample point was sheared.
