CEEn-2018CPST-012

Centilium Engineering

## Problem Statement

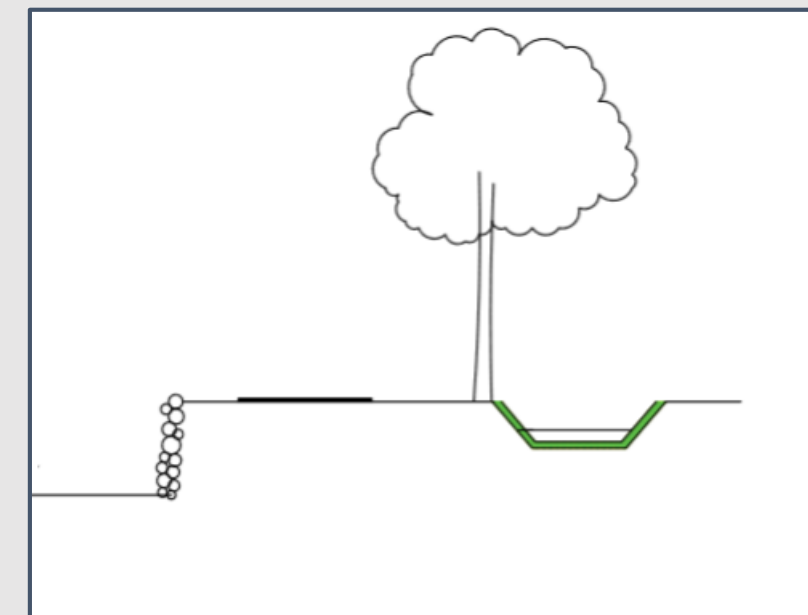
**Solution 1: Reline the canal with concrete or geo-membrane liner**

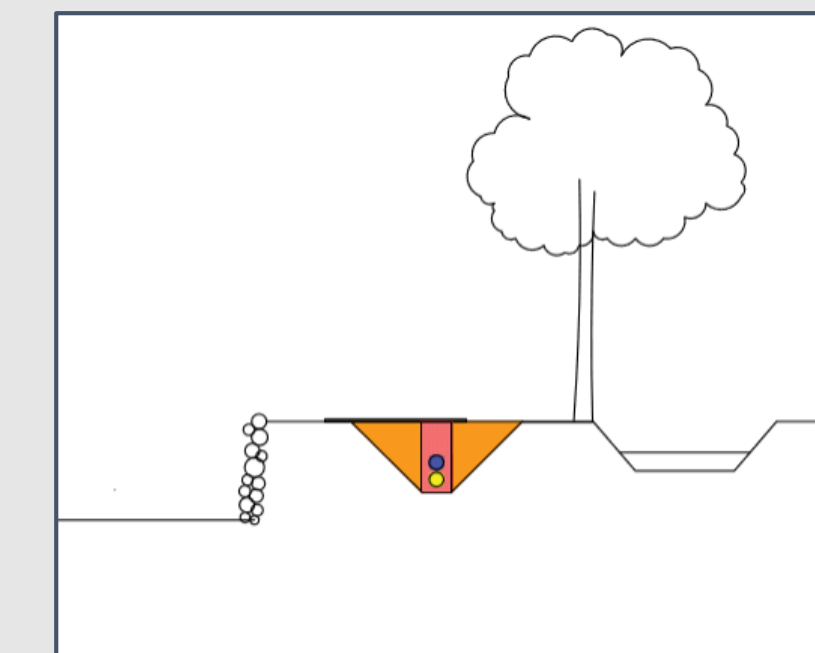
**Solution 3b: Install 2 hdpe pipes to carry water from the pond and carry water to the pond to increase circulation in the cut-off wall**

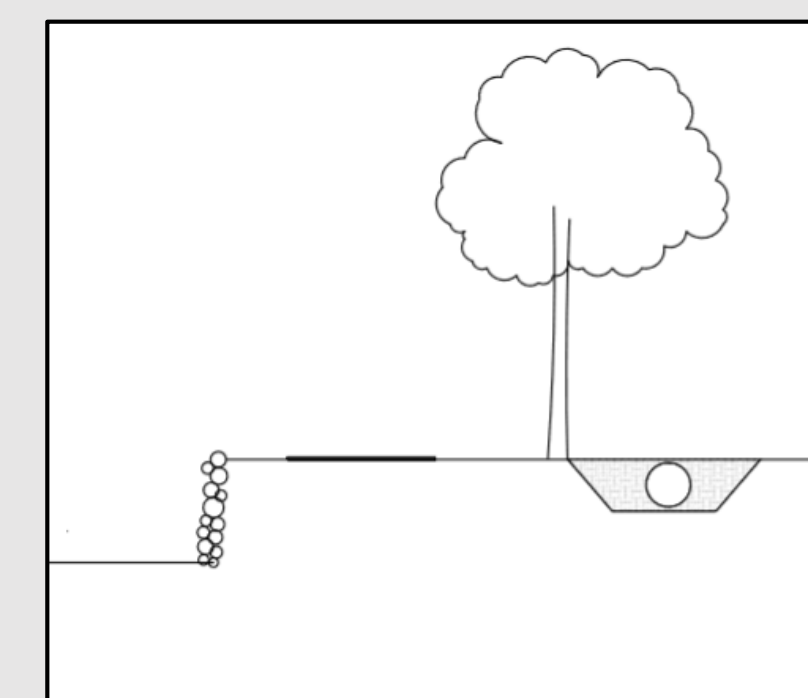
**Solution 2: Encase the entire canal in HDPE pipe**

The recommended solutions to mitigate the breach and improve water quality are solutions 3 and Solution 5. Solution 2 to mitigate the breach proved to be the most expensive solution initially, however, it eliminates the potential of overtopping. If the canal were to overtop, the expense to the city would be more than piping the canal. All other solutions presented run the risk of overtopping and, within minutes of canal flow being impeded by debris or fallen trees, flooding all of the residential basements south of the canal. Solution 5 is the most cost effective and minimizes negative effects while still providing improved water quality.

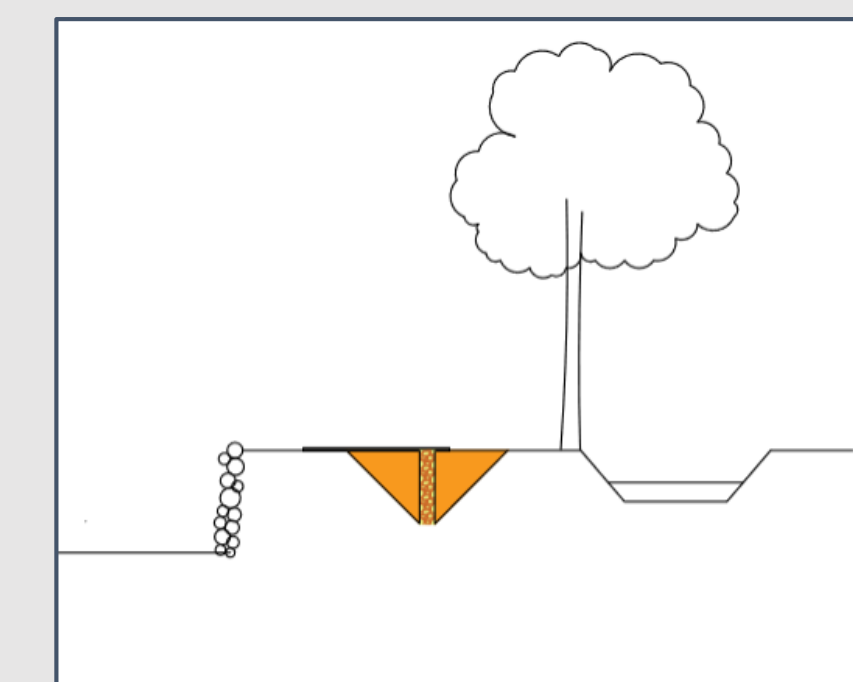
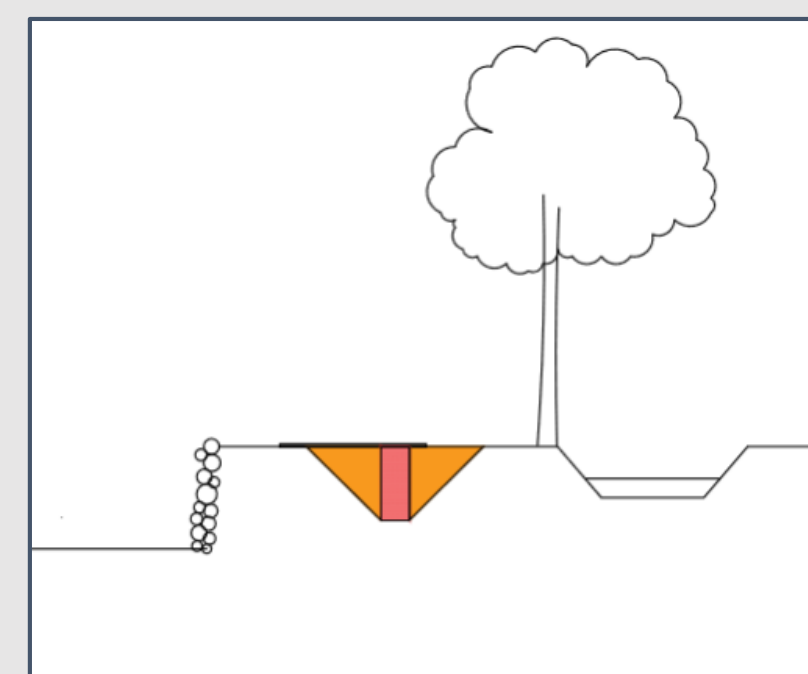
**Solution 4: Install a french drain and perforated pipe to remove the excess groundwater**

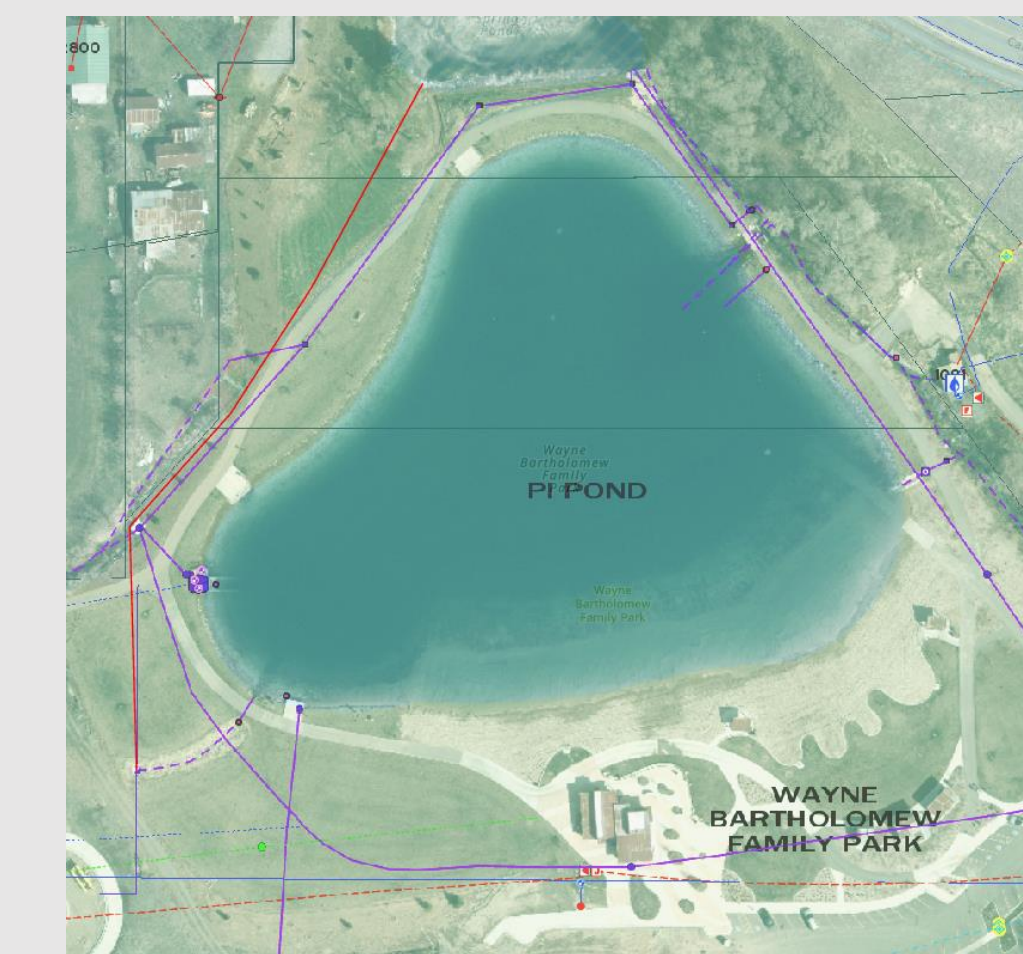
**Solution 3: Install a concrete cut-off wall running the length of the canal**

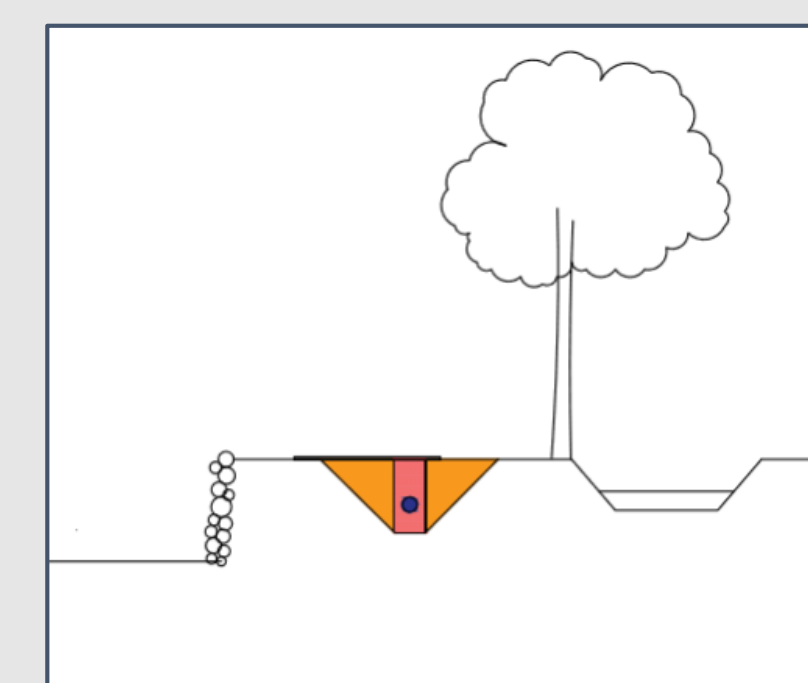
**Solution 3a: Install HDPE pipe to carry the majority of the canal flow in the cut-off wall**

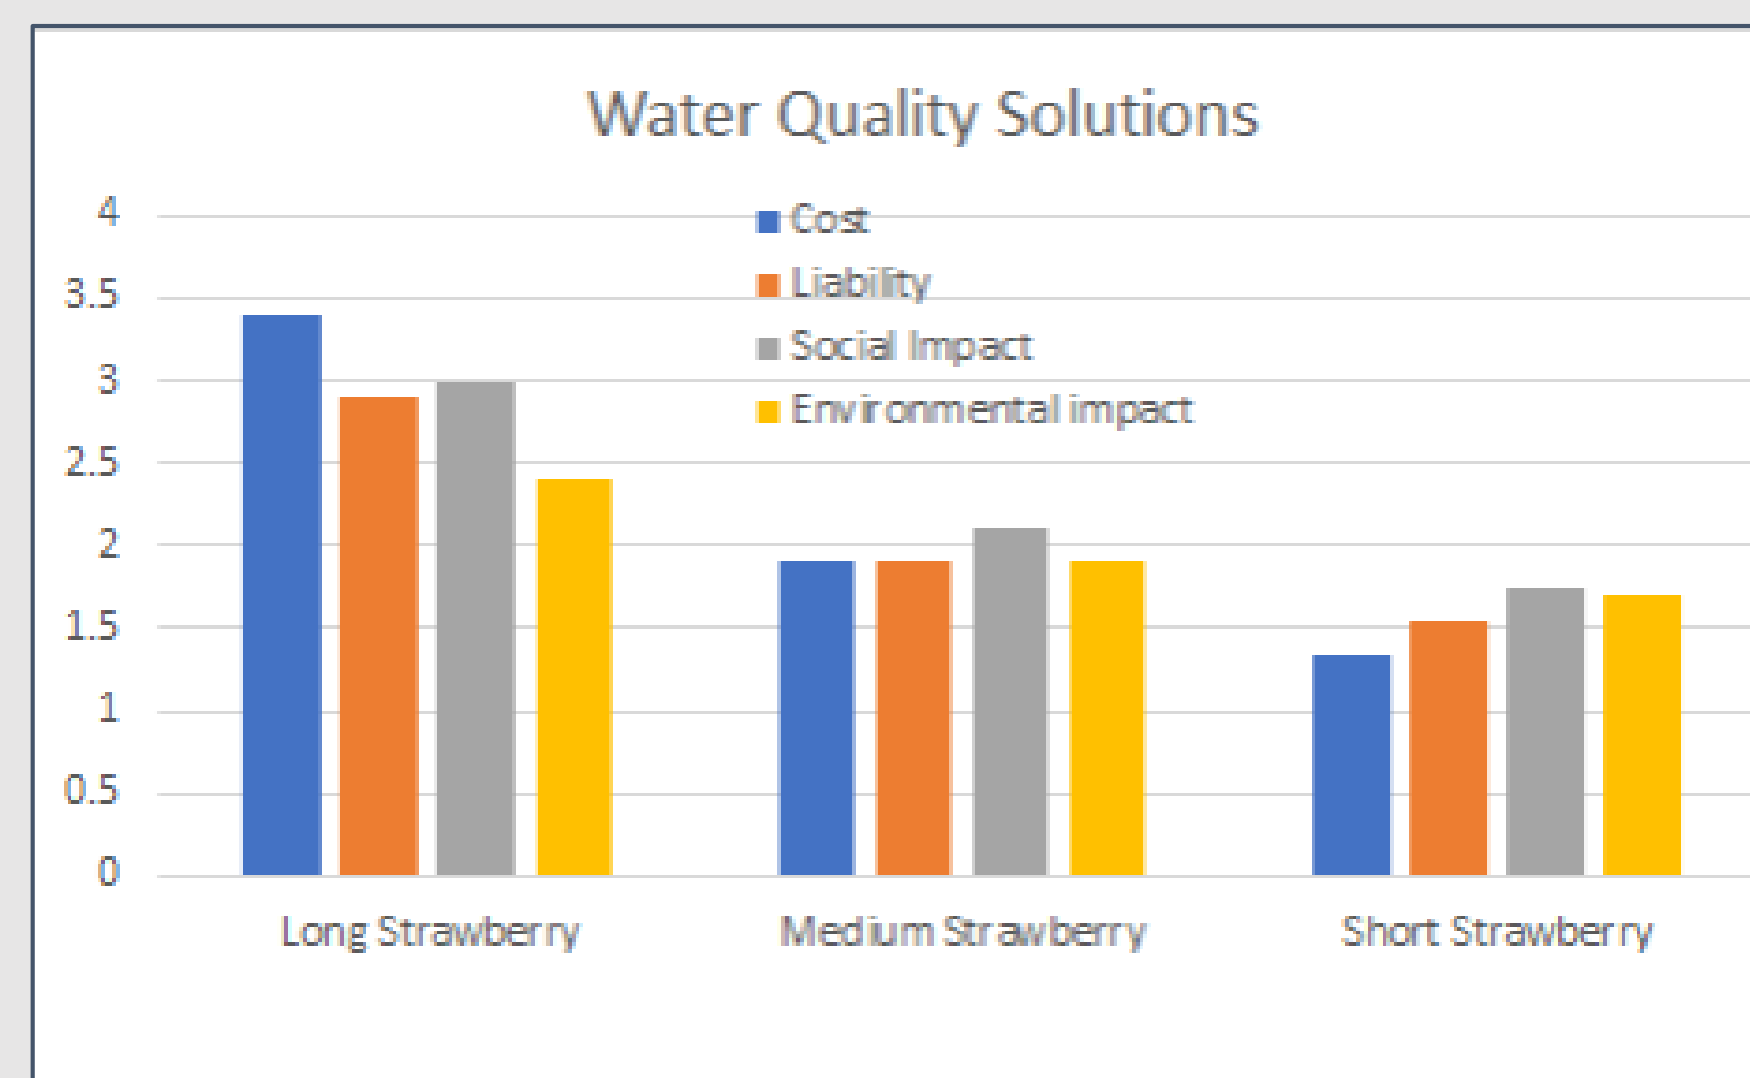
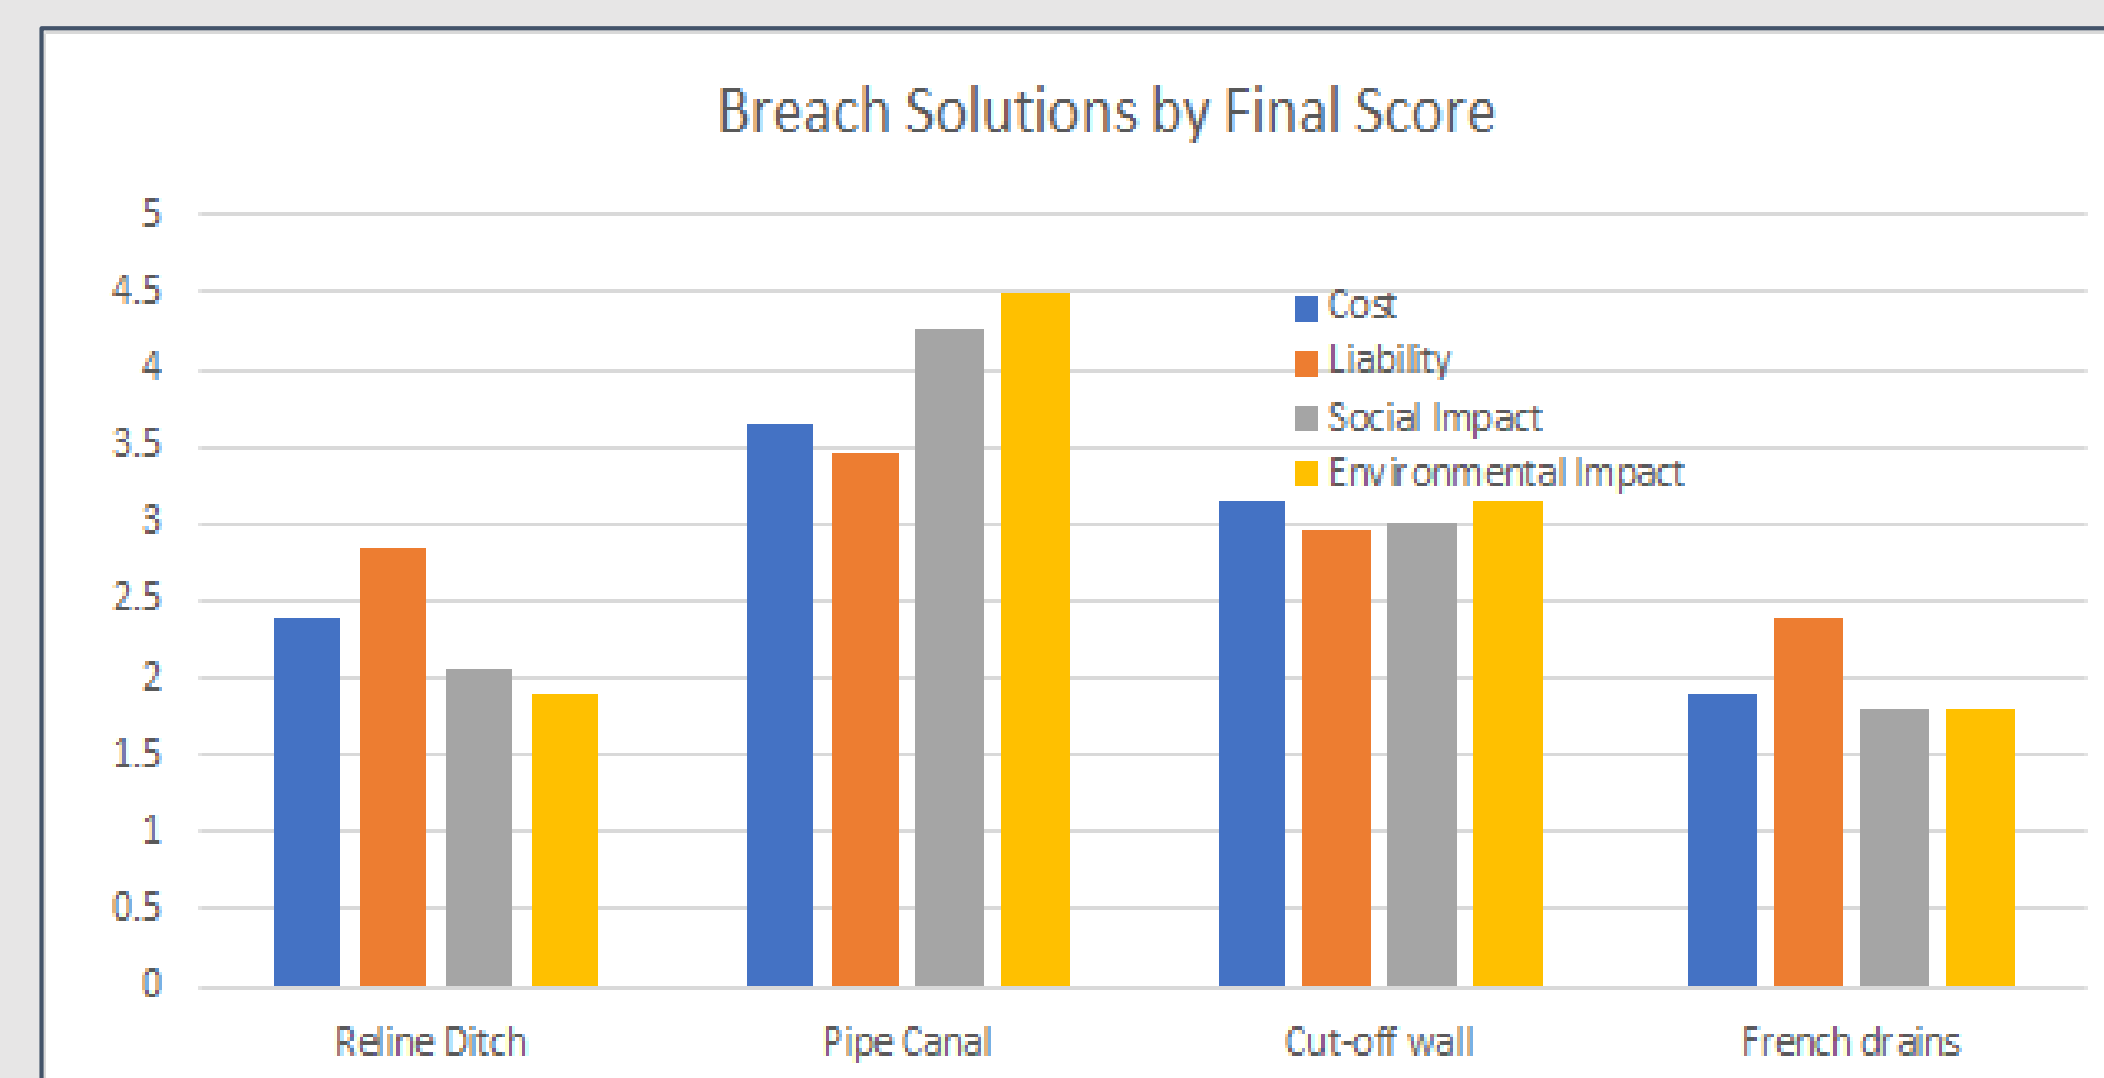
The potential solutions were analyzed according to their cost, implementation, social impact, environmental impact, aesthetic, environmental impact, and liability. The solutions were ranked by how well they scored in each category and a weighted average was taken to identify the optimal solutions. Some of the results are posted to the right. It was also considered what would happen if the canal were to overtop.
