**CAMP BEN LOMOND AND CAMP SHAWNEE  
WATER TANK ANALYSIS  
Project ID: CEEn\_2017CPST\_012**

**Genesis Engineering**

**A Capstone Project Final Report  
Submitted to**

**PROJECT TITLE:** Church Camp Water Tank Analysis  
**PROJECT ID:** CEEEn-2017CPST-012  
**PROJECT SPONSOR:** The Church of Jesus Christ of Latter-Day Saints  
**TEAM NAME:** Genesis Engineering

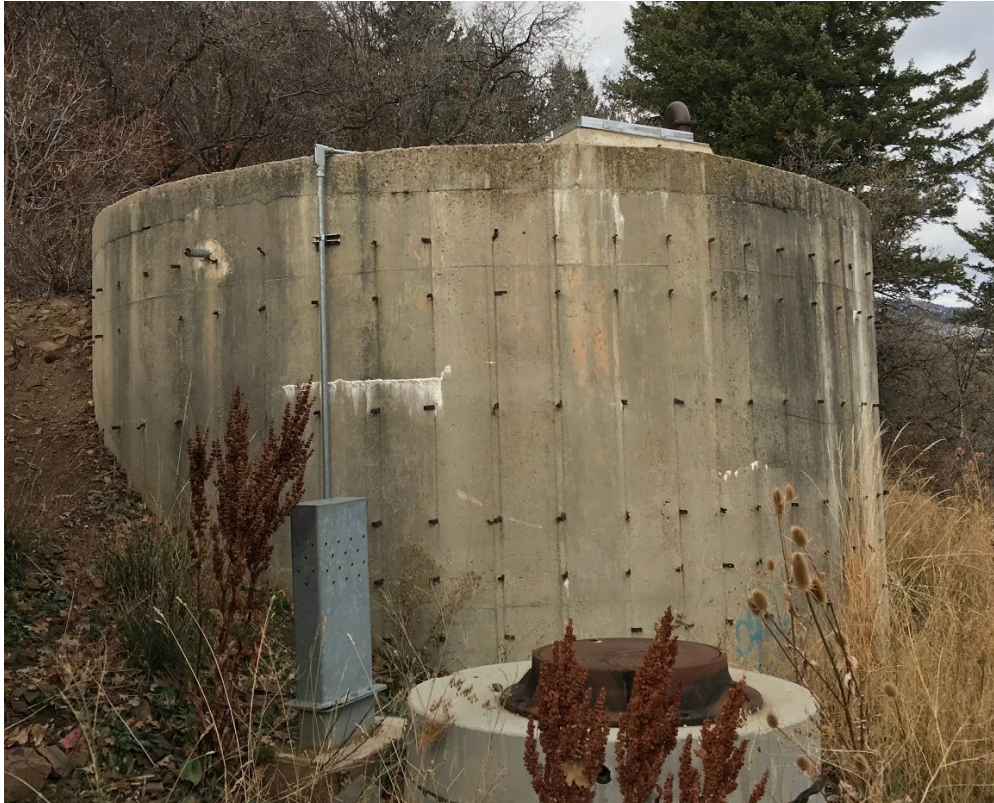
In October 2017, a preliminary site visit was performed to observe the general condition of the two water tanks. This visit helped to better reveal the scope of the project. From the site visit we could easily see that the tanks were rather old. The top of the south tank exhibited spalling and exposed rebar. There were, additionally, signs of past leakage through cracks on the sides of both tanks. Included below are pictures of the north tank, and south tank respectively.

North Tank - Treated Water

The tanks are built partially into a hillside. Signs of past leakage are visible on both tanks. It also appears that the tanks were built at different times, or in different manners. This is evident from small differences in lids, tank tops, color, and general condition. The north tank appears to be newer than the south tank.

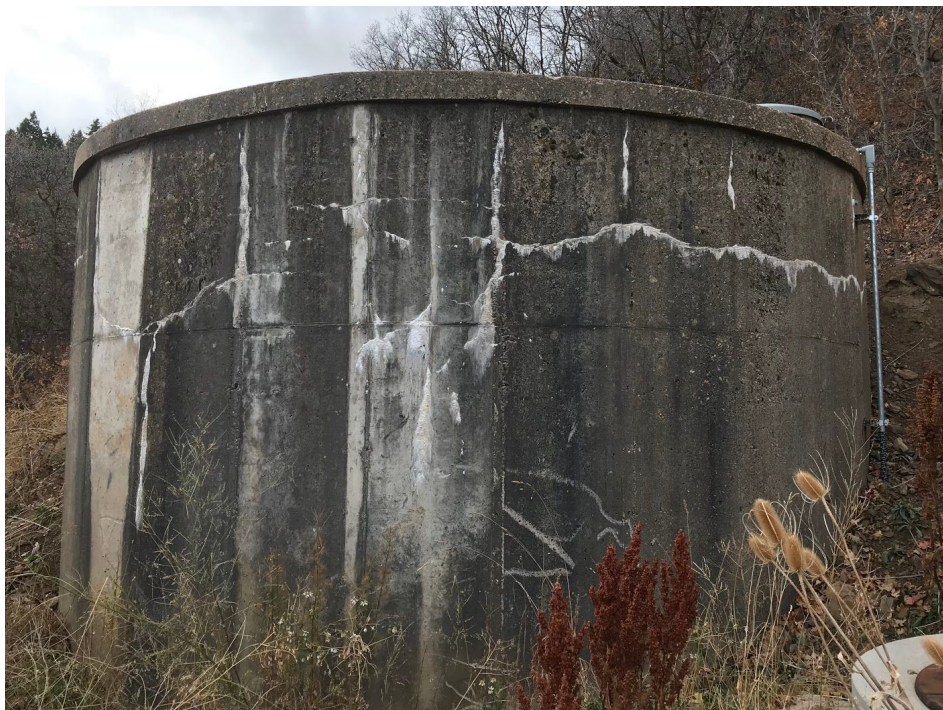
South Tank - Raw Water

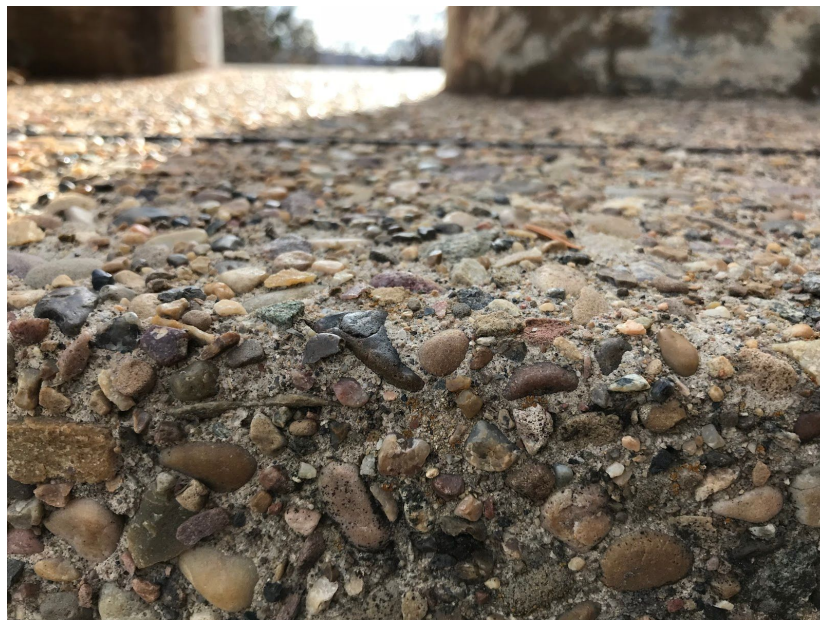
During our site visit a few months ago, we observed several signs of wear that could result in tank failure at some point. The first thing that we observed was significant spalling on the South tank. The top of the tank had significant amounts of concrete worn off, exposing the aggregate on top (see picture below).

Spalling on top of the South Tank

To further specify the recommended course of action, Xypex concentrate should be used to coat the insides of both tanks, and the outer tops of both tanks, to prevent further wear from precipitation. In areas where cracks larger than 0.4 mm are found, the cracks will have to be chipped out to a depth of 1.5 inches and width of 1 inch, then cleaned and wetted, to apply a brush coat of Xypex concentrate. After drying the rest of the crack must be filled with Dry Pac, which is another product sold by the same company. After all the Xypex has been applied, it must be allowed to cure for 3 days, and set for 12 days before filling again with water. More detailed instructions on the use of Xypex can be found on the product data sheets available on their website. It is estimated that 11 of the 60 lb buckets of Xypex Concentrate will be needed to complete the task.

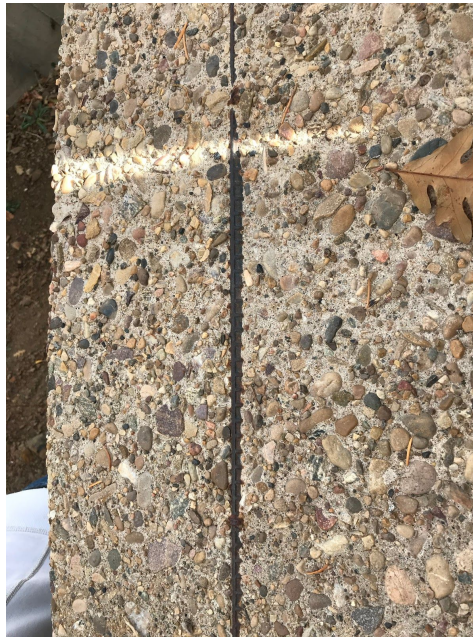
Another related sign of wear was that of exposed rebar on the South Tank (see picture below).

Exposed Rebar on top of the South Tank

It is unknown if these defects will directly lead to the failure of the tank, but it is cause for concern.

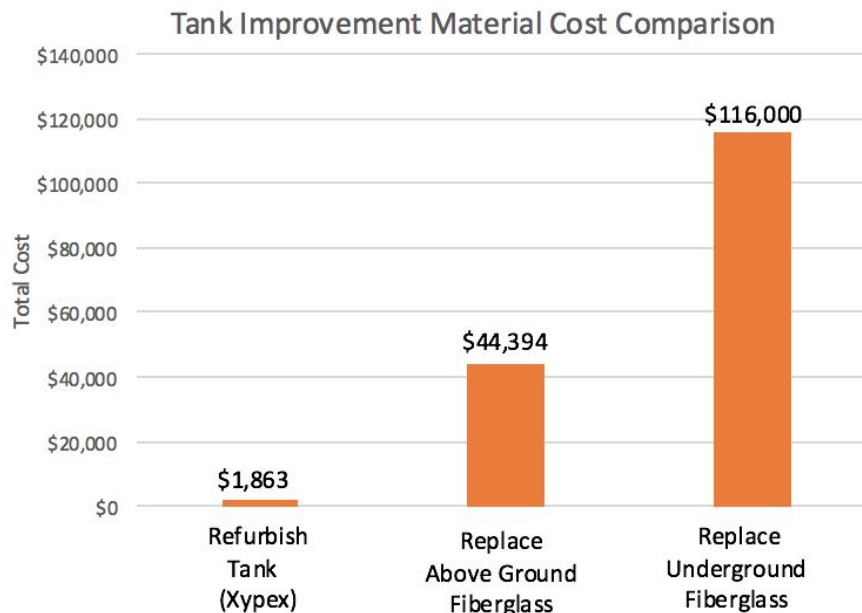
Also, as previously pointed out, the cost of Xypex when compared to the cost of replacement is small (See Figure 1 Below). Xypex has the possibility of extending the lifetime of the tanks for several more years, perhaps even beyond that. According to the Xypex website, if installed properly it is considered permanent and requires no maintenance. With that in mind it would appear the best course of action.

**Figure 2: Price Comparison of Replacement Options**
