CEEn-2017CPST-001

Structural & Geotechnical Report

# ARROWHEAD CENTER

KADD Engineering

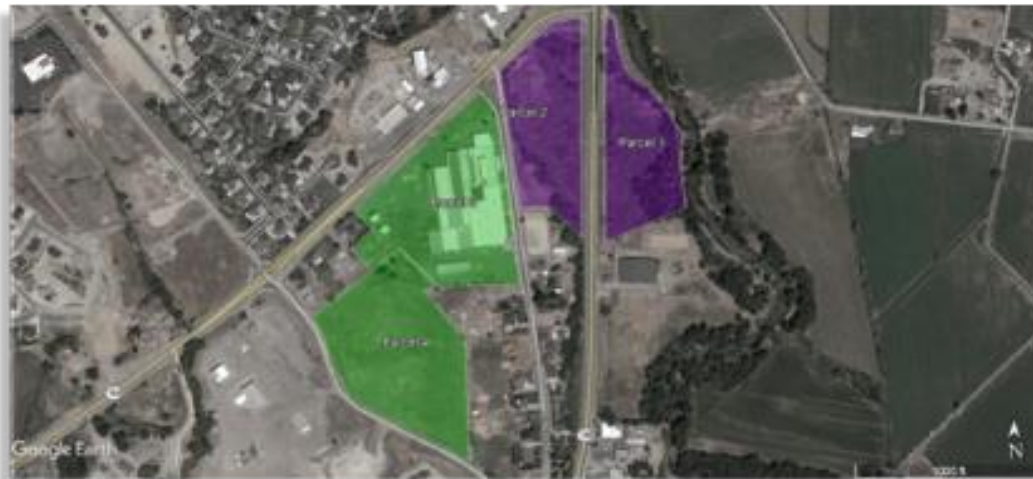
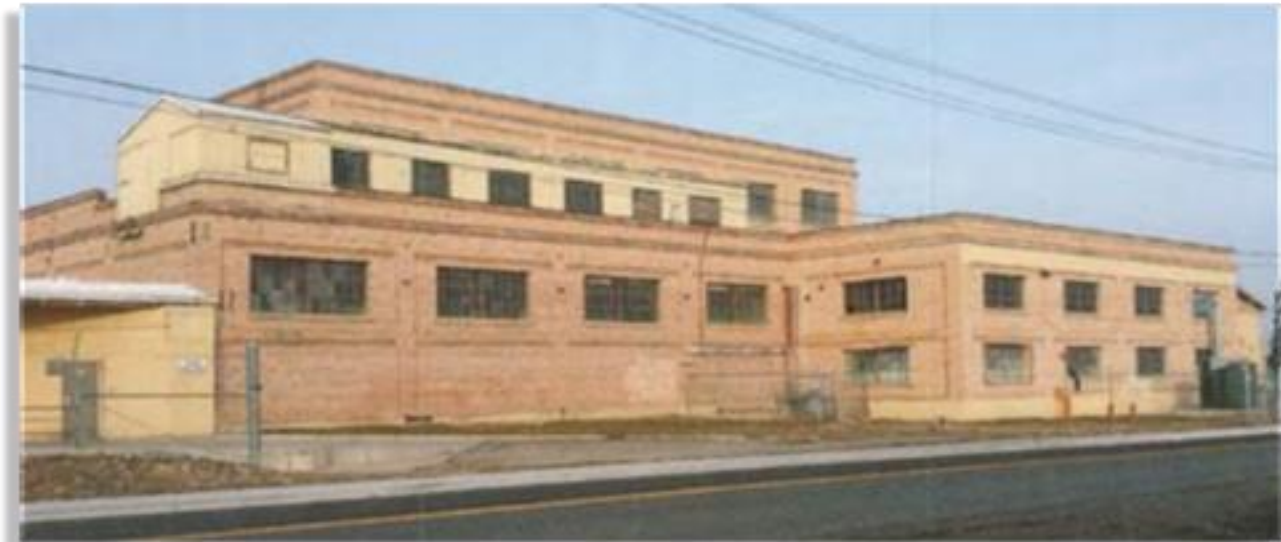
- Geotechnical reports were provided for the plots shown to the left.
- It was determined that Plot 1 is located in a floodplain and precautionary measures will need to be undertaken, such as perimeter drainage.
- The soil for Plots 2-4 are adequate to support residential structures and will not need to be altered.
- Structures built on Plot 1 with bearing pressure in excess of 1,500 psf should be constructed on compacted fill.
