**ARROWHEAD STRUCTURAL/GEOTECHNICAL**  
**Project ID: CEEEn\_2017CPST\_001**

**A Capstone Project Final Report**

**Fritzi Realty**

**PROJECT TITLE:** Arrowhead Structural/Geotechnical

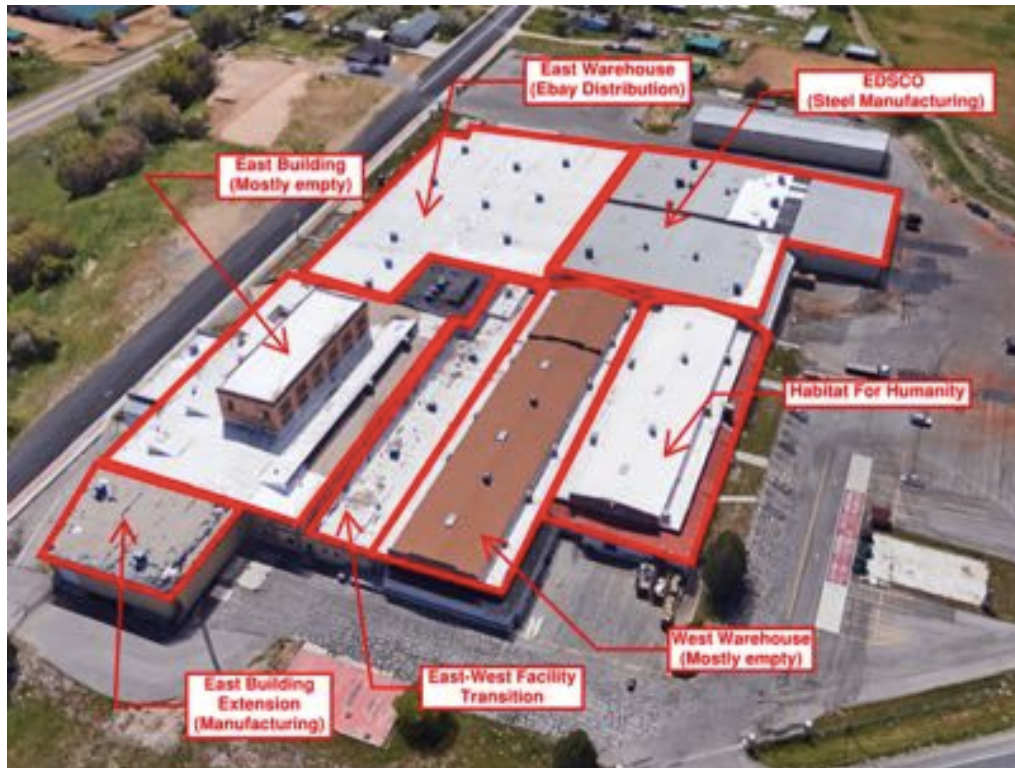
Figure 16. Arrowhead Center configuration.

Two main areas of the building had steel framing: EDSCO and the East Warehouse (see Figure 16 in the appendix). Some columns have been damaged by workplace accidents in the EDSCO section. These columns should be inspected and analyzed by a licensed engineer to determine structural adequacy. Analysis of the EDSCO shed roof and warehouse open web trusses showed compliance with the current building code used in Spanish Fork. The analyses were based on measurements taken by engineers in training and should be verified by a licensed structural engineer before use in design. The East Warehouse seems to be in overall good conditions.

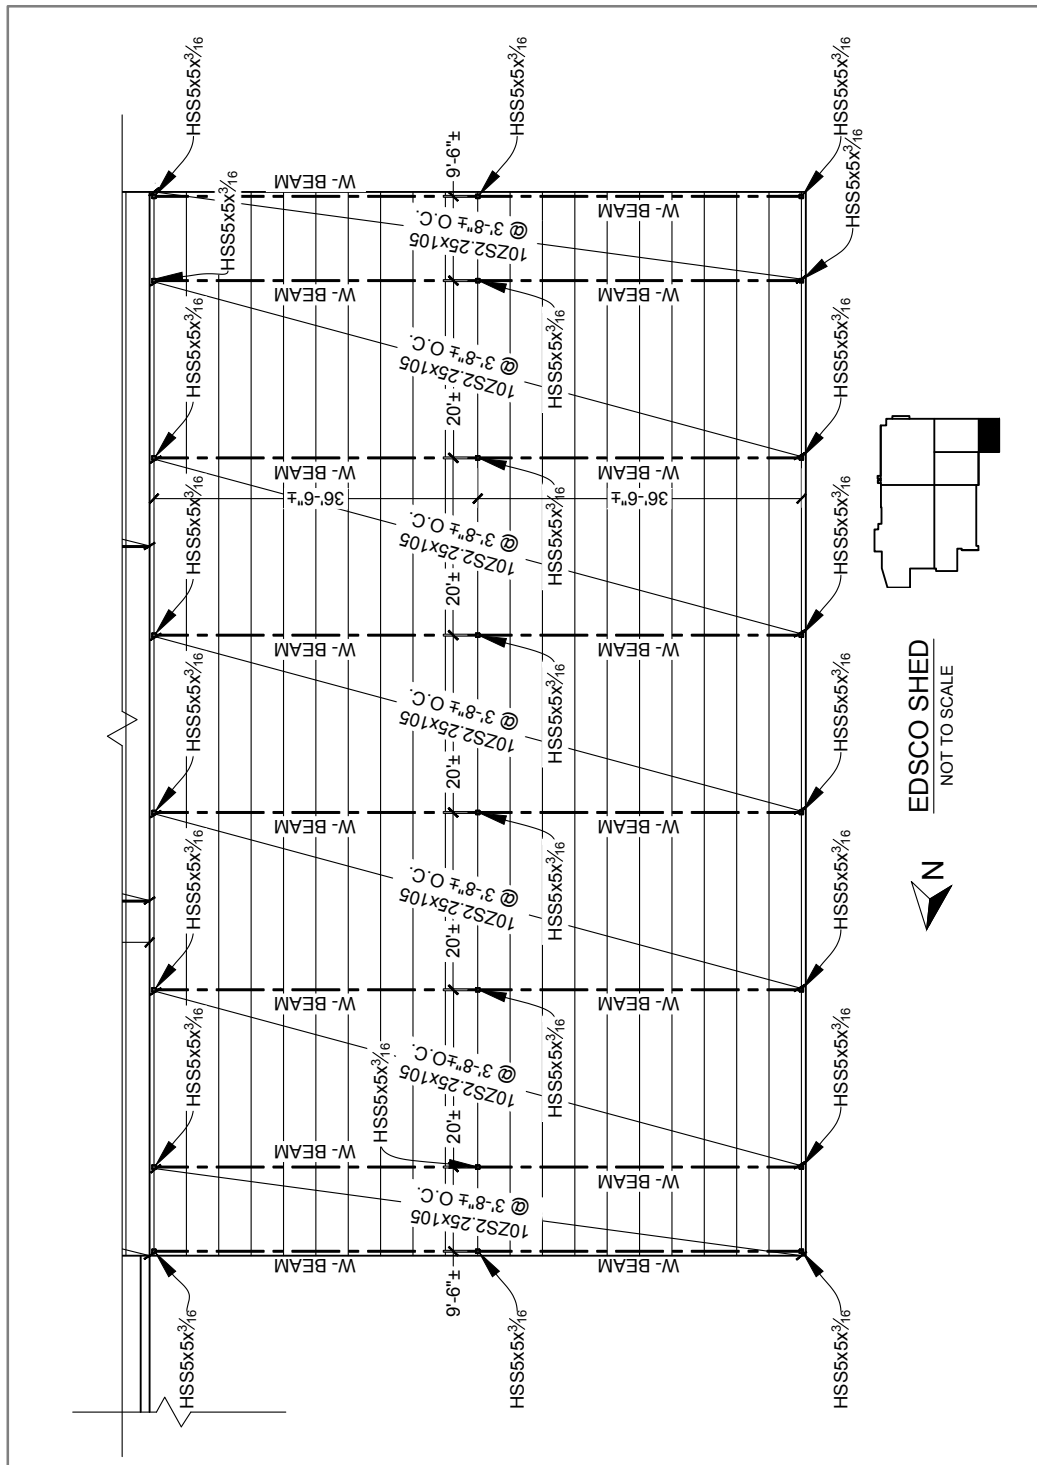
Figure 20. EDSCO Shed approximate structural plan.

RISA 2D was used to analyze the steel Z-purlins supporting the metal deck roof in the EDSCO shed structure (shown below). A roof live load of 20 psf and a dead load of 3 psf were assumed. (Only supporting metal seam and weight of beam is included in RISA automatically.) Using ASCE 7-10, a ground snow load of 45 psf was reduced to a roof snow load of 33 psf (see Figure 22 in Appendix A). These loads were converted to linear loads of 70 plf for the roof live load (L), 10.5 plf for the dead load (D), and 116 plf for the snow load (S). Calculations for this conversion can be found in Figure 23 in Appendix A. The governing LRFD load combination was  $1.2D+1.6S$ . With these loads, the Z-purlins of the roof structure in the EDSCO shed were found to be adequate to support the factored loads according to the International Building Code, 2015 and ASCE 7-10, supporting 86% of their factored capacity. The RISA analysis of these members can be seen in Figure 24 in Appendix A. Due to inadequate information, the supporting beams and columns of the EDSCO shed were not analyzed as a part of this project.
