CEEn-2016CPST-003

LID APPROACH EFFECTIVENESS & FUNCTIONALITY STUDY

Team LID

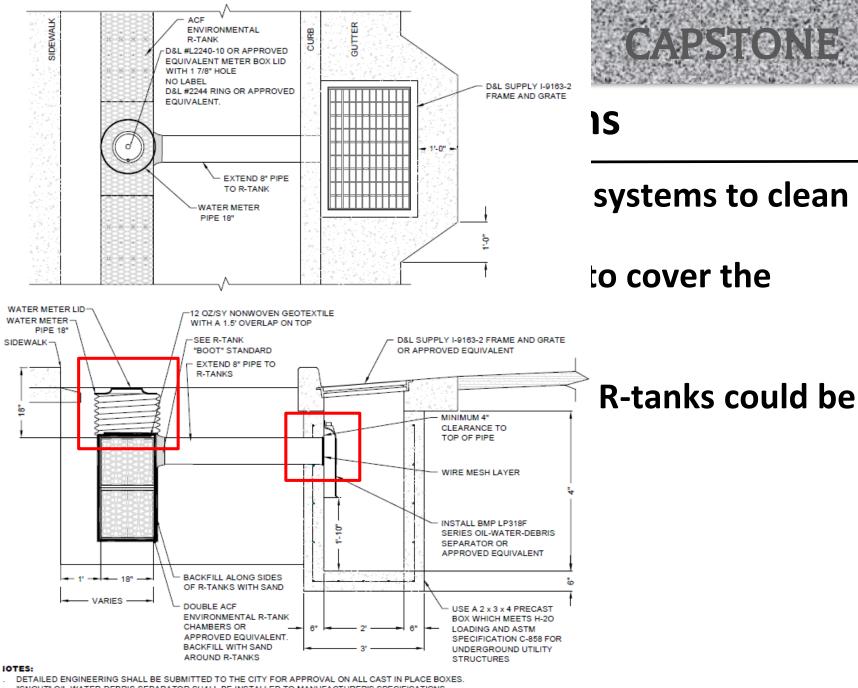
- "SNOUT" OIL-WATER-DEBRIS SEPARATOR SHALL BE INSTALLED TO MANUFACTURER'S SPECIFICATIONS.
- ALL PLANTER AREAS BETWEEN THE CURB AND SIDEWALK SHALL BE LANDSCAPED WITH PERVIOUS MATERIALS UNLESS OTHERWISE APPROVED BY THE CITY ENGINEER OR DESIGNEE.
