Purpose

Re-design the Daybreak Parkway Couplet in South Jordan, UT in order to reduce the 85th percentile speed from 35 mph to 25 mph by implementing various traffic calming methods.

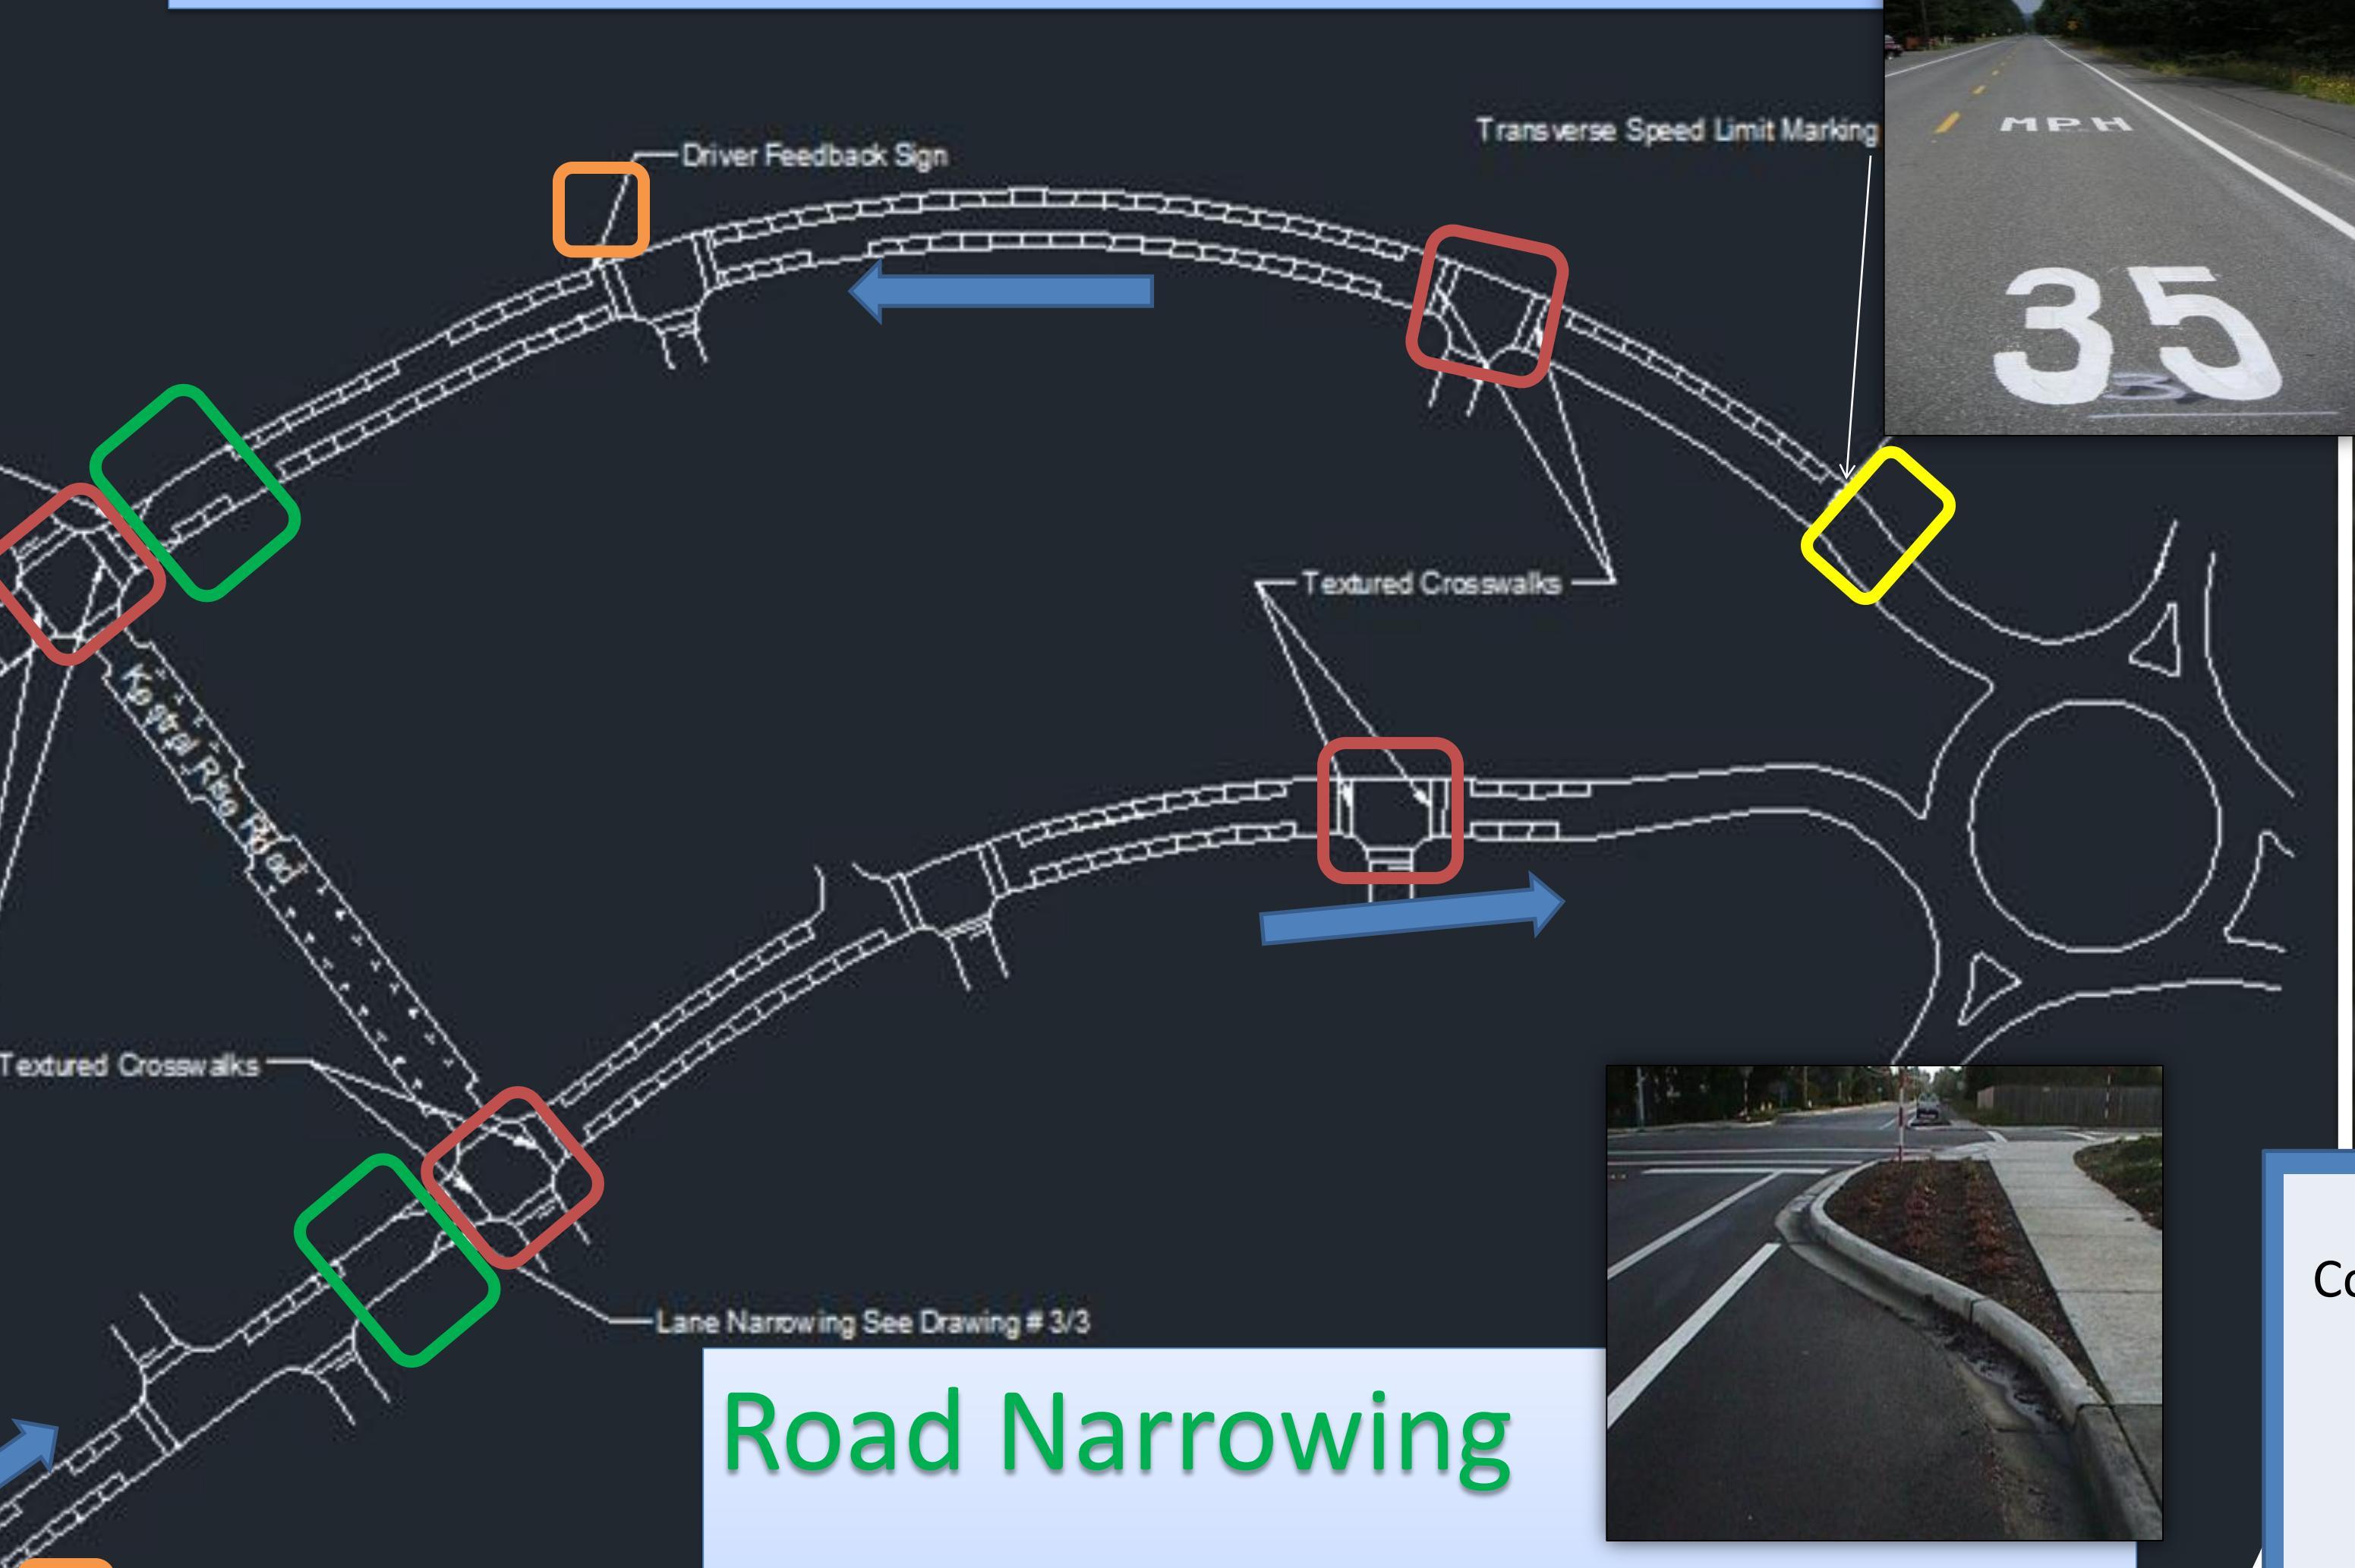
iver Feedback Sign

Driver feedback signs are an active way of encouraging speeding drivers to slow down by displaying the vehicles current speed. In this case they are placed about 400ft before Kestrel Rise road so that drivers will have adequate time to slow down before entering the most developed regions of the Daybreak Parkway couplet. This method has been found to reduce speeds anywhere from 5-9 mph.
